Aquatic Facility Evaluation

Weston Aquatic Center
Weston, Wisconsin

September 14, 2016

Water Technology, Inc. (WTI)
100 Park Avenue, PO Box 614
Beaver Dam, WI 53916
www.wtiworld.com

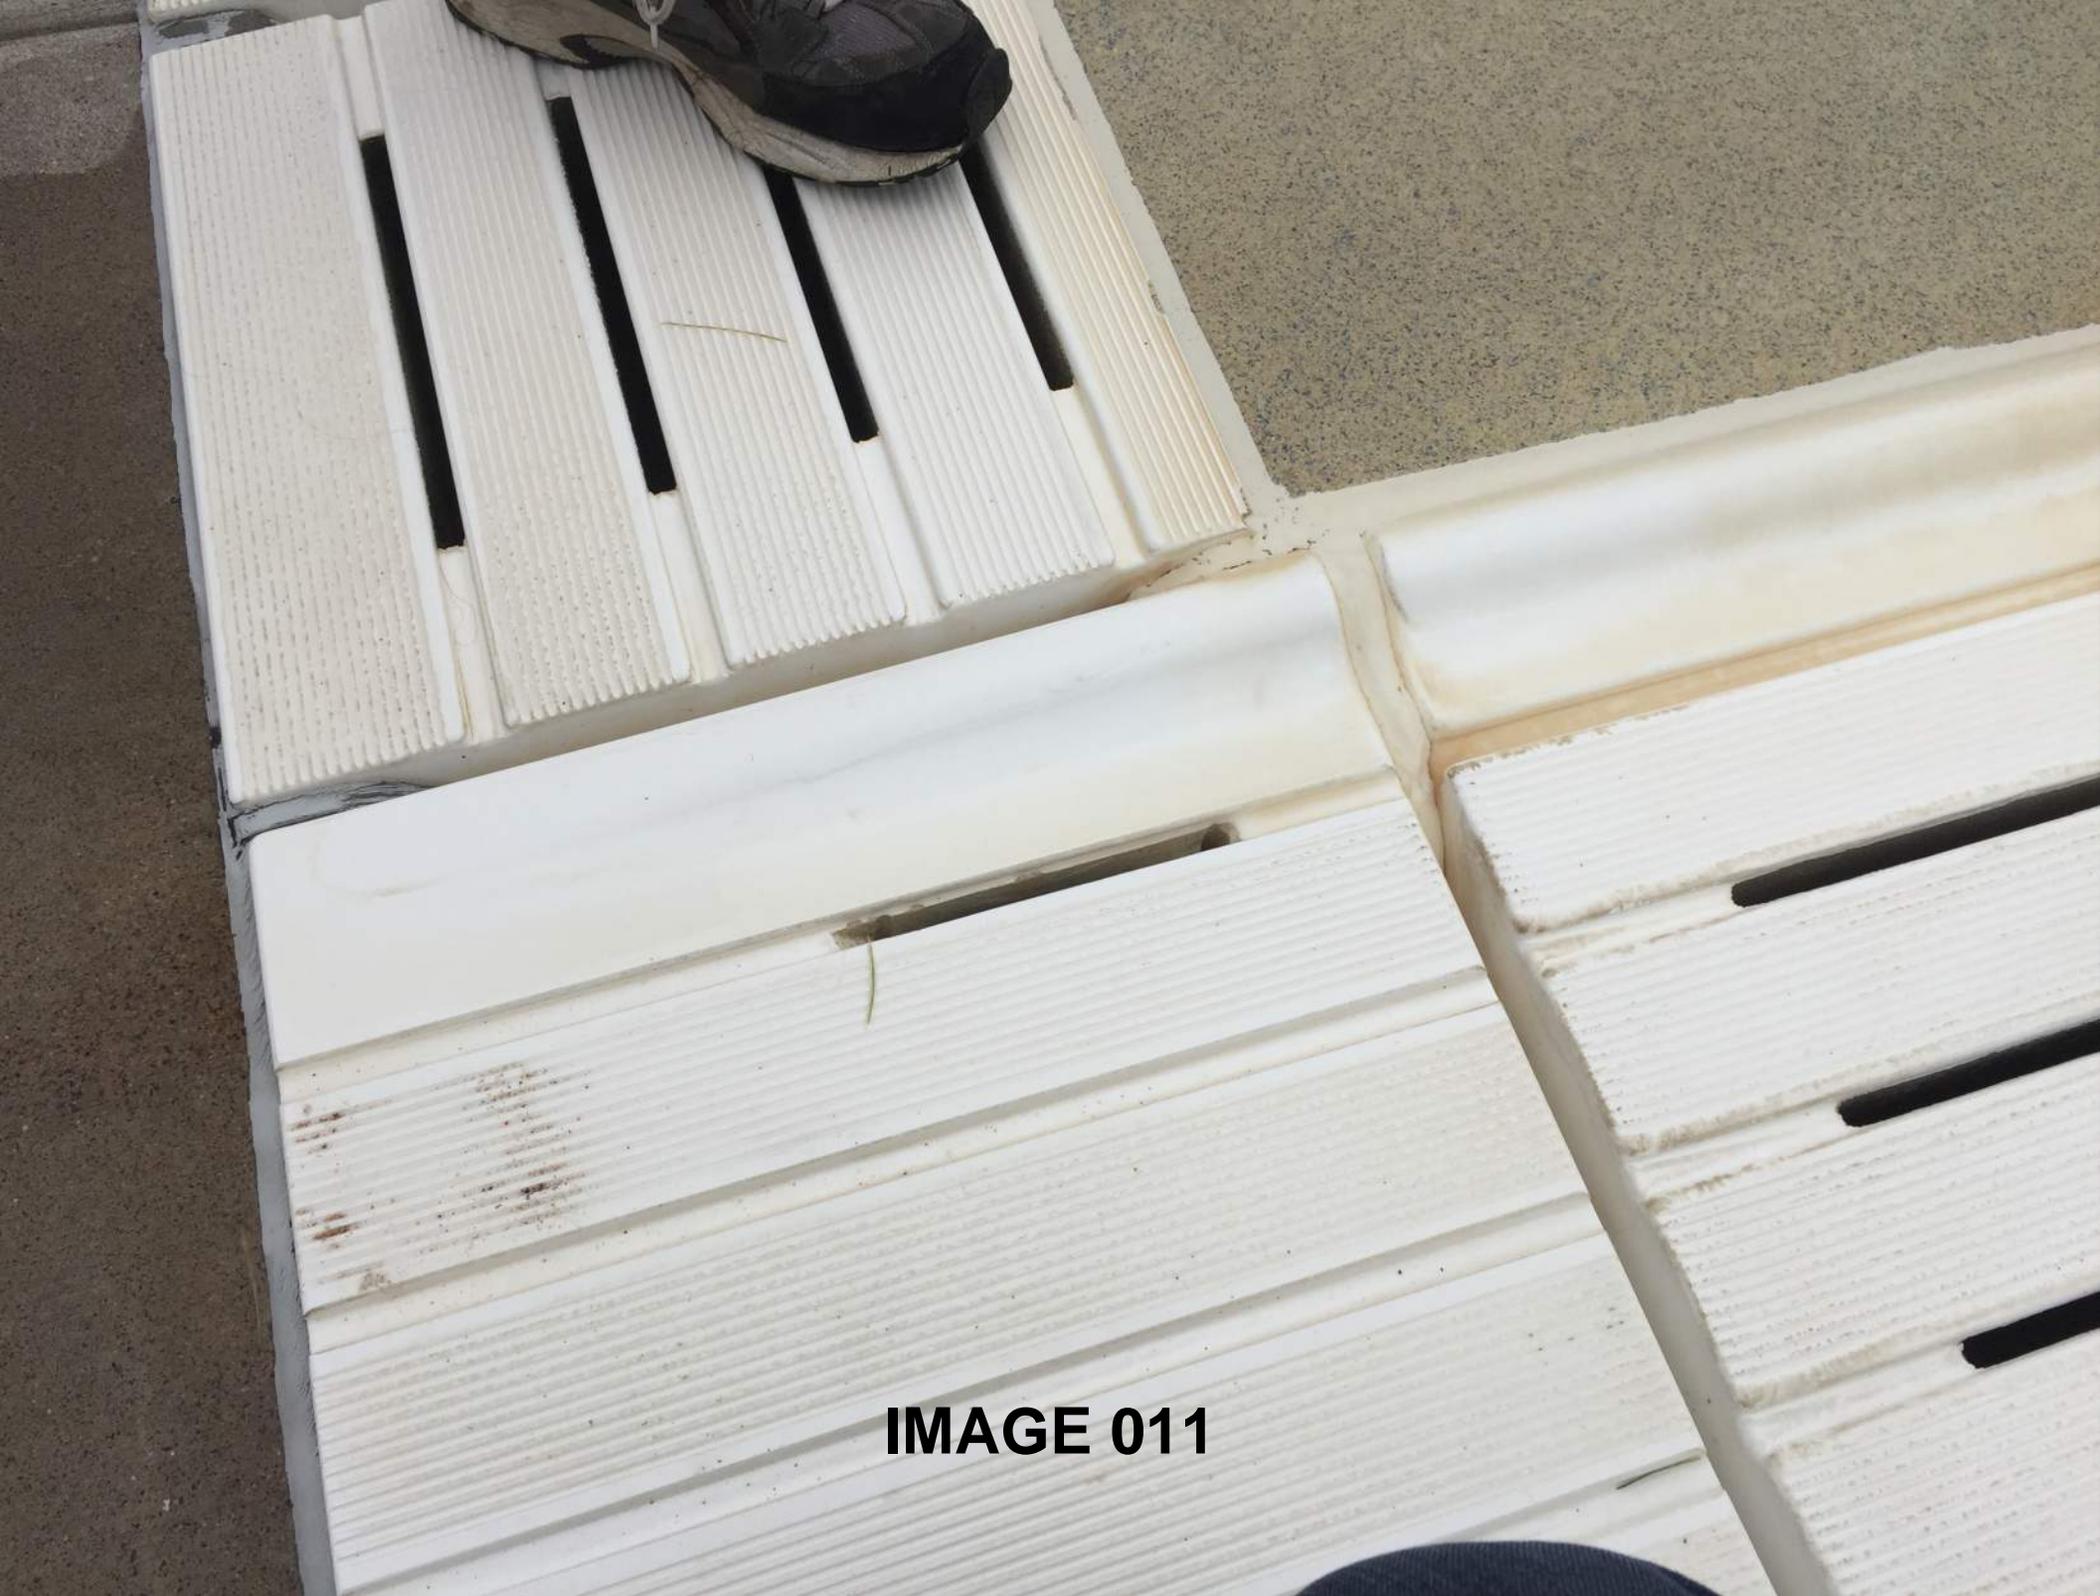
IMAGE 010

There are two locations of the pool gutter which allow water to escape the pool and puddle on the deck. The first area is at the corner of the pool in the zero depth area adjacent to the play structure. The gutter grating was installed in this corner using sections configured in a way to allow water to channel in the indentations of the grating and bypass the openings in the grating. Staff has since cut additional openings in this section of grating and have greatly reduced the amount of water escaping in this area. However, water loss has not been stopped completely. An additional element enabling water to escape at the zero depth entry is the slope of the gutter grating in this area. Pool gutter grating should slope toward the pool, thus making it an uphill climb for any water attempting to bridge the grating. However, in this area the grating actually slopes away from the pool and down to a lower deck. This slope away from the pool is slight, but only aids in the escape of water over the gutter grating.

Image 010 – Water on pool deck escaping from corner of pool gutter

Recommendation: Immediate replacement of the pool gutter grating is not necessary. However, over time with regular wear and tear an increasing number of elements regarding the pool gutter will become more difficult to manage without replacement of the gutter grating. Grating replacement should be planned as a future capital expenditure. At that time the gutter should also be modified to repair the negative slope of the zero depth entry grating, as well as a modification to install gutter and grating underneath the slide flume where it enters the pool. The grating underneath the crossing activity padding should also then be replaced and become uniform with the rest of the pool grating.

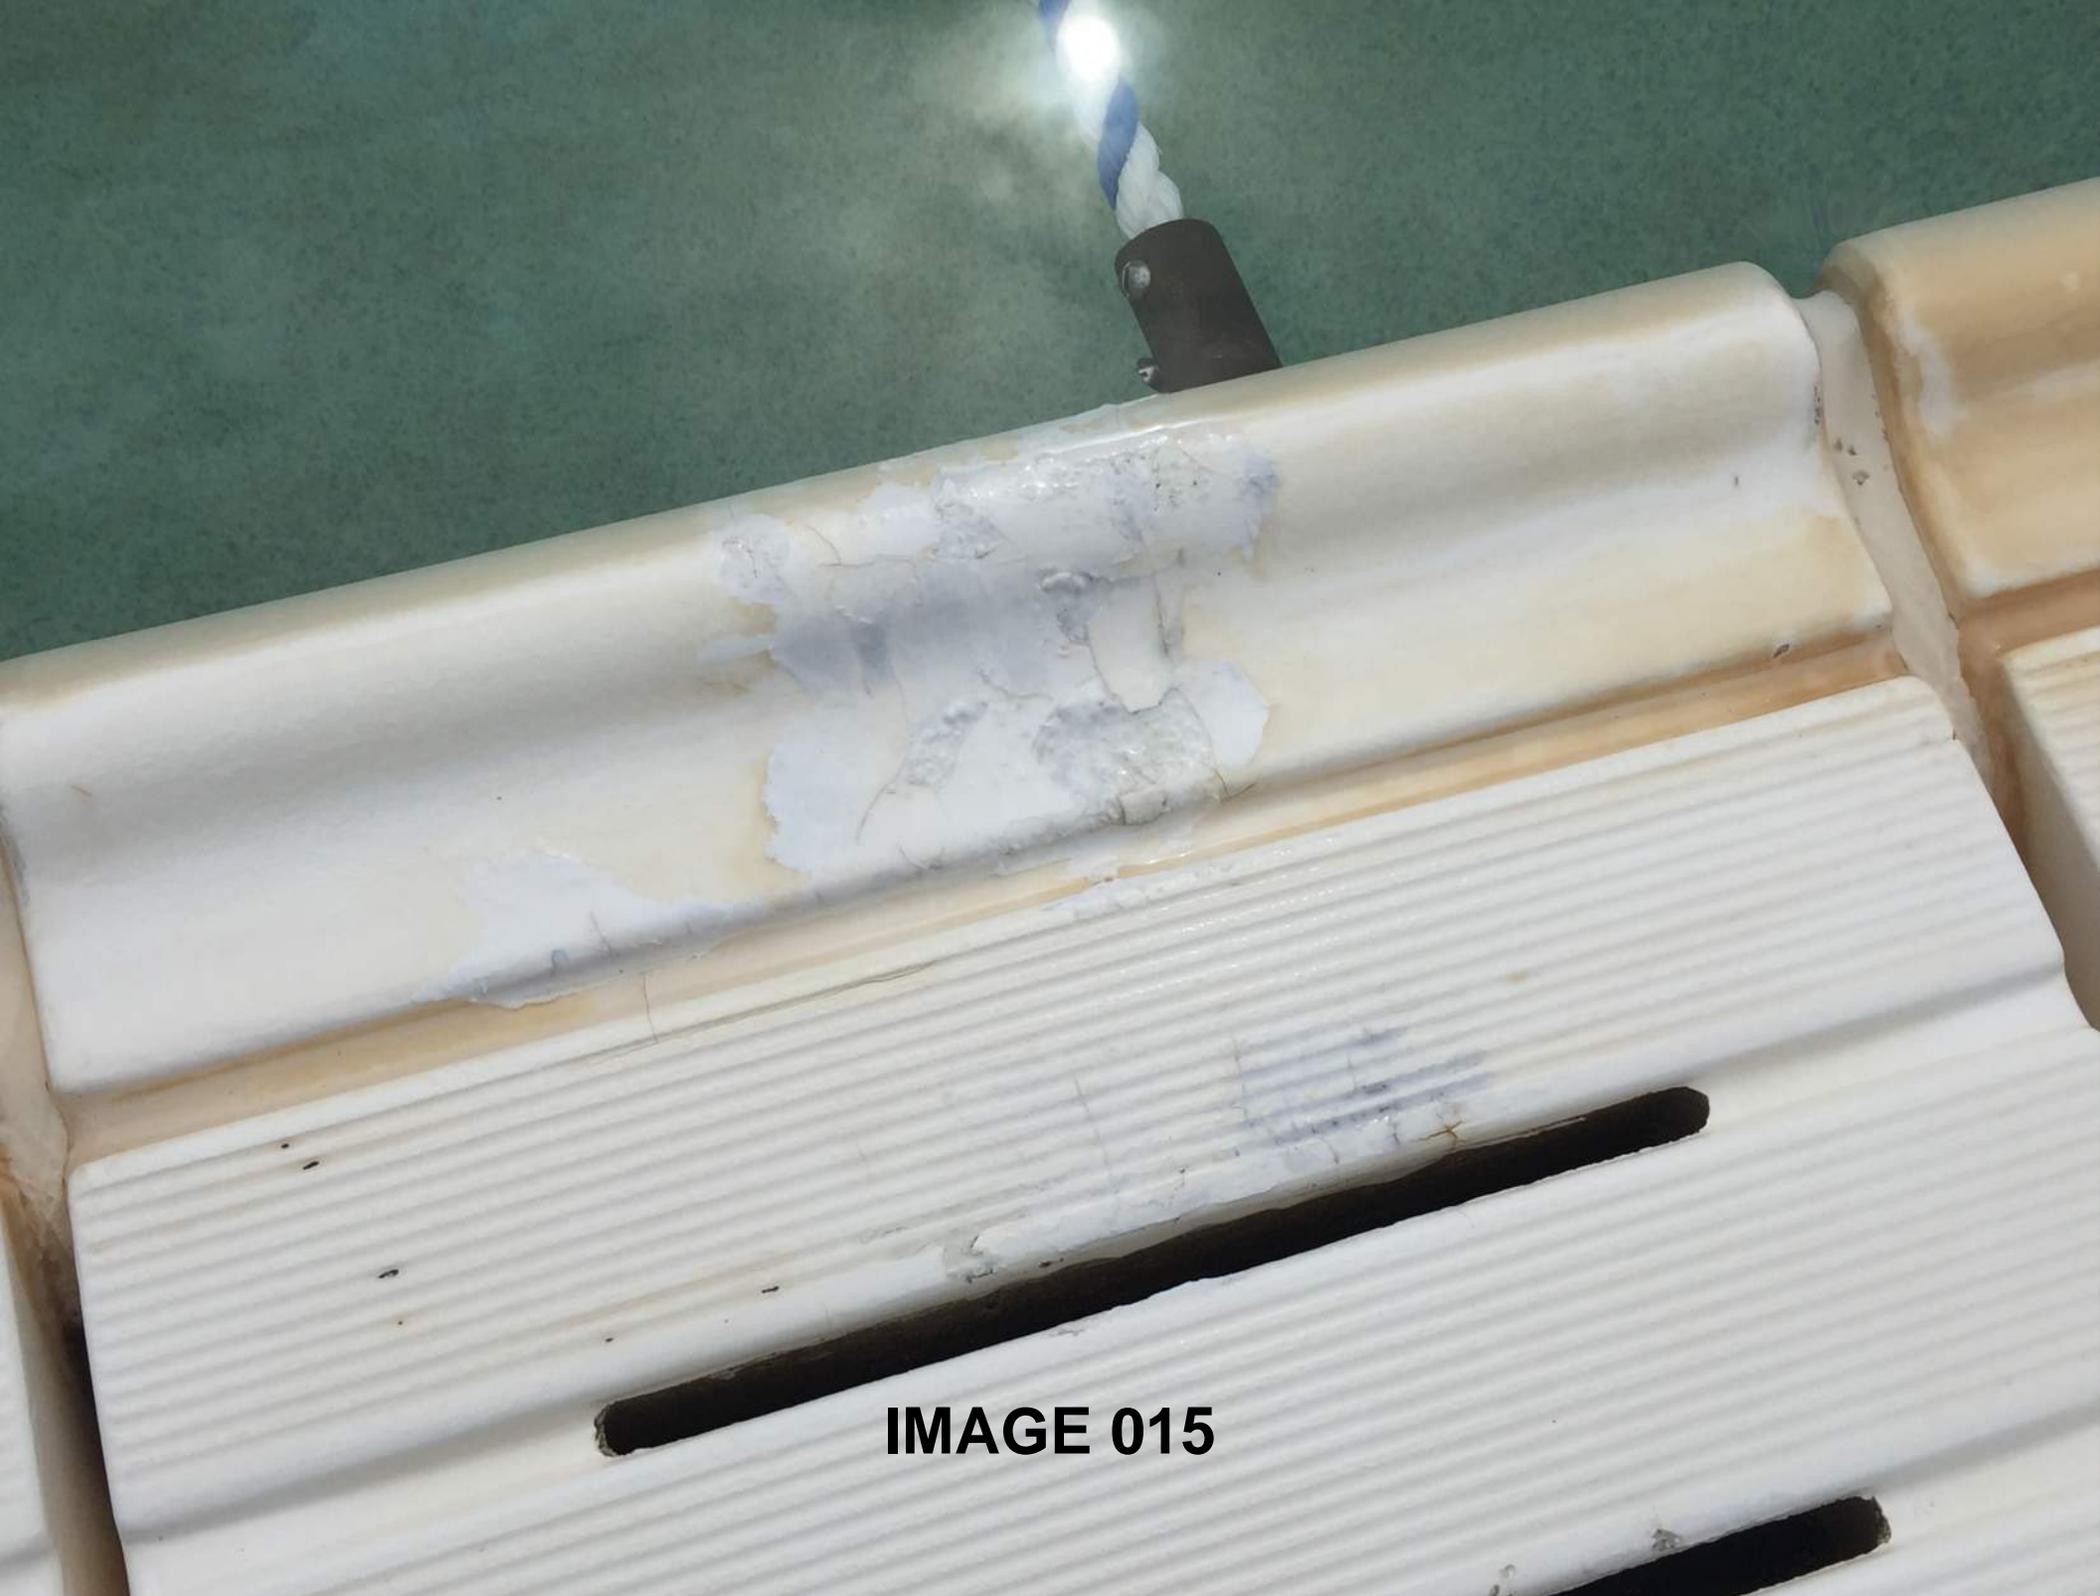
IMAGE 014

The second area of the pool gutter where water makes its way to the pool deck is under and around the slide entering the plunge area. There is no pool gutter underneath the slide flume, and the edge of the pool in this location was formed with the same profile as the gutter. Therefore, water skims over the top of this profile, just as it does with the gutter. However in this area the water has nowhere else to go but flow across the deck to the nearest deck drain.

Image 014 – Water leaking out of pool under and around slide flume

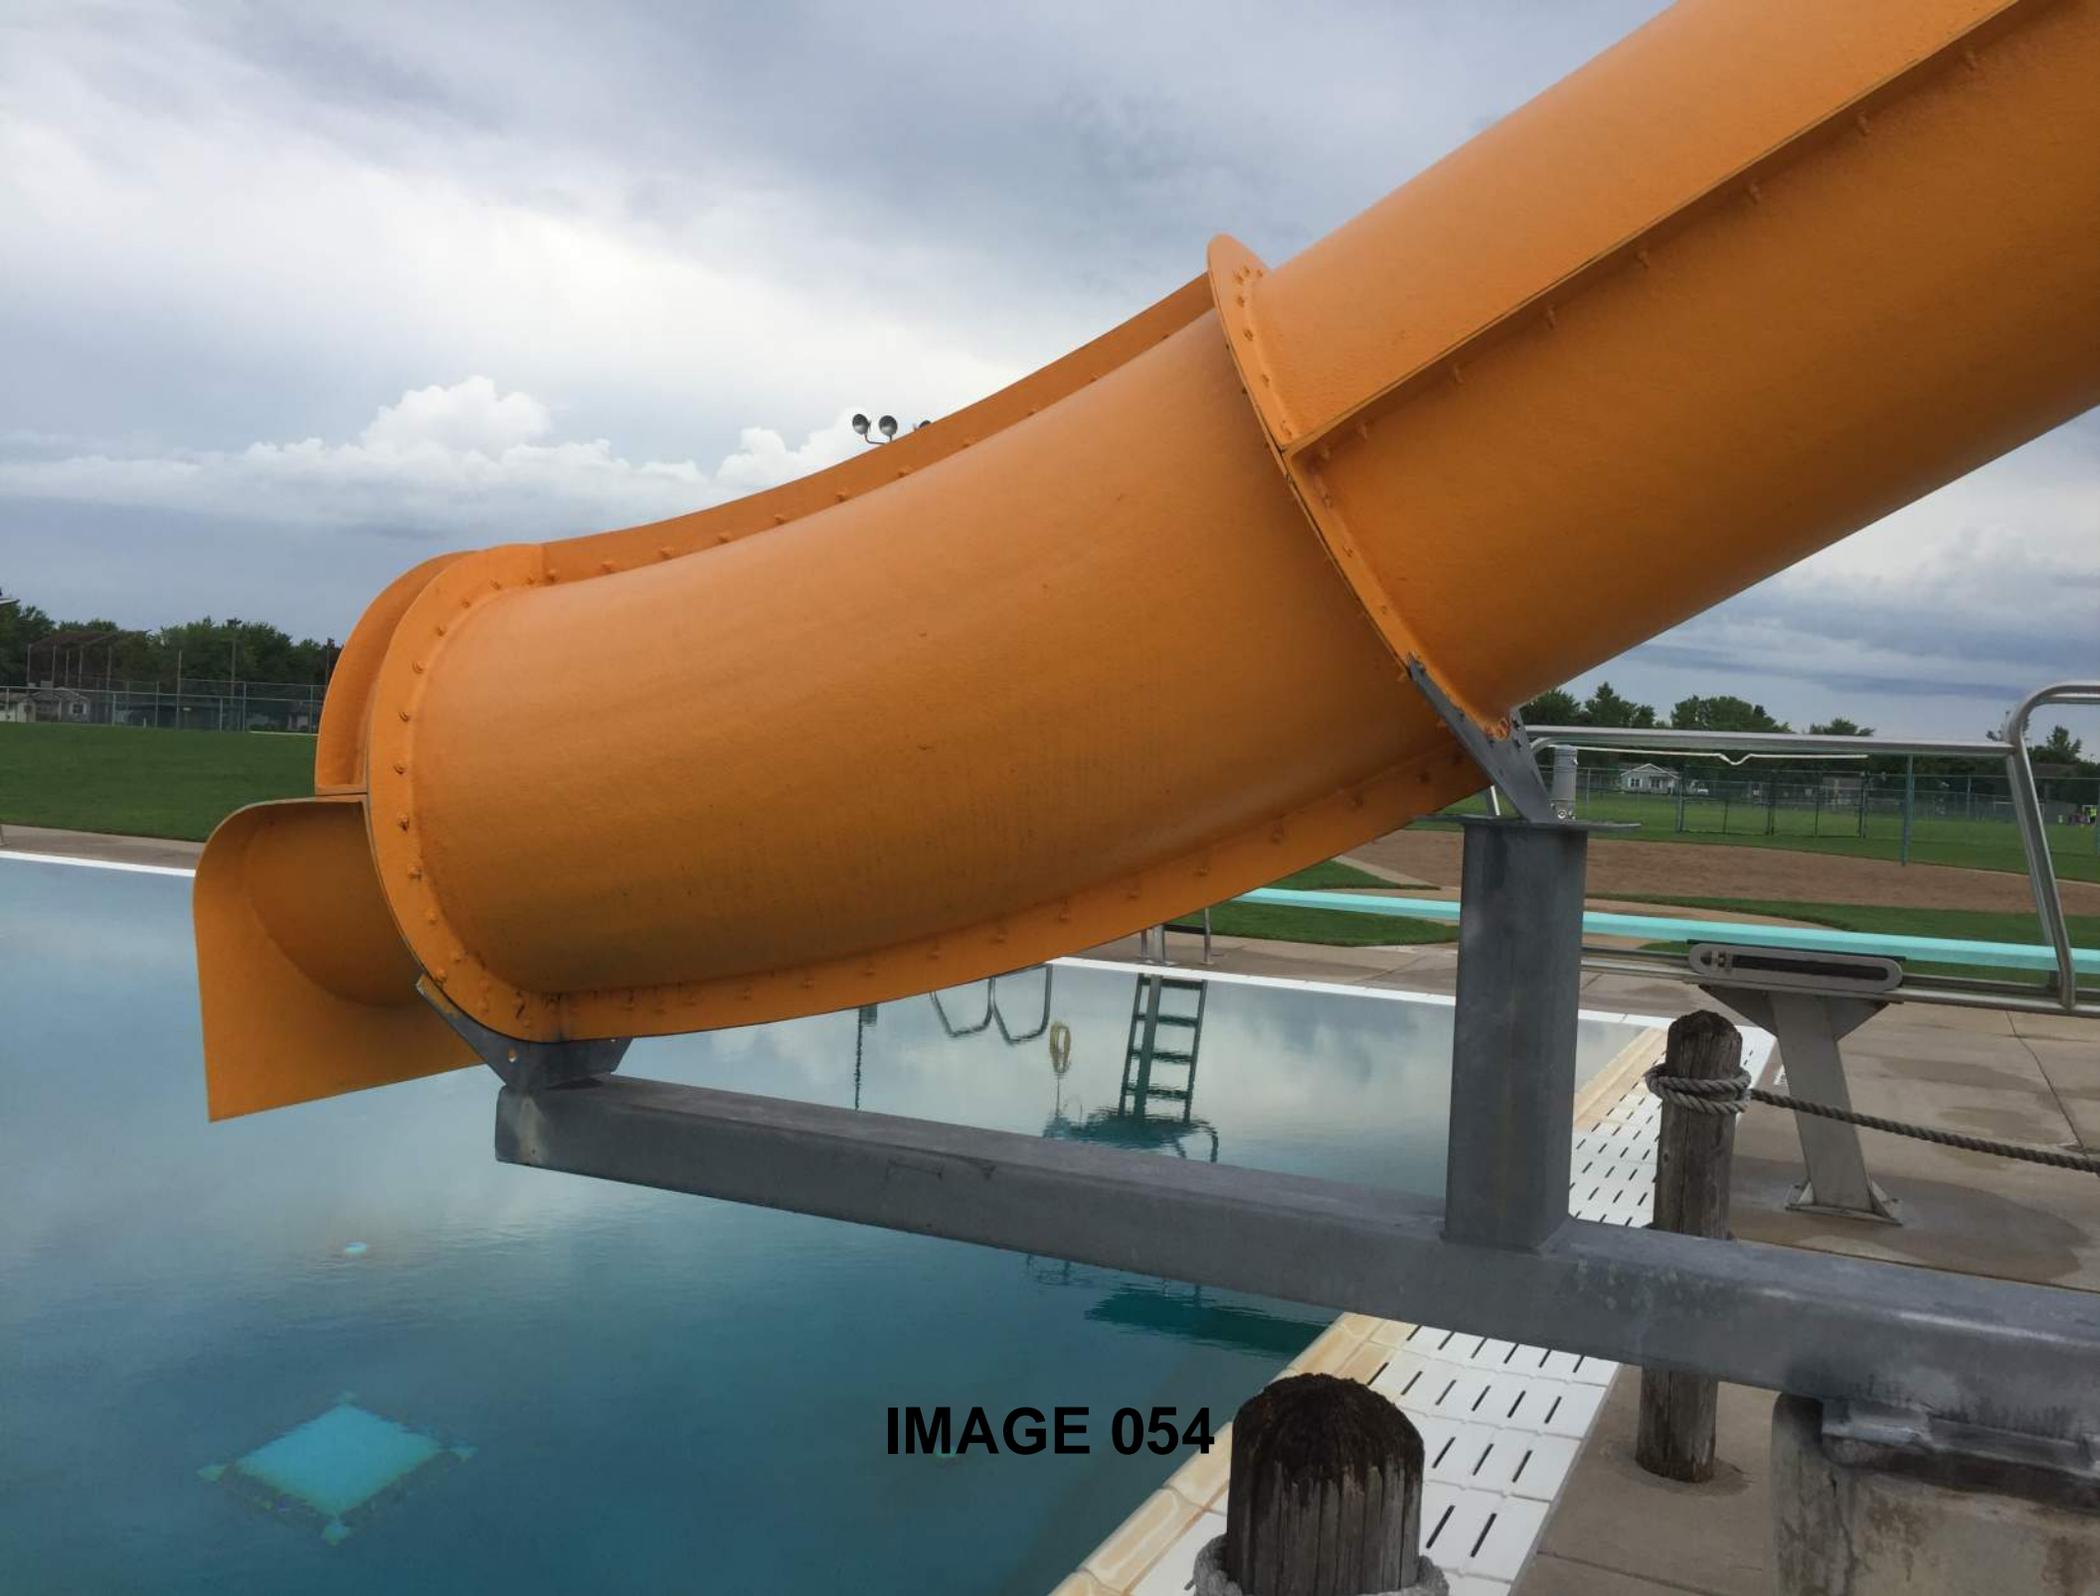
IMAGE 053

The drop slide appears in good condition, and similar to the slide tower complex, the drop slide tower has some superficial corrosion and water damage.

Image 053 – Corrosion on drop slide tower
