Eau Claire River Blockage Report

10/31/2017

Abram Weller-Owner
TIMBER HARVESTING SOLUTIONS LLC
5902 PINE PARK ST.
WESTON, WI 54476
715-302-4648
abramweller@gmail.com

POST BLOCKAGE REPORT

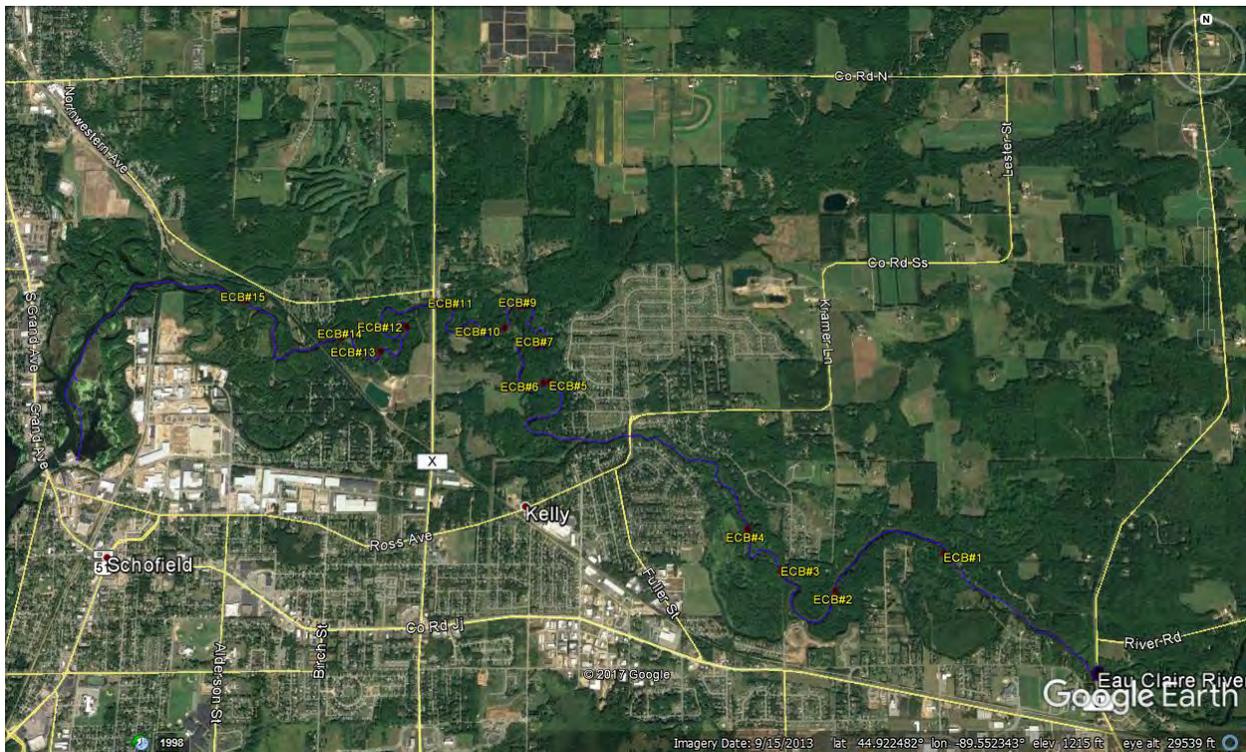
Blockage Map:

Below is the overview map showing each blockage location. Each blockage is labeled “ECB#1-15.” “E.C.B” is the abbreviation for “Eau Claire Blockage”, followed by the site number. There are fifteen total blockages currently in place on the Eau Claire river system in the surveyed areas defined above. This does not include any side current sections, or alternate routes that navigate when water levels are high. Please refer to this page while reviewing the next report section titled “Individual blockages”, to aid in referencing.

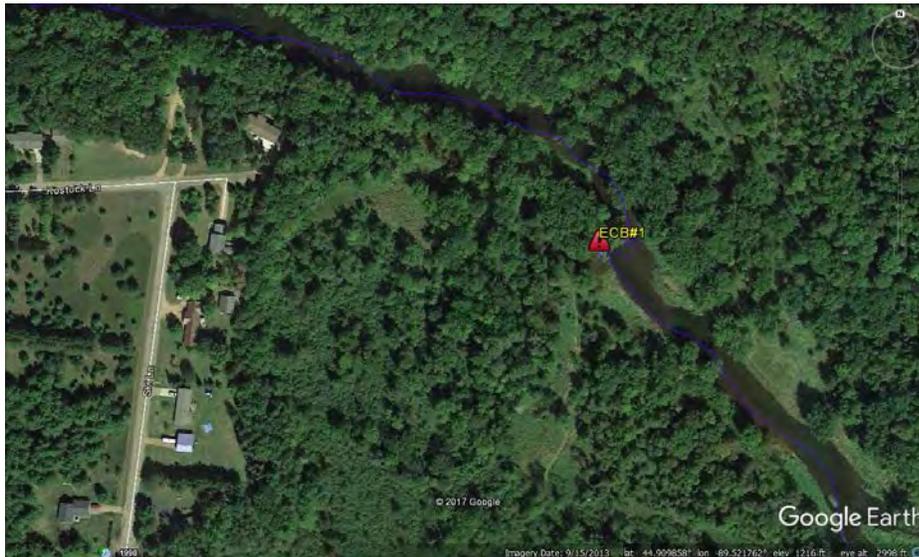
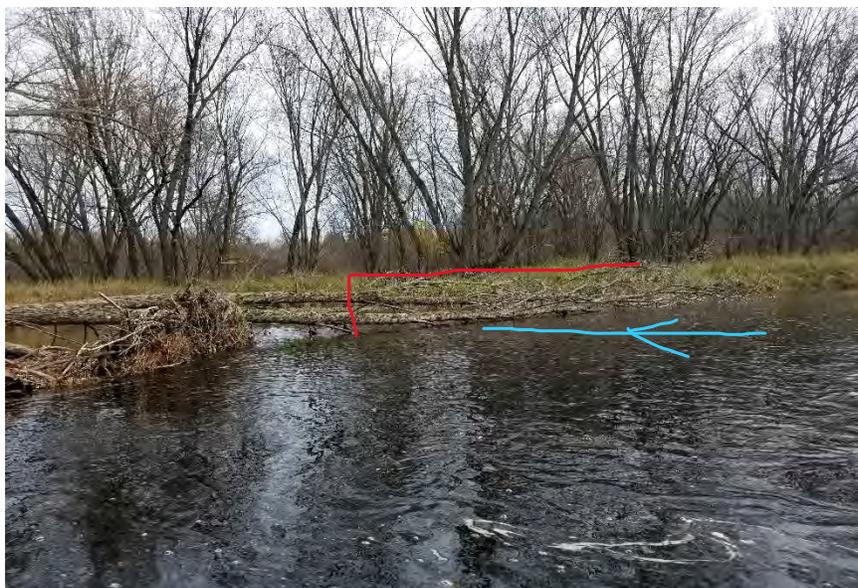
ECB#1

Blockage severity: High, hung up on an island, complete blockage and had to portage around Recommend removal of top 30 feet of trees.

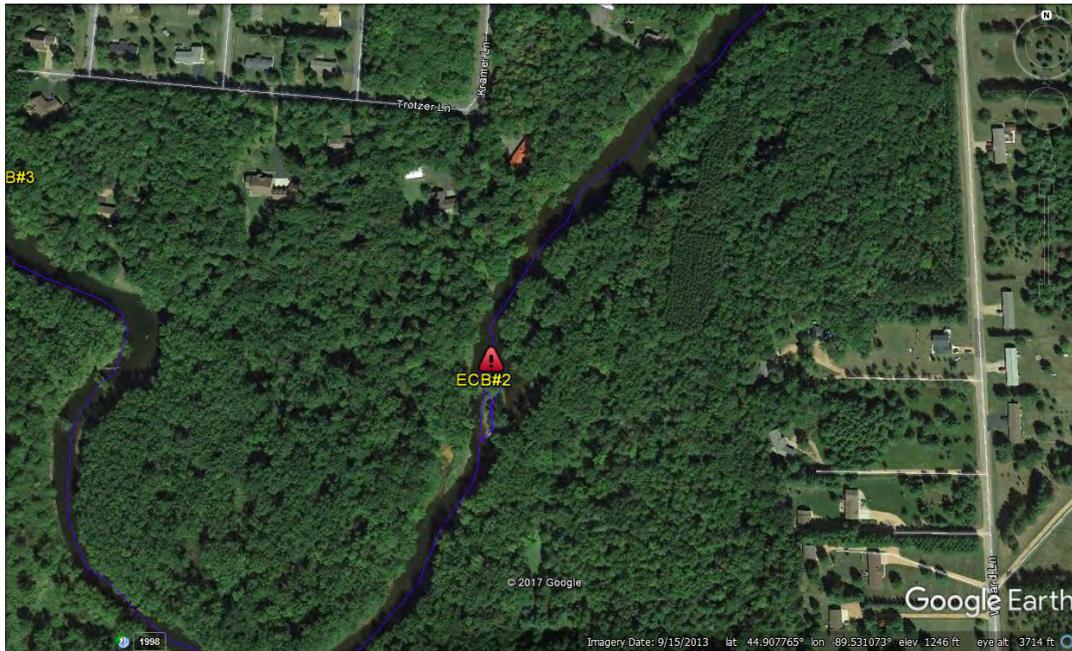
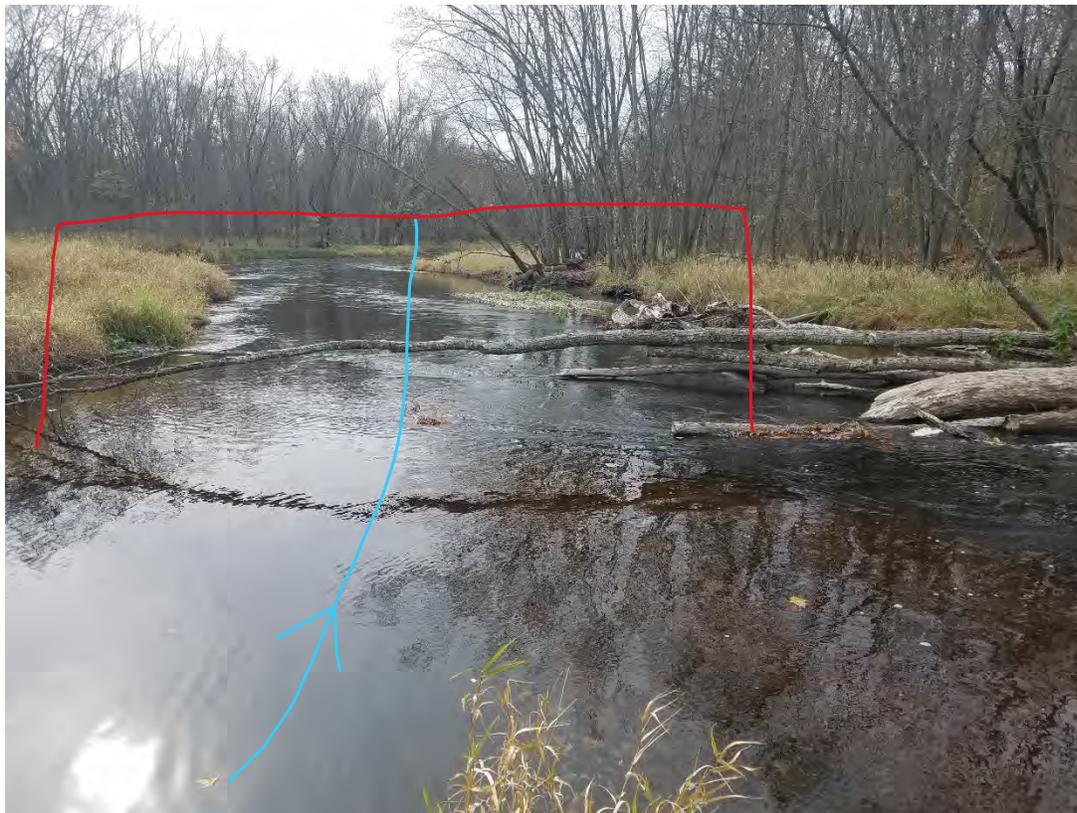
ECB#2

- Blockage severity: Low. Single branch hanging into channel. Recommend removing top 20' of branch.

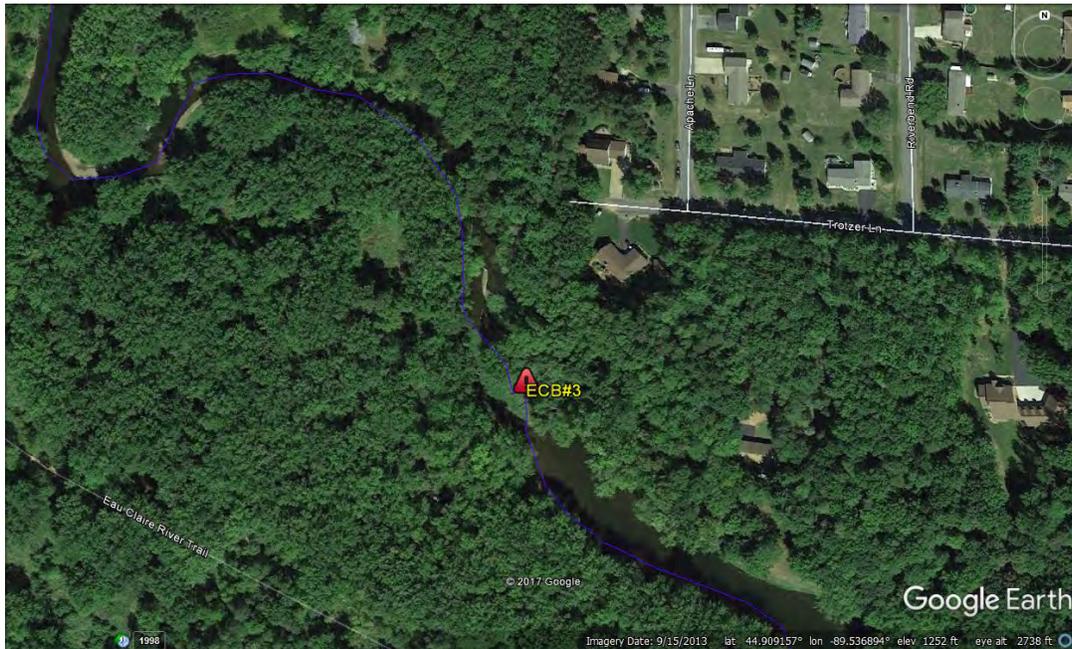
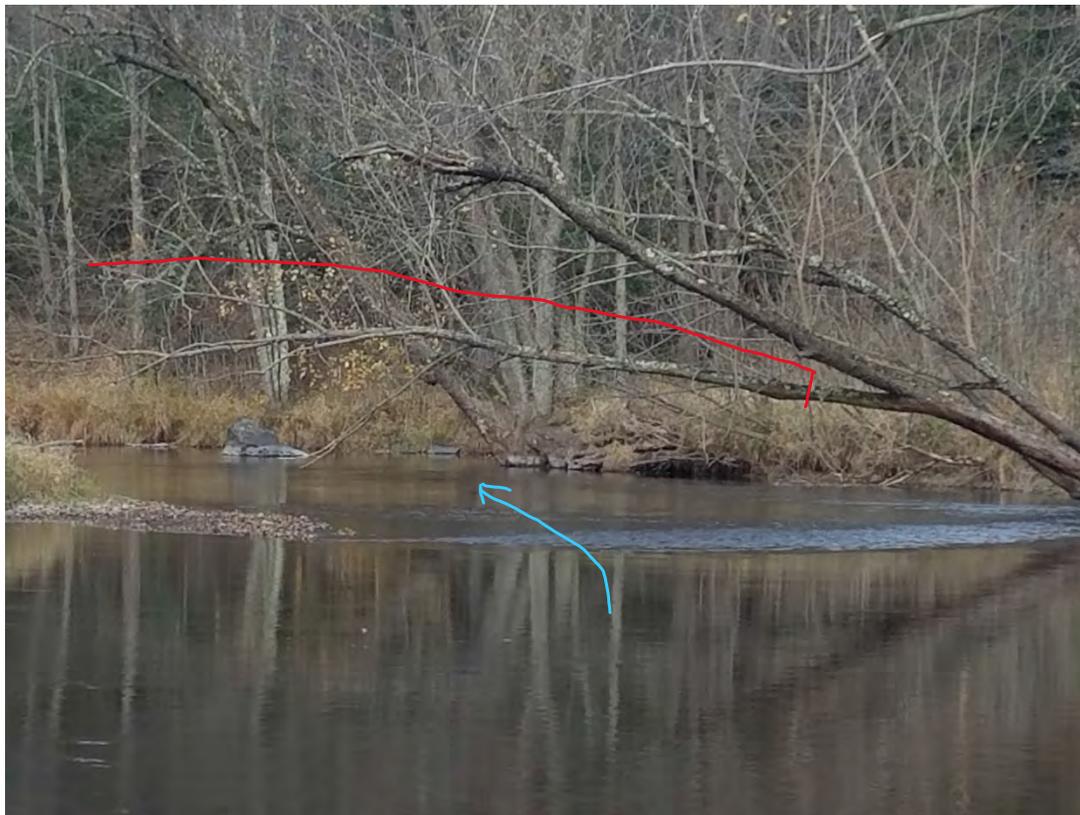
ECB#3

Blockage severity: Low, over hanging lowest branch will restrict channel once water levels rise. Recommend removing lowest branch atleast, or removal entire tree.

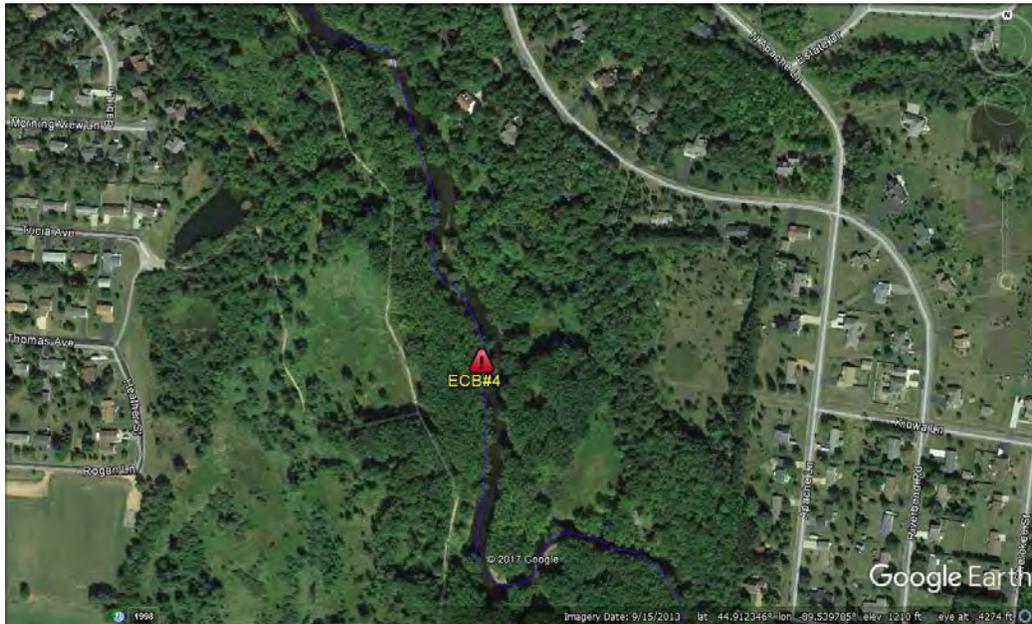
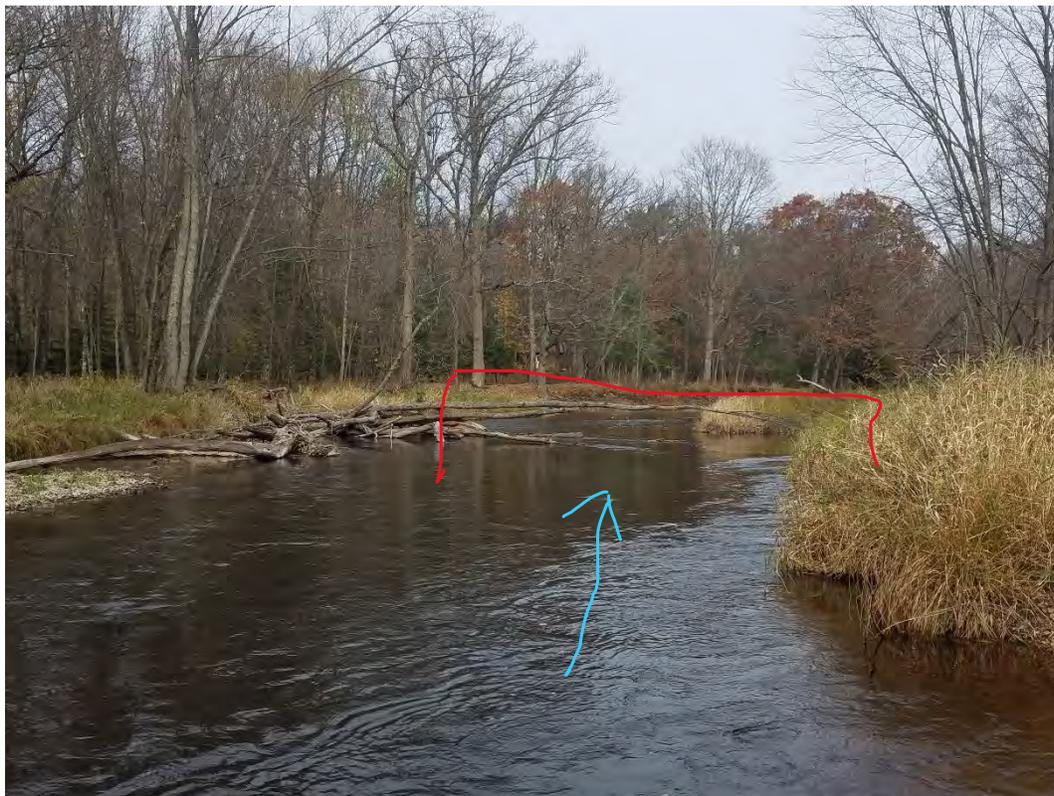
ECB#4

Blockage Severity: low, double hanging branch into channel. Recommend cutting top 20 '

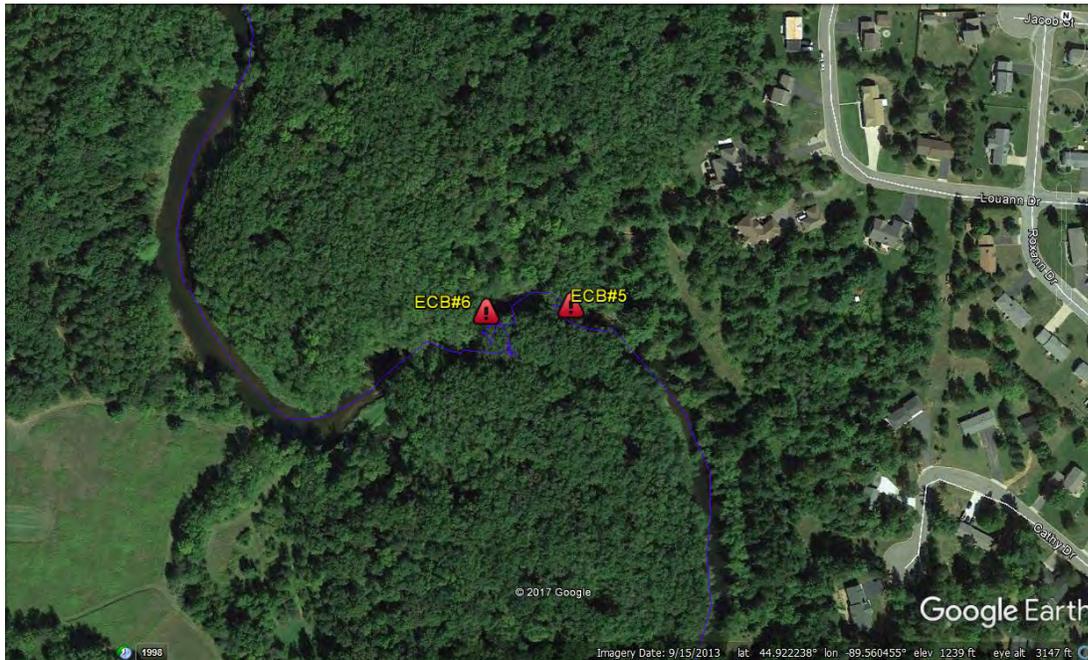
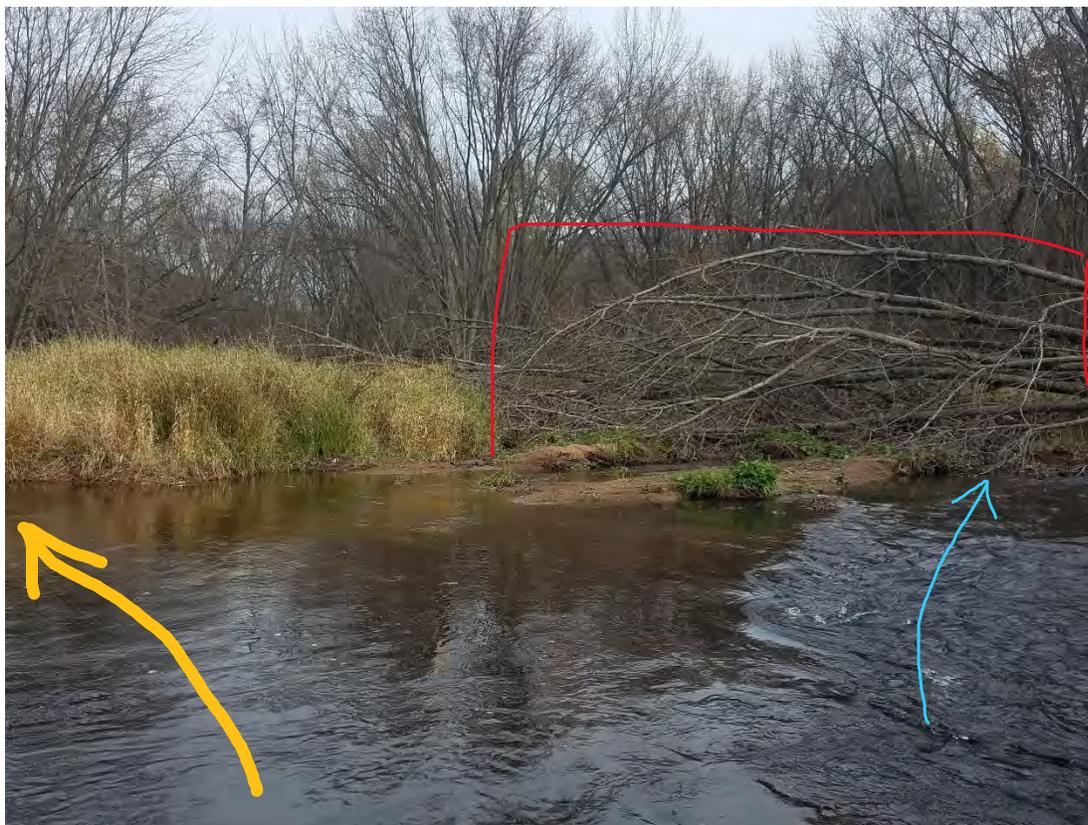
ECB#5

Blockage Severity: High, Multiple trees in the river across channel. Alternate channel goes to the left (orange), but blocked as well (ecb#6). Recommend removing at least tops of trees. To open a 15' wide channel.

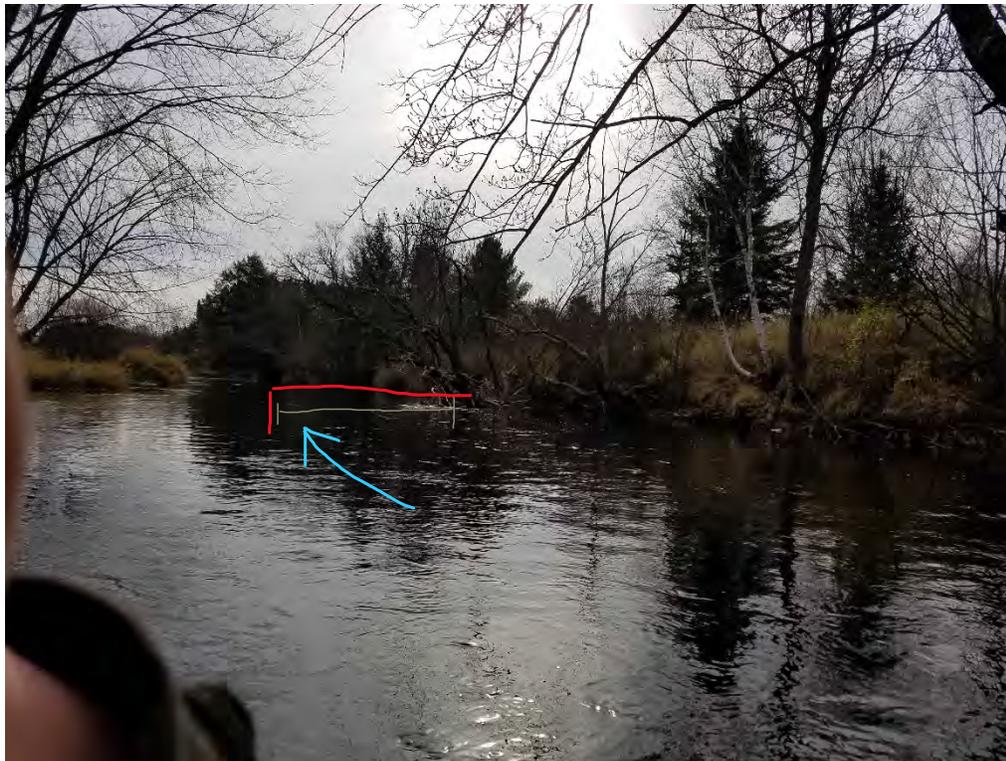
ECB#6

Blockage Severity: Medium, Tree branches exposed above and below water level, channel is wide enough to go around, however boats will possibly hit submerged branch (brown).

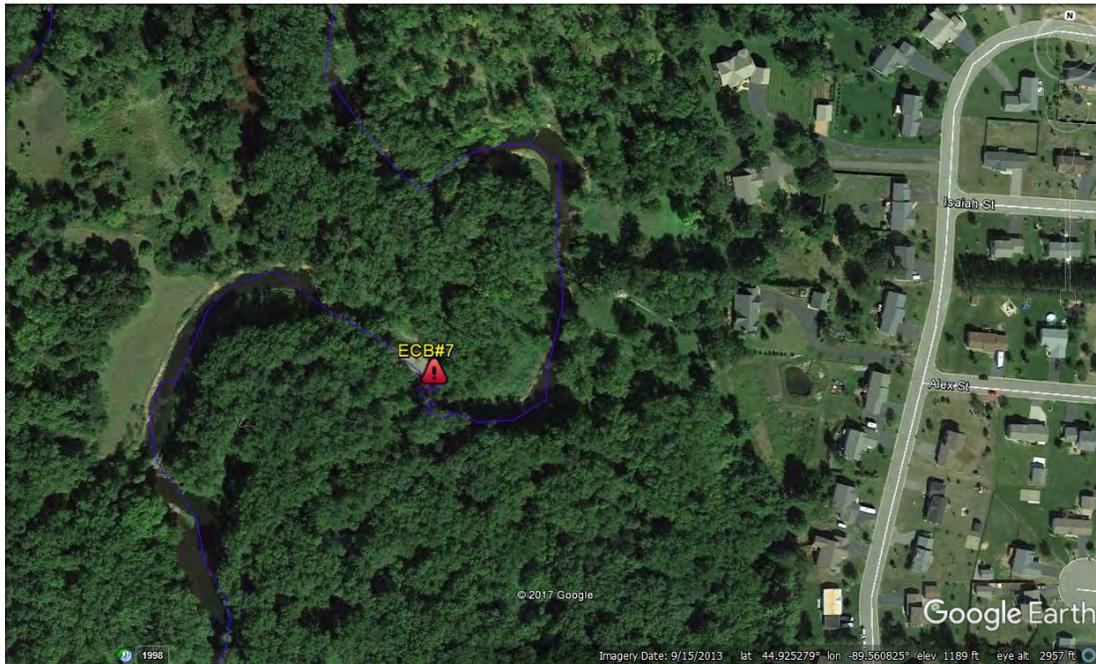
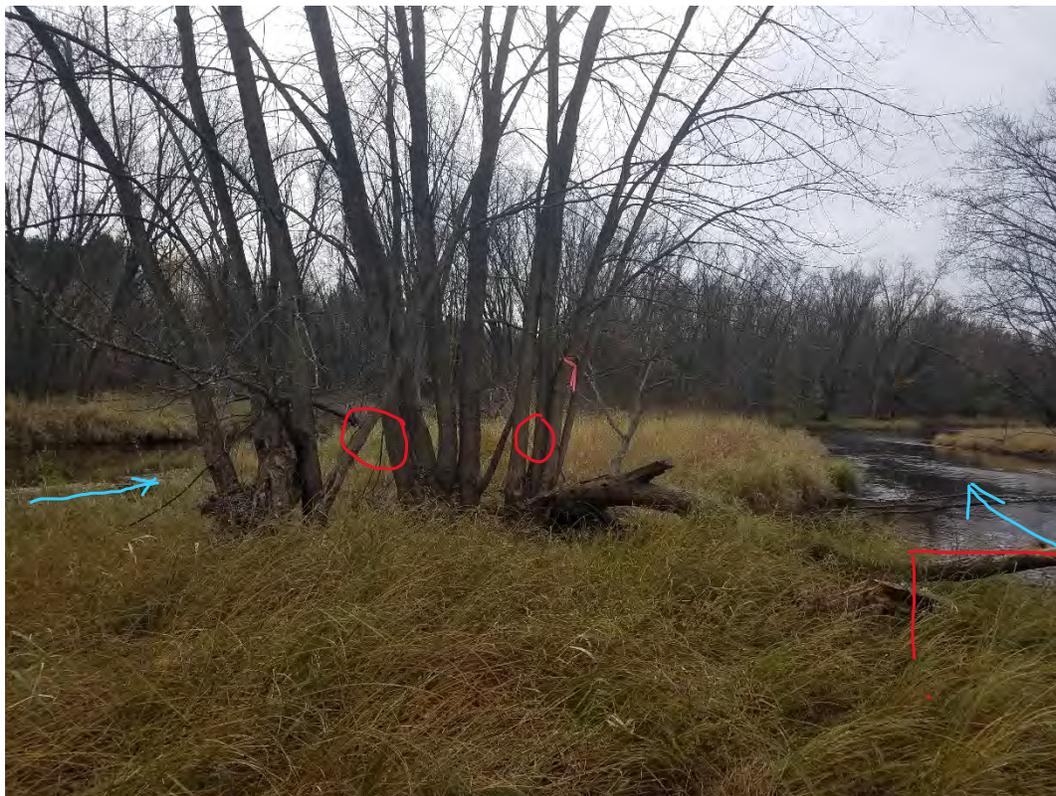
ECB#7

Block severity: medium, Split in channel. Right fork blocked by single branch hanging into channel. Left fork Completely blocked by multiple tree tops (behind the standing trees). Recommend removing both fork blockages.

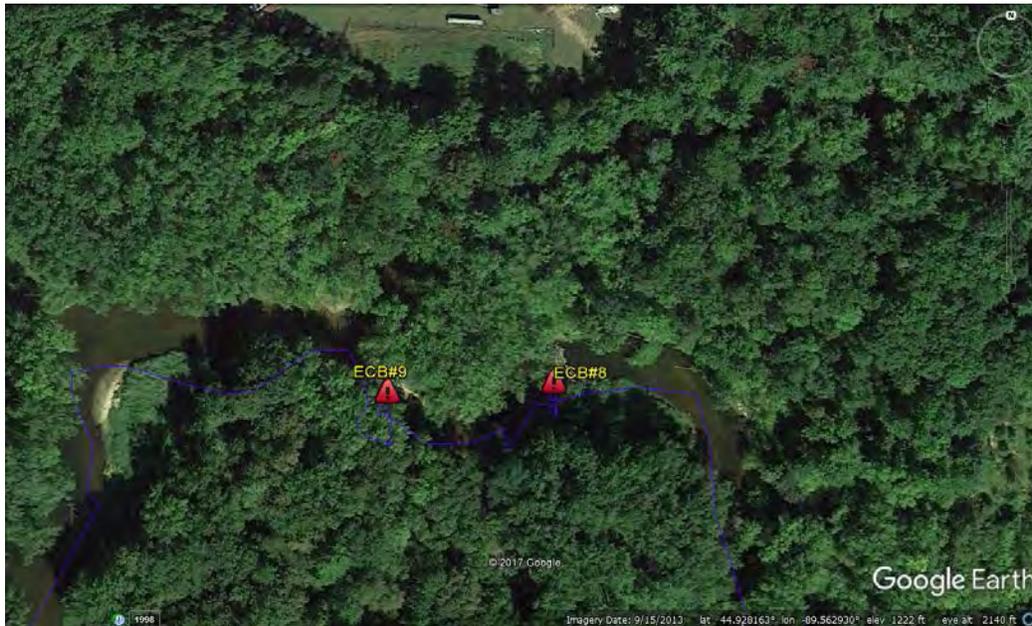
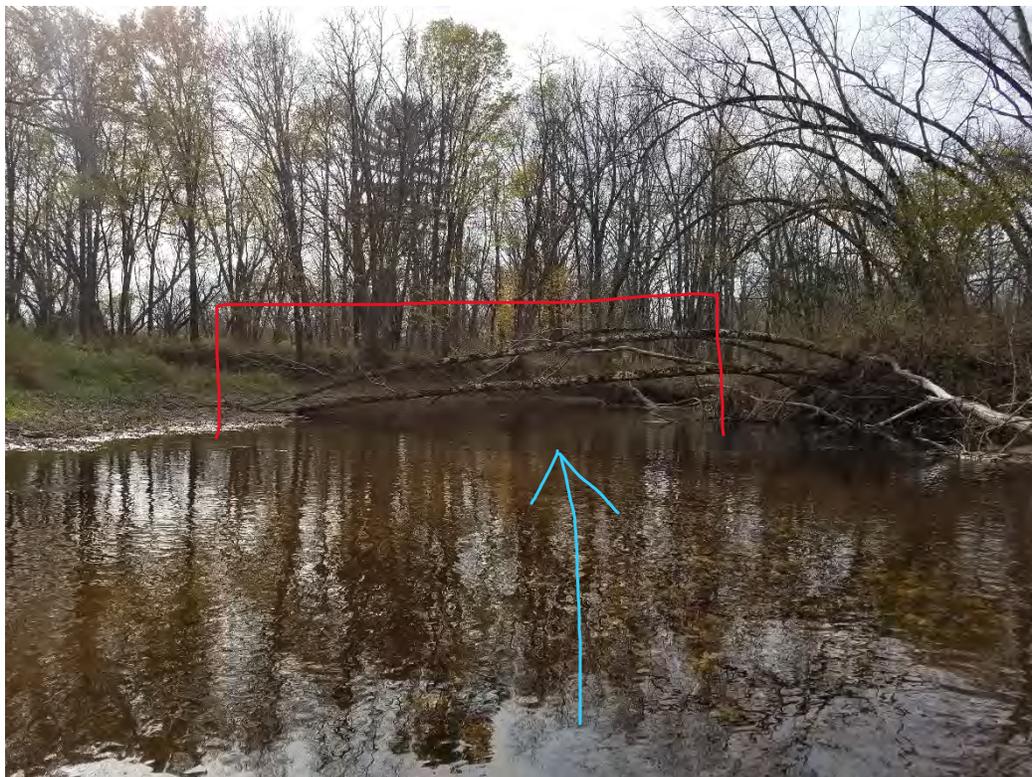
ECB#8

Blockage severity: Medium, 3 branches hanging into channel. Will block most of channel when water rises. Recommend removing all 3 branches.

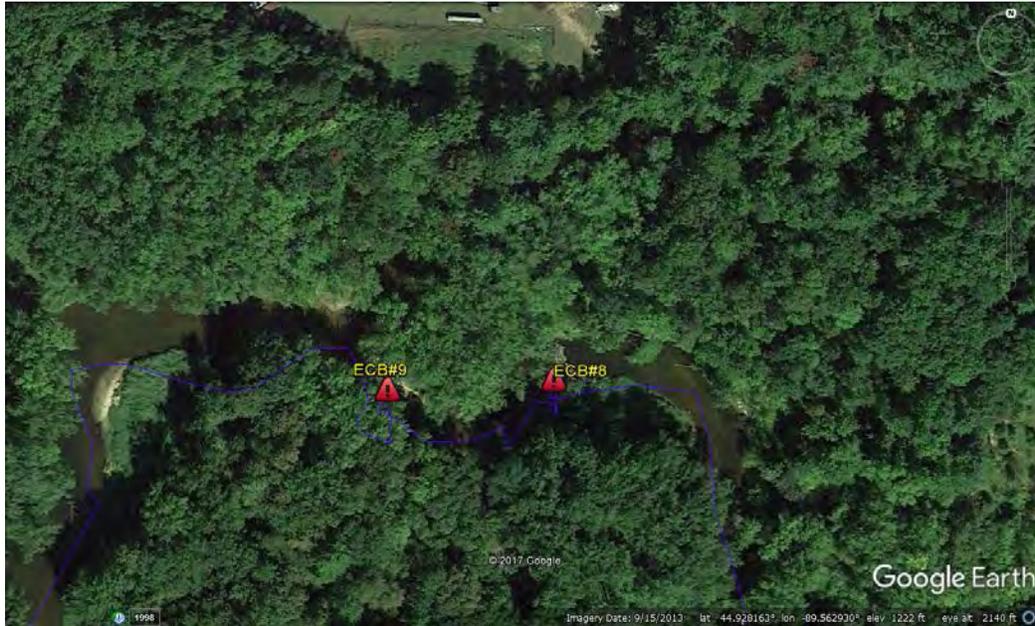
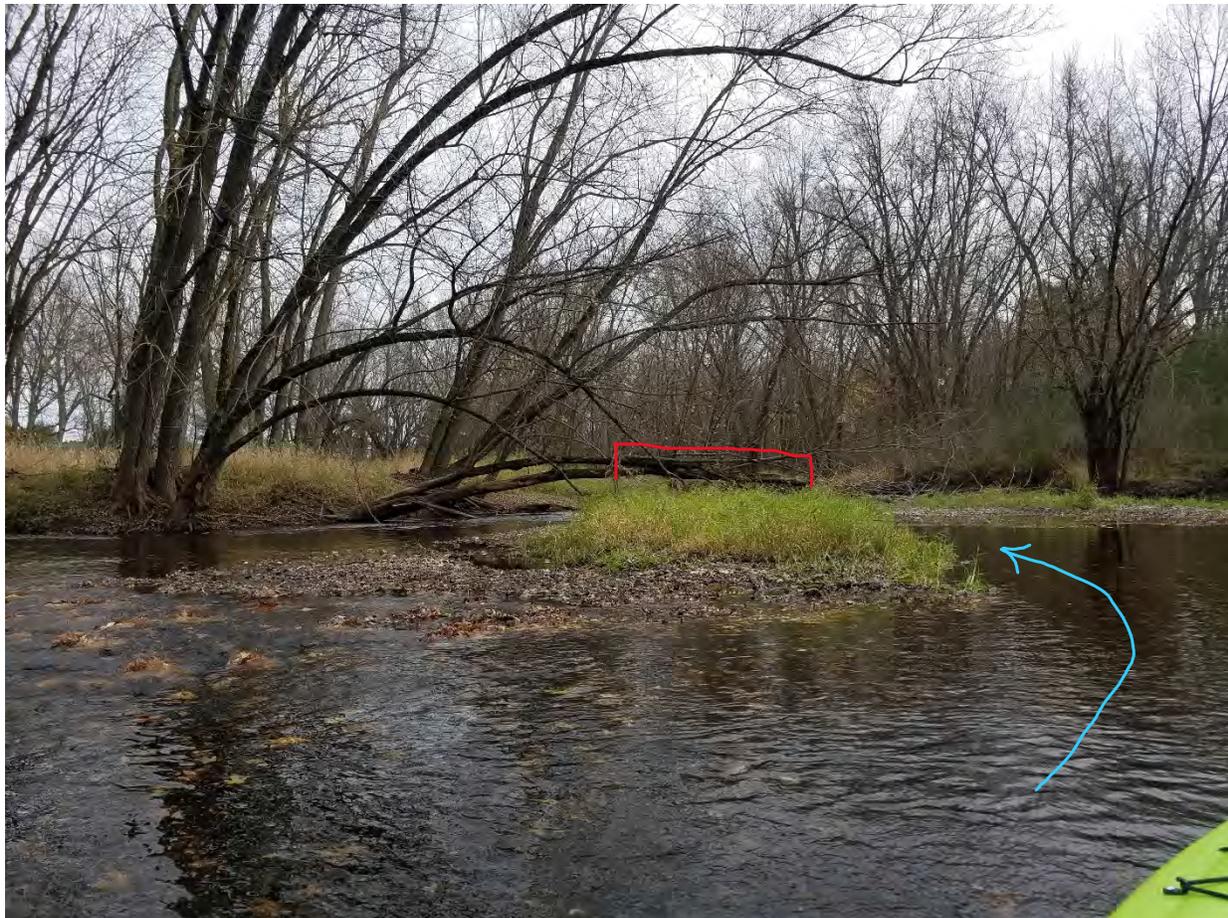
ECB#9

Blockage severity: Medium, 2 branches hanging into center of channel. Recommend removal of 15' off top.

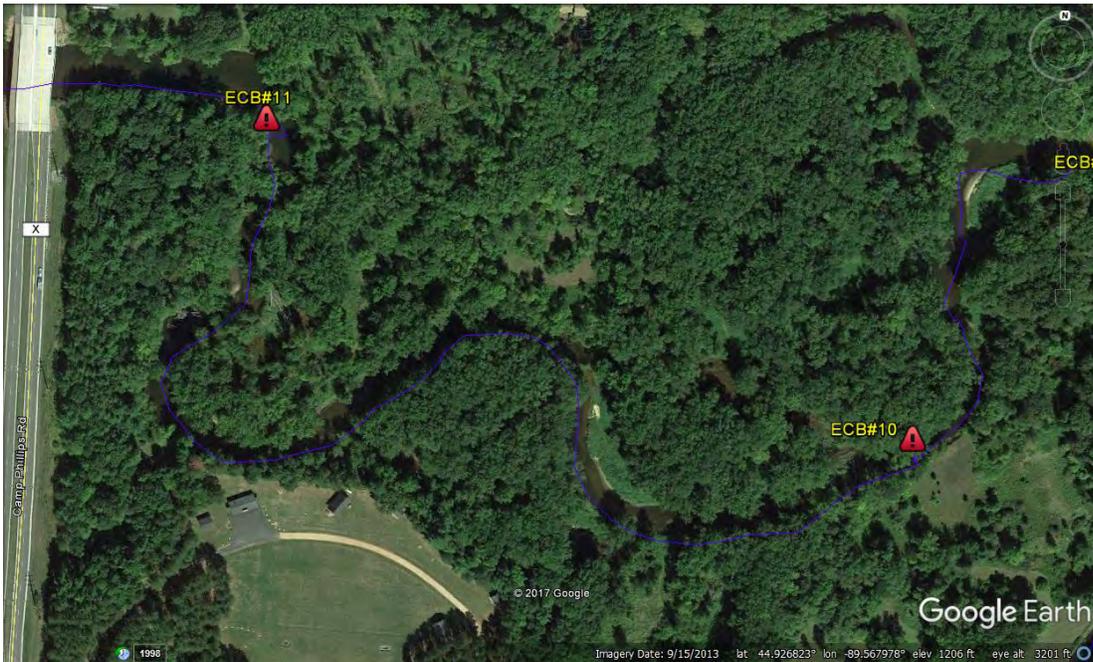
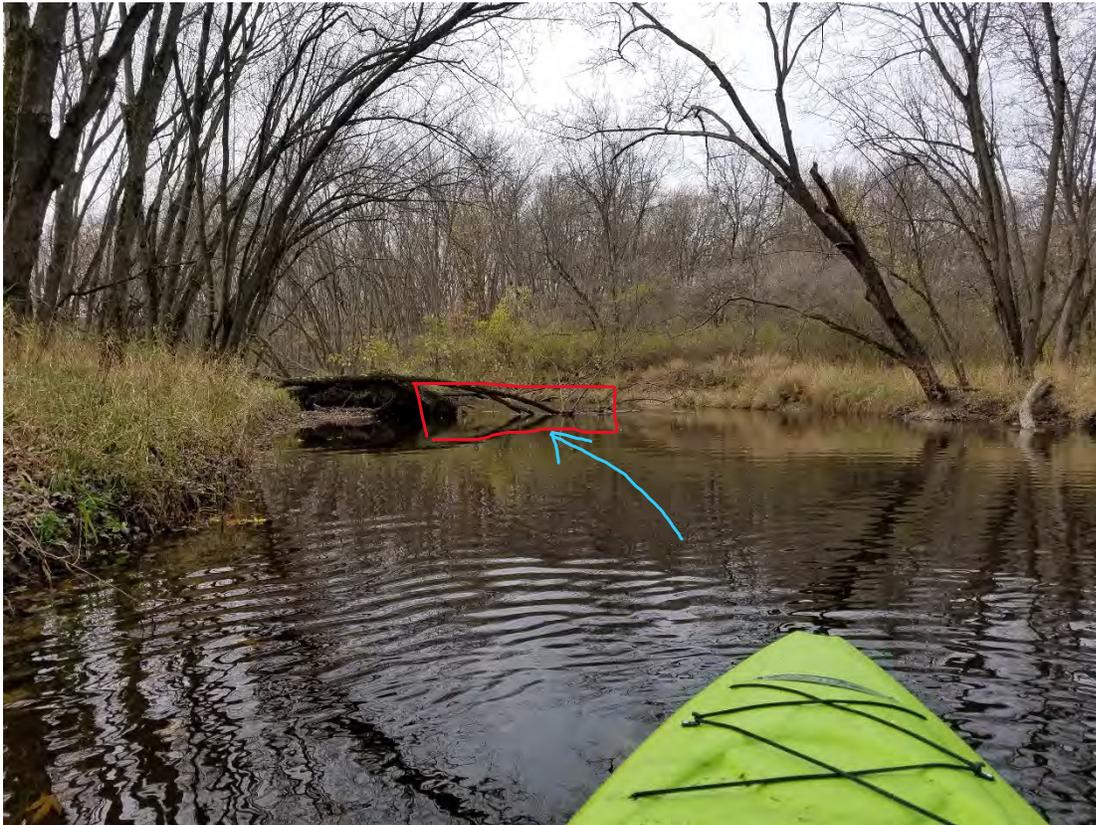
ECB#10

Blockage Severity: Medium, submerged branches. Can get around, but difficult. Recommend 15' top cut

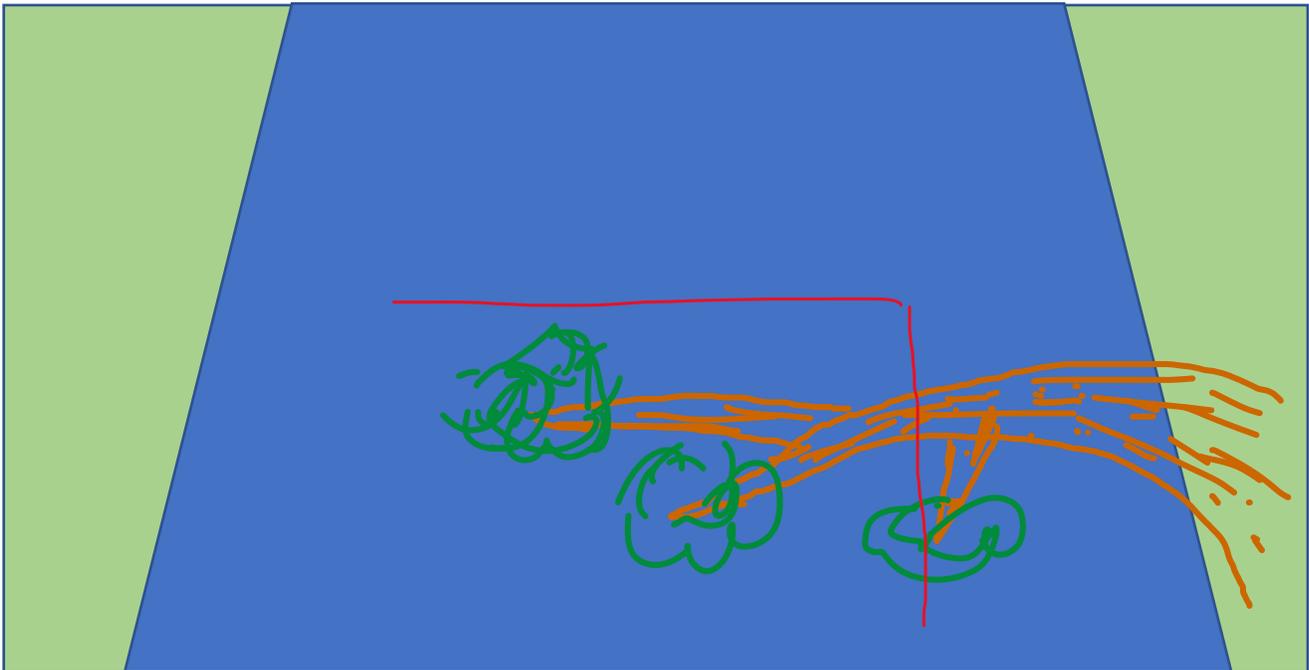
Blockage Severity: Medium

Single hanging tree, blocks half of channel but room to go around if needed. Tree is 3' above water level.

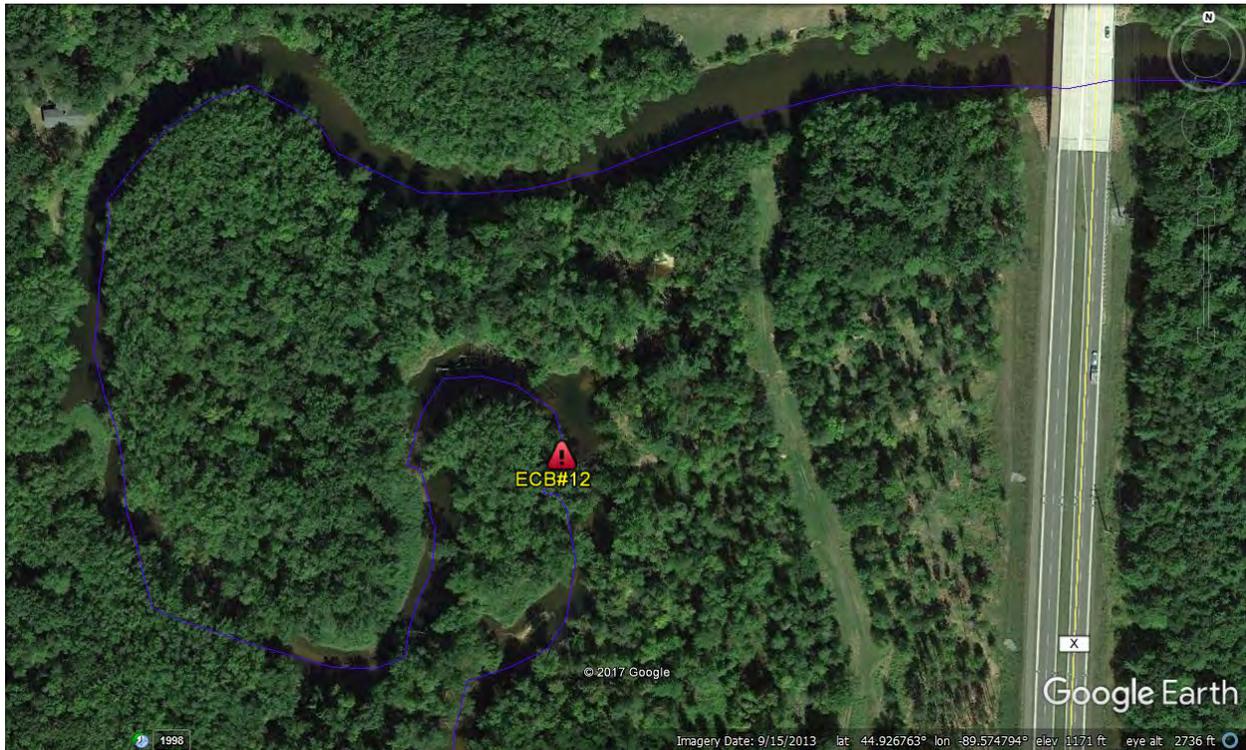
ECB#12

Blockage Severity: High, Multiple trees and old blockages tied together. Recommend removal of all timber back to shore lines.

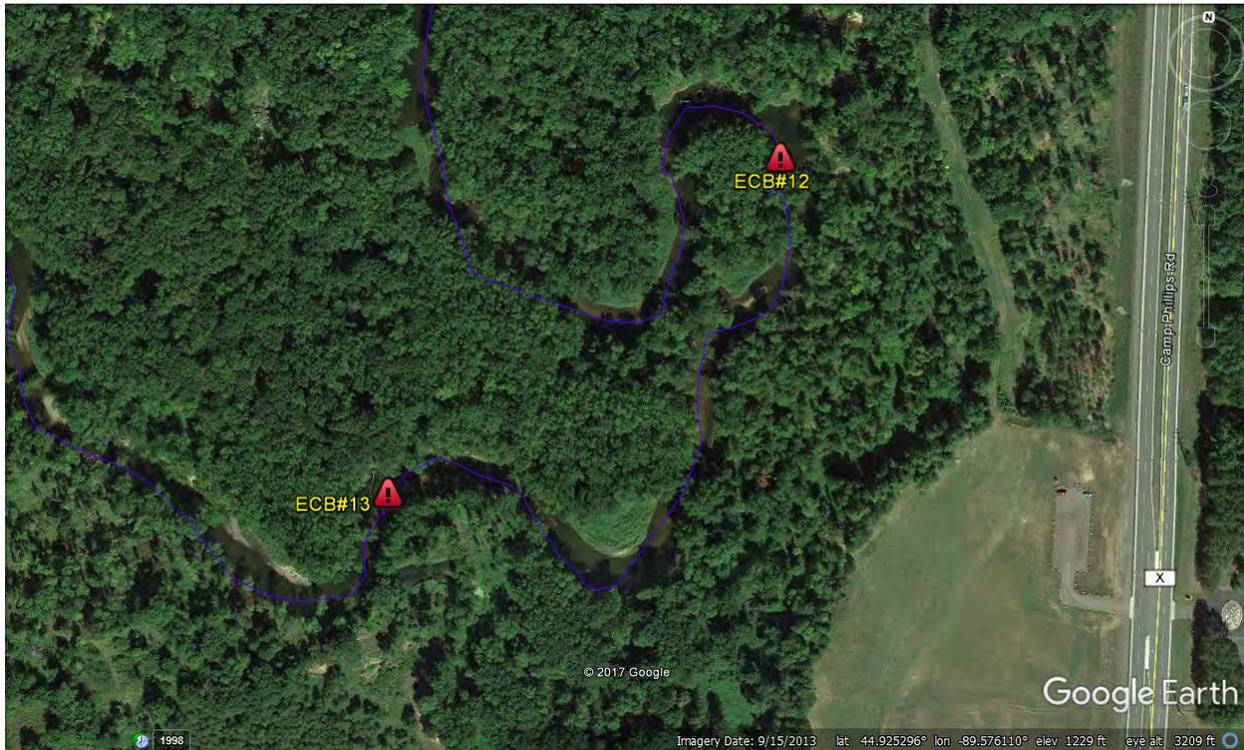
ECB#13

Blockage Severity: Low, 1 single tree, hanging over channel, branches are only touching water. Room to go under or around. Recommend trimming up branches.

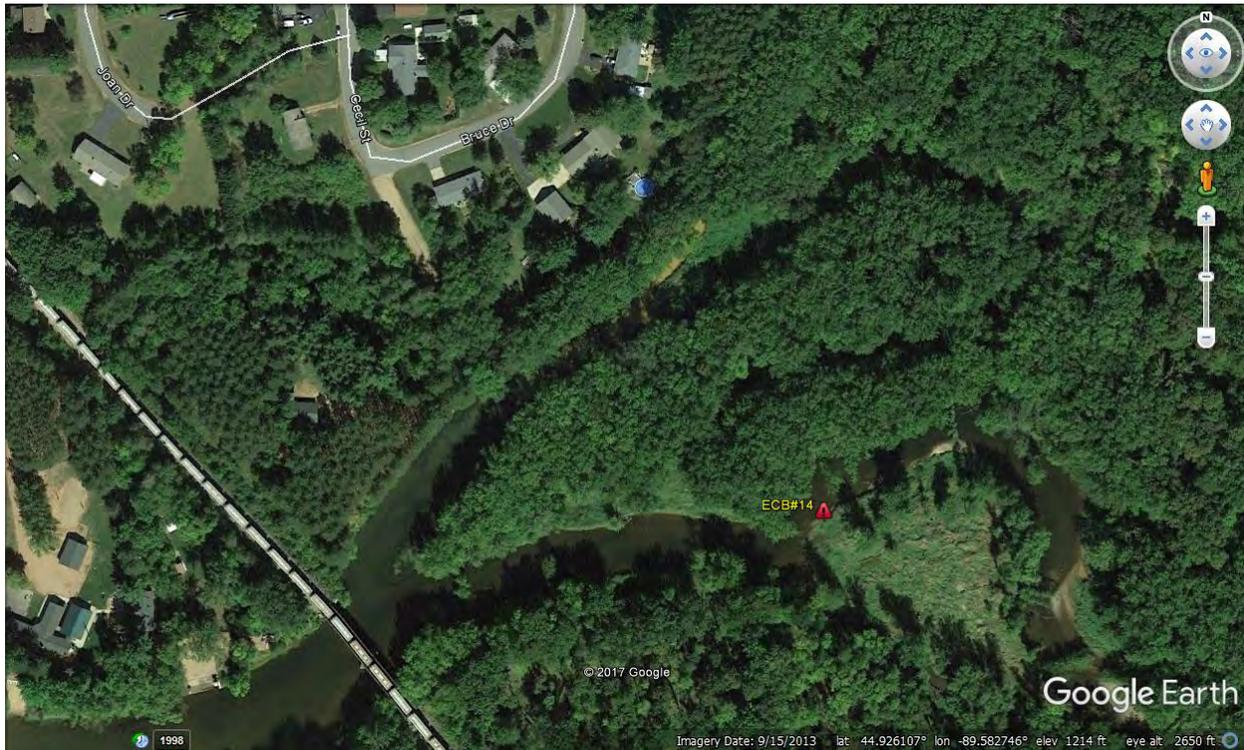
ECB#14

Blockage Severity: Medium, 2 trees that hang close to water level, but are not blocking channel. Recommend cutting back limbs to maintain open channel when water levels are higher.

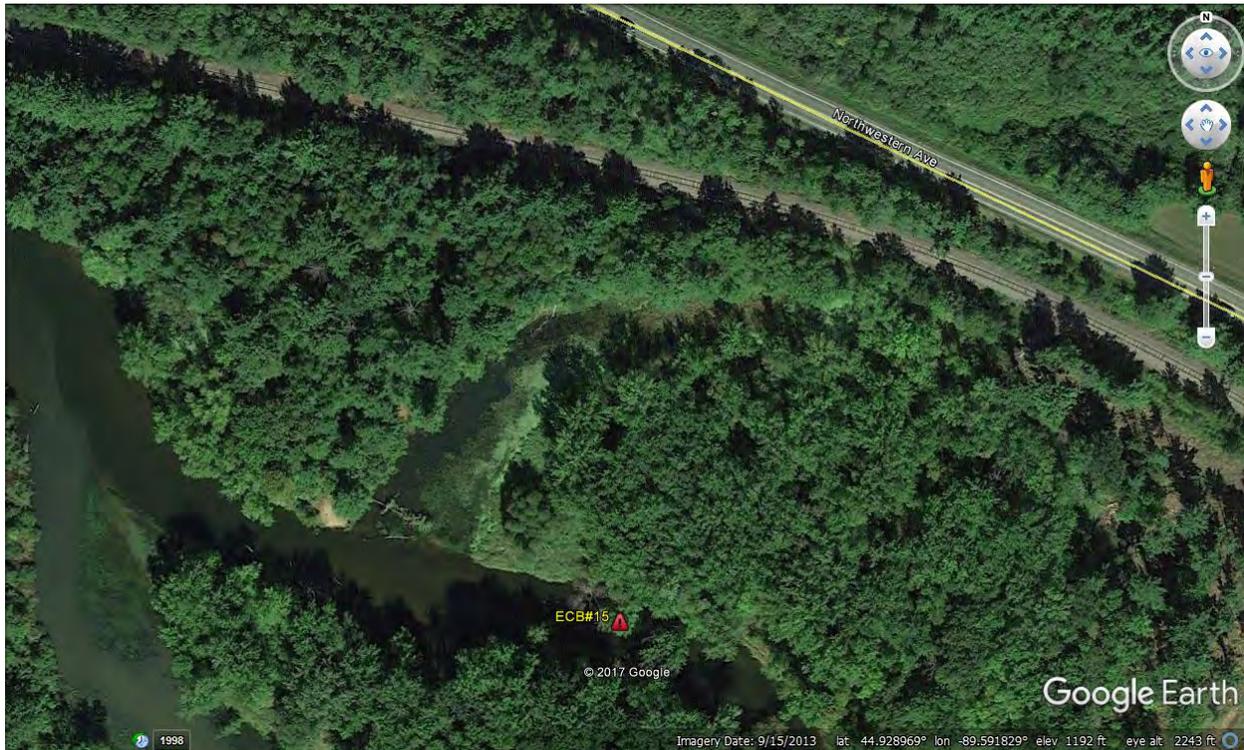
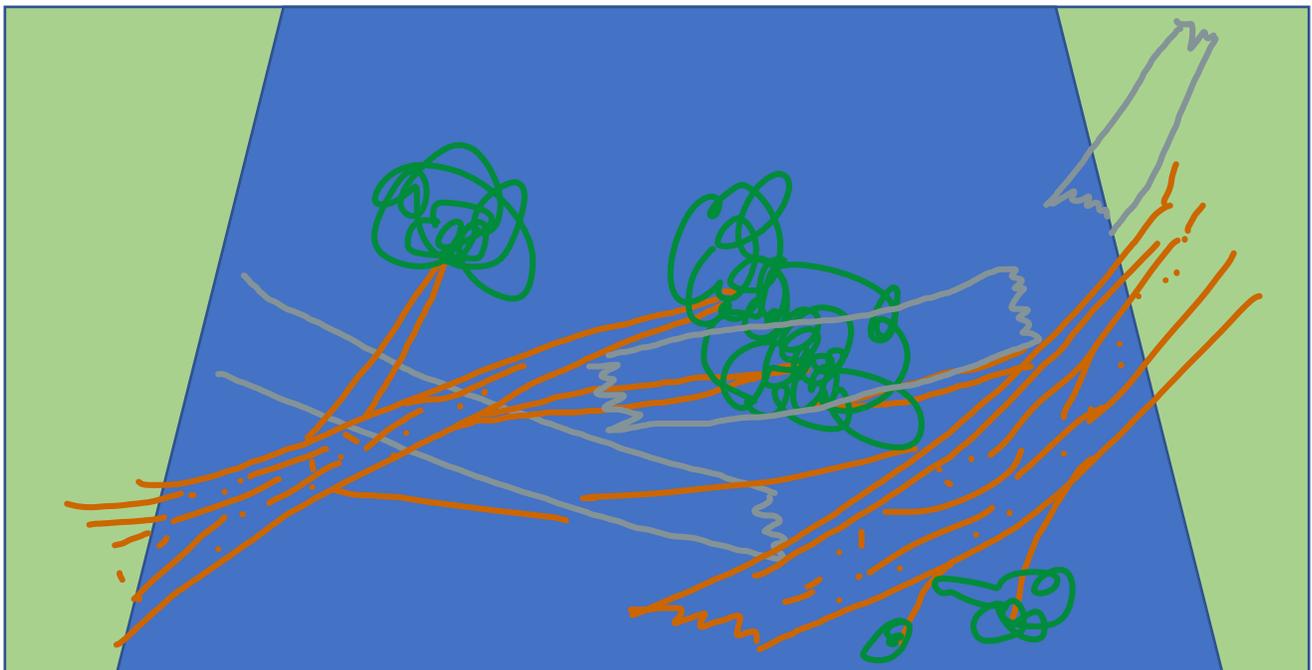
ECB#15

Blockage Severity: High, Multiple trees down across channel. Old blockages have drifted and tangled into branches causing blockage to increase in size. Larger log under water extends from bank 20 feet. Recommend cutting out all timber, including submerged log. This will open channel up to 20 feet.

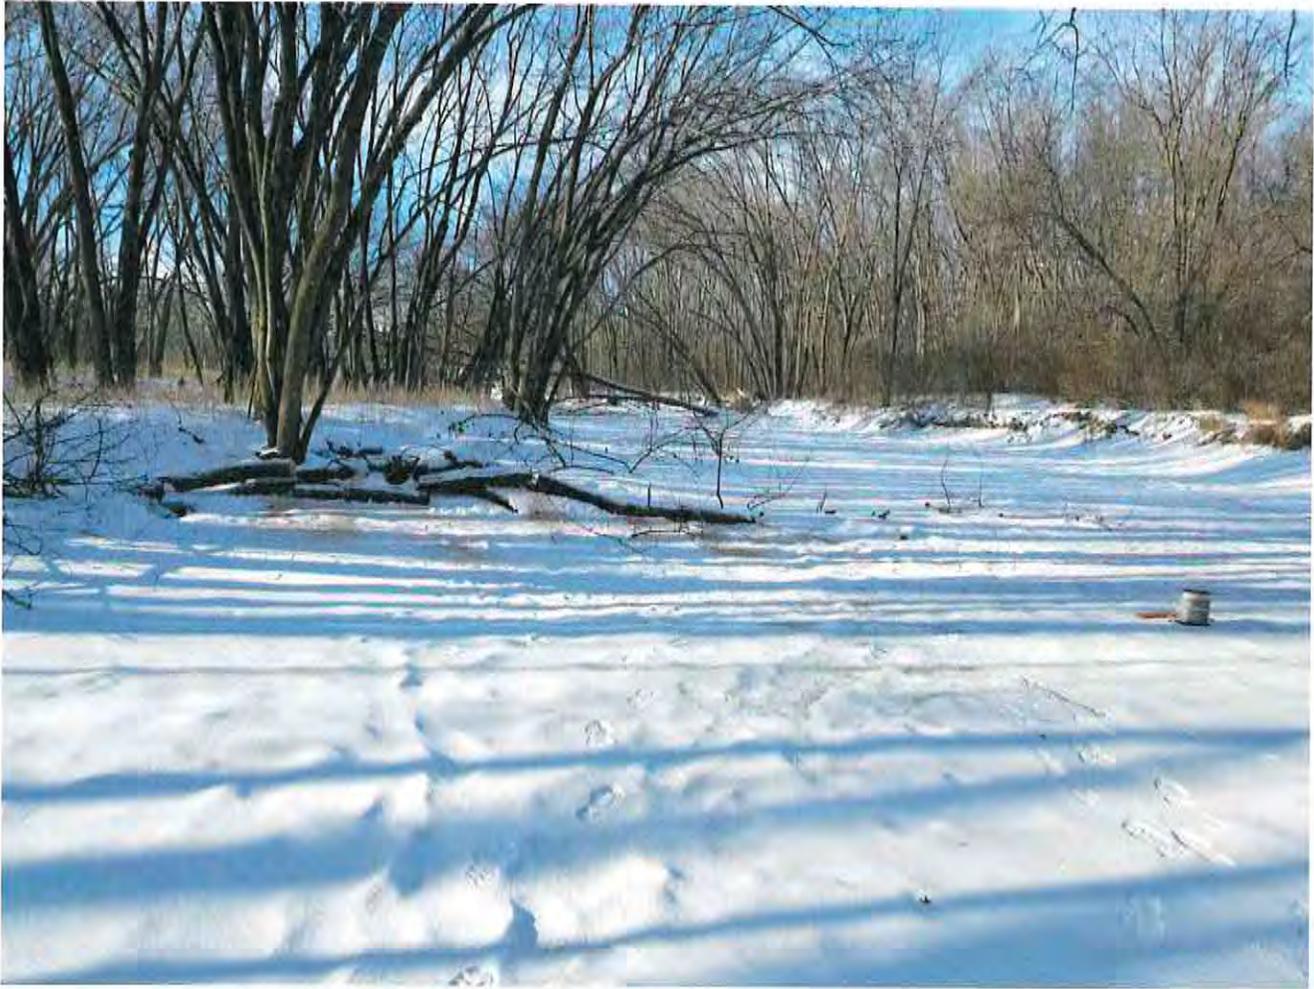
ECB#5

Before and after pic
