Eau Claire River Blockage Report

10/31/2017

Abram Weller-Owner
TIMBER HARVESTING SOLUTIONS LLC
5902 PINE PARK ST.
WESTON, WI 54476
715-302-4648
abramweller@gmail.com

POST BLOCKAGE REPORT

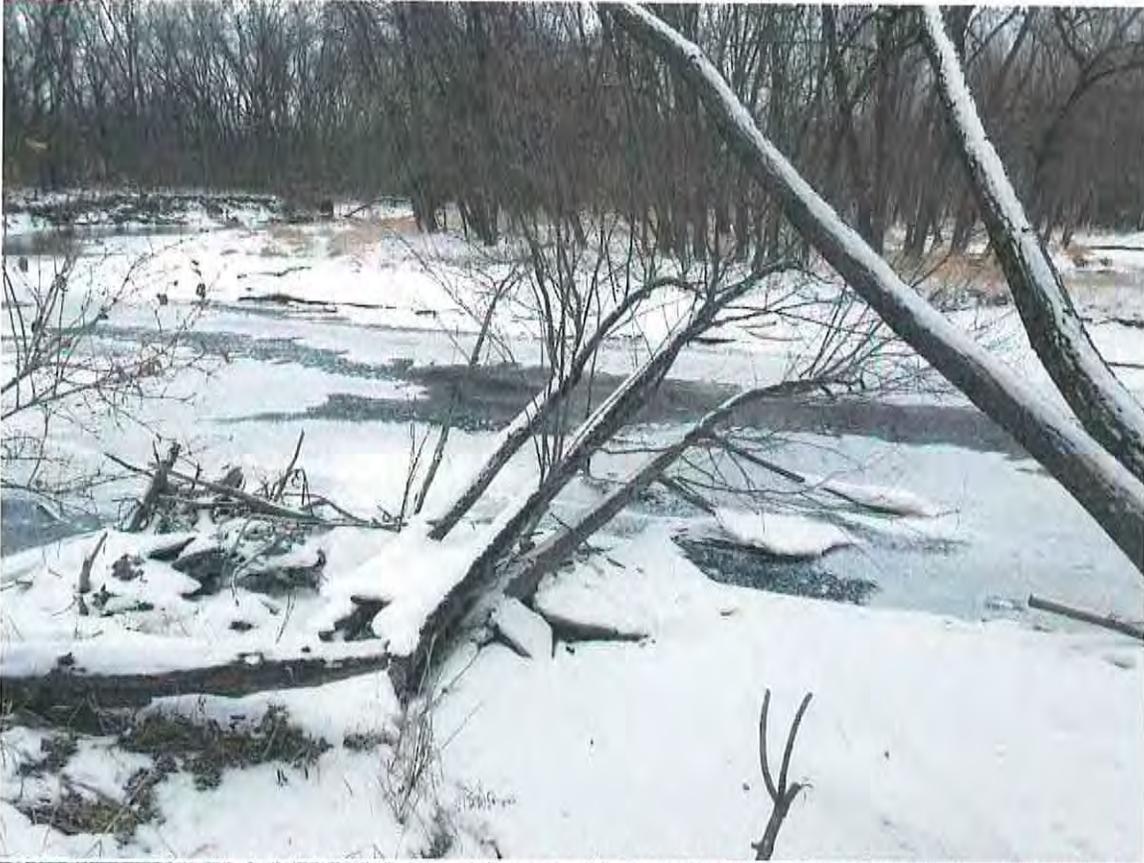
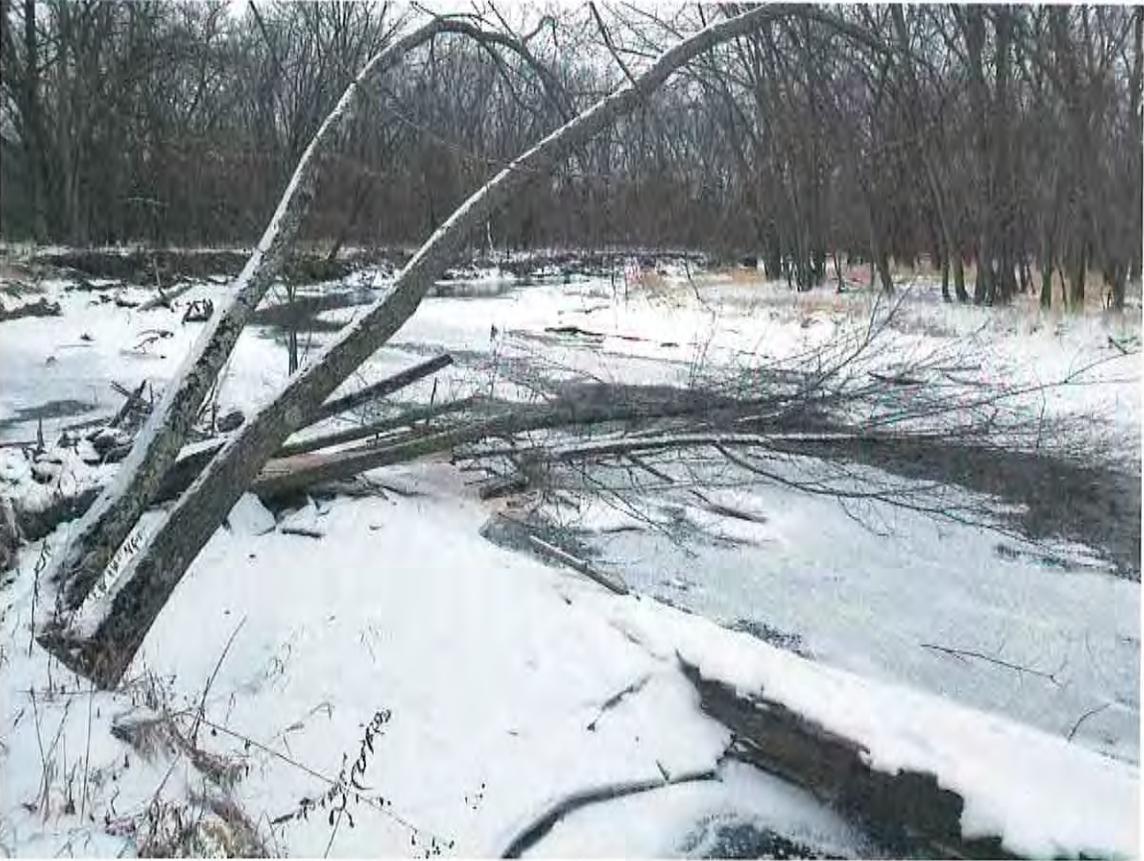
ECB#13

The cutting at each site varied depending on ice conditions. As stated above, majority of the timber at each site was cut into small pieces not to exceed 3 feet, if attainable. Only two sites had to be left in larger chunks which are ECB 13,14. At those two sites, the ice showed unsafe

signs and tested not to be safe enough to work on the timber from standing on the ice. We did however cut the blockages from shore, and enough to keep the channel open to boat traffic.

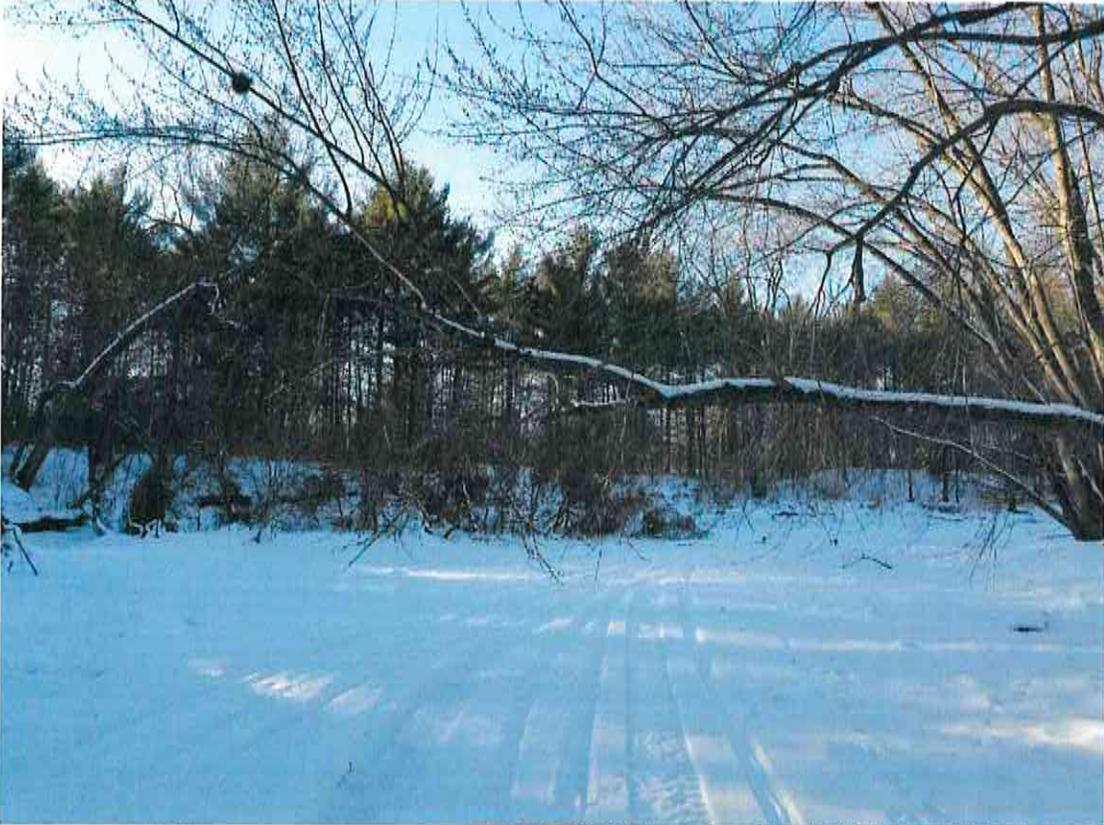
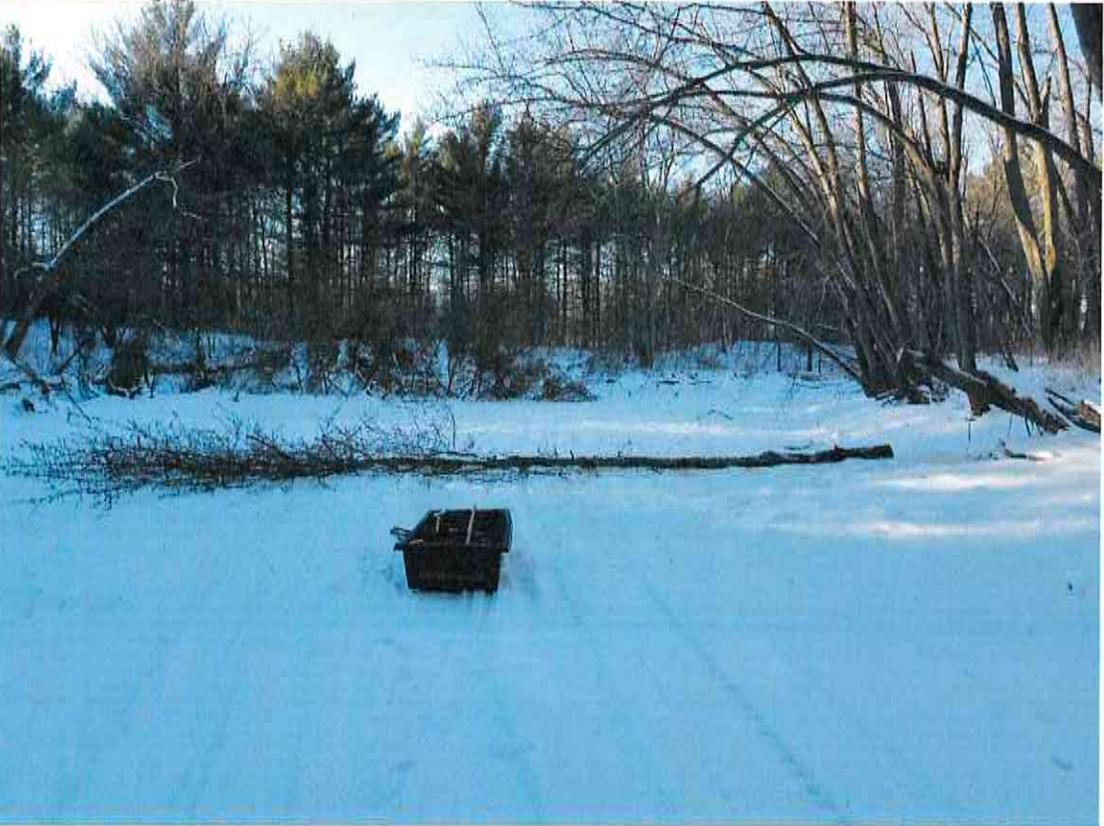
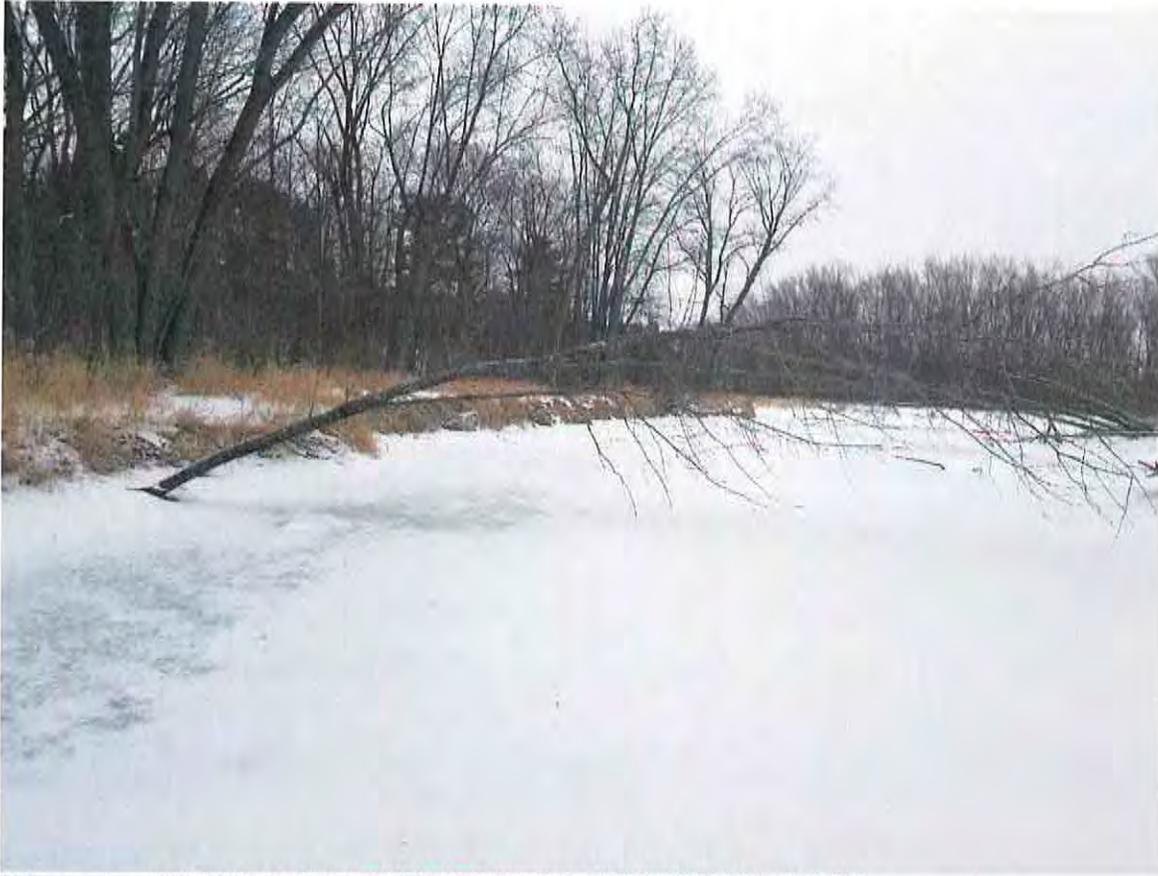
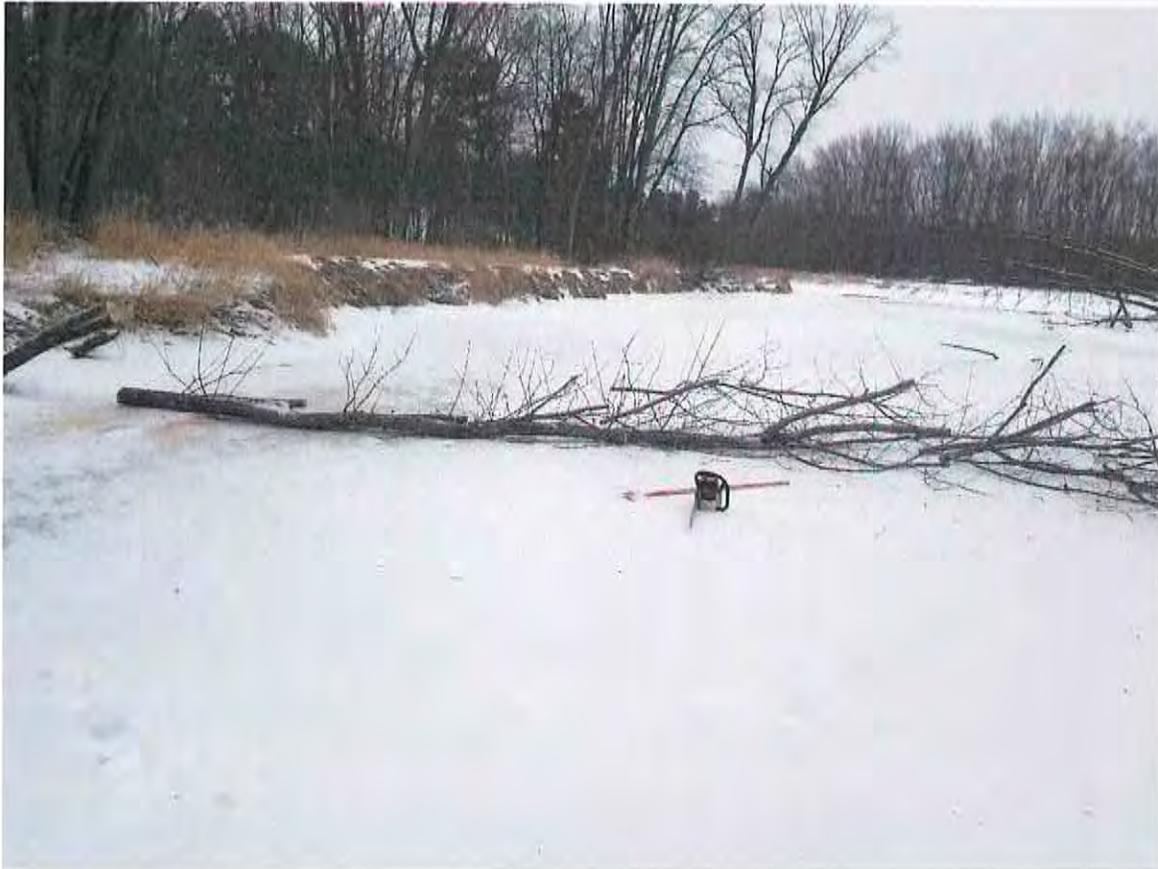
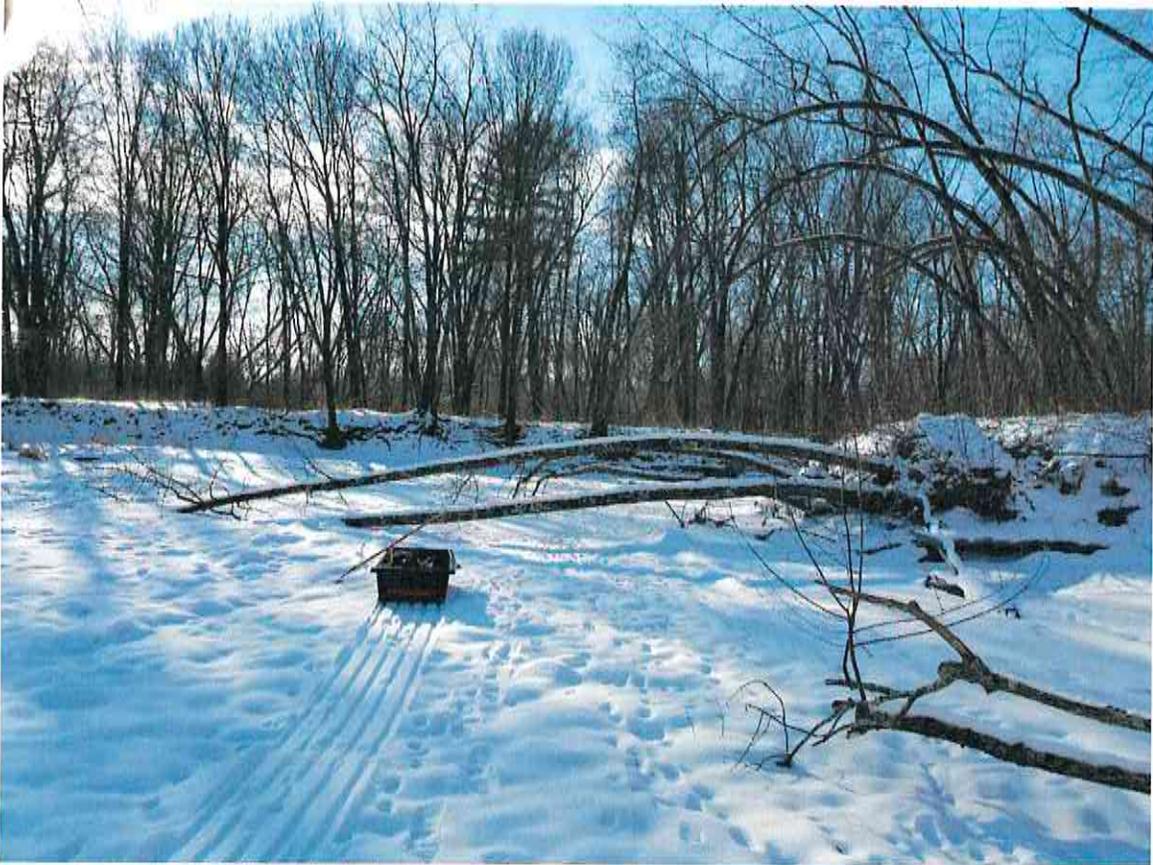
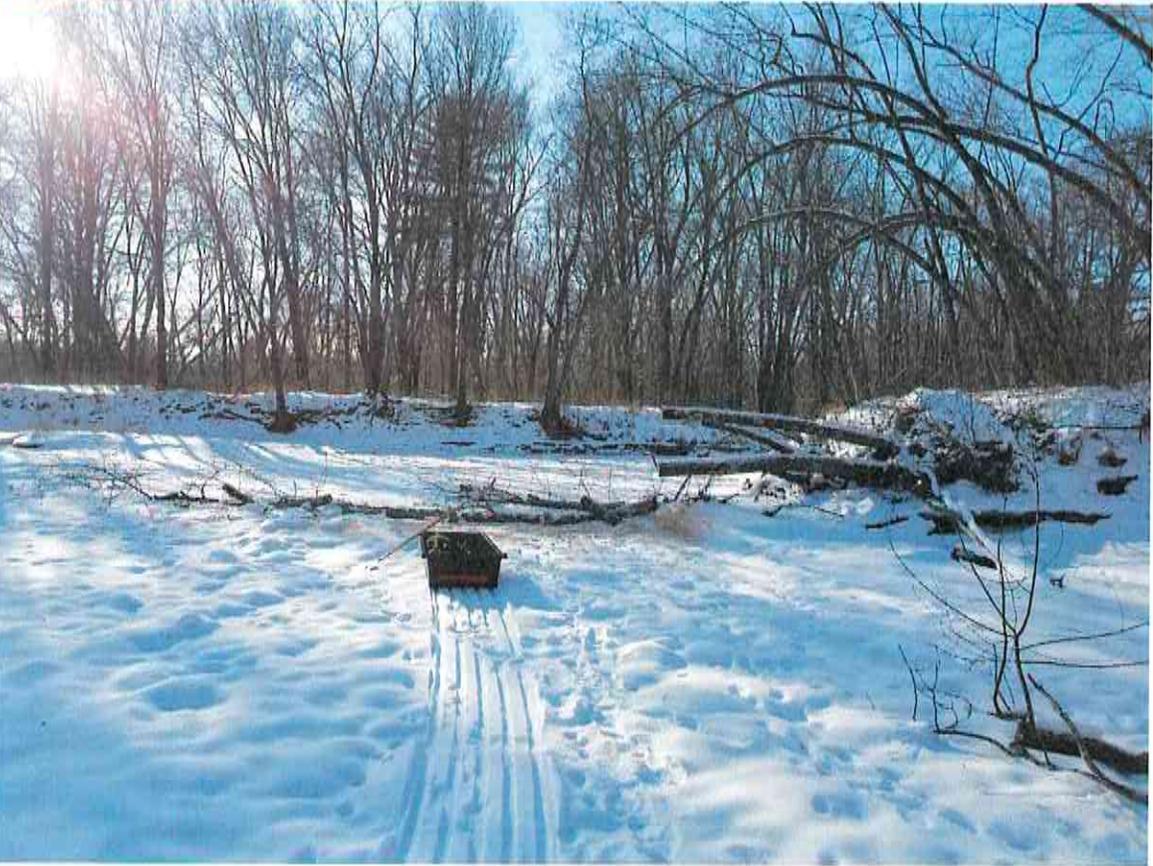
Additional Blockages that were created sometime after the survey and January. Timber Harvesting Solutions LLC did remove the blockages to continue forward without delays. Below are pictures showing the size and work completed.
