Aquatic Facility Evaluation

Weston Aquatic Center
Weston, Wisconsin

September 14, 2016

Water Technology, Inc. (WTI)
100 Park Avenue, PO Box 614
Beaver Dam, WI 53916
www.wtiworld.com

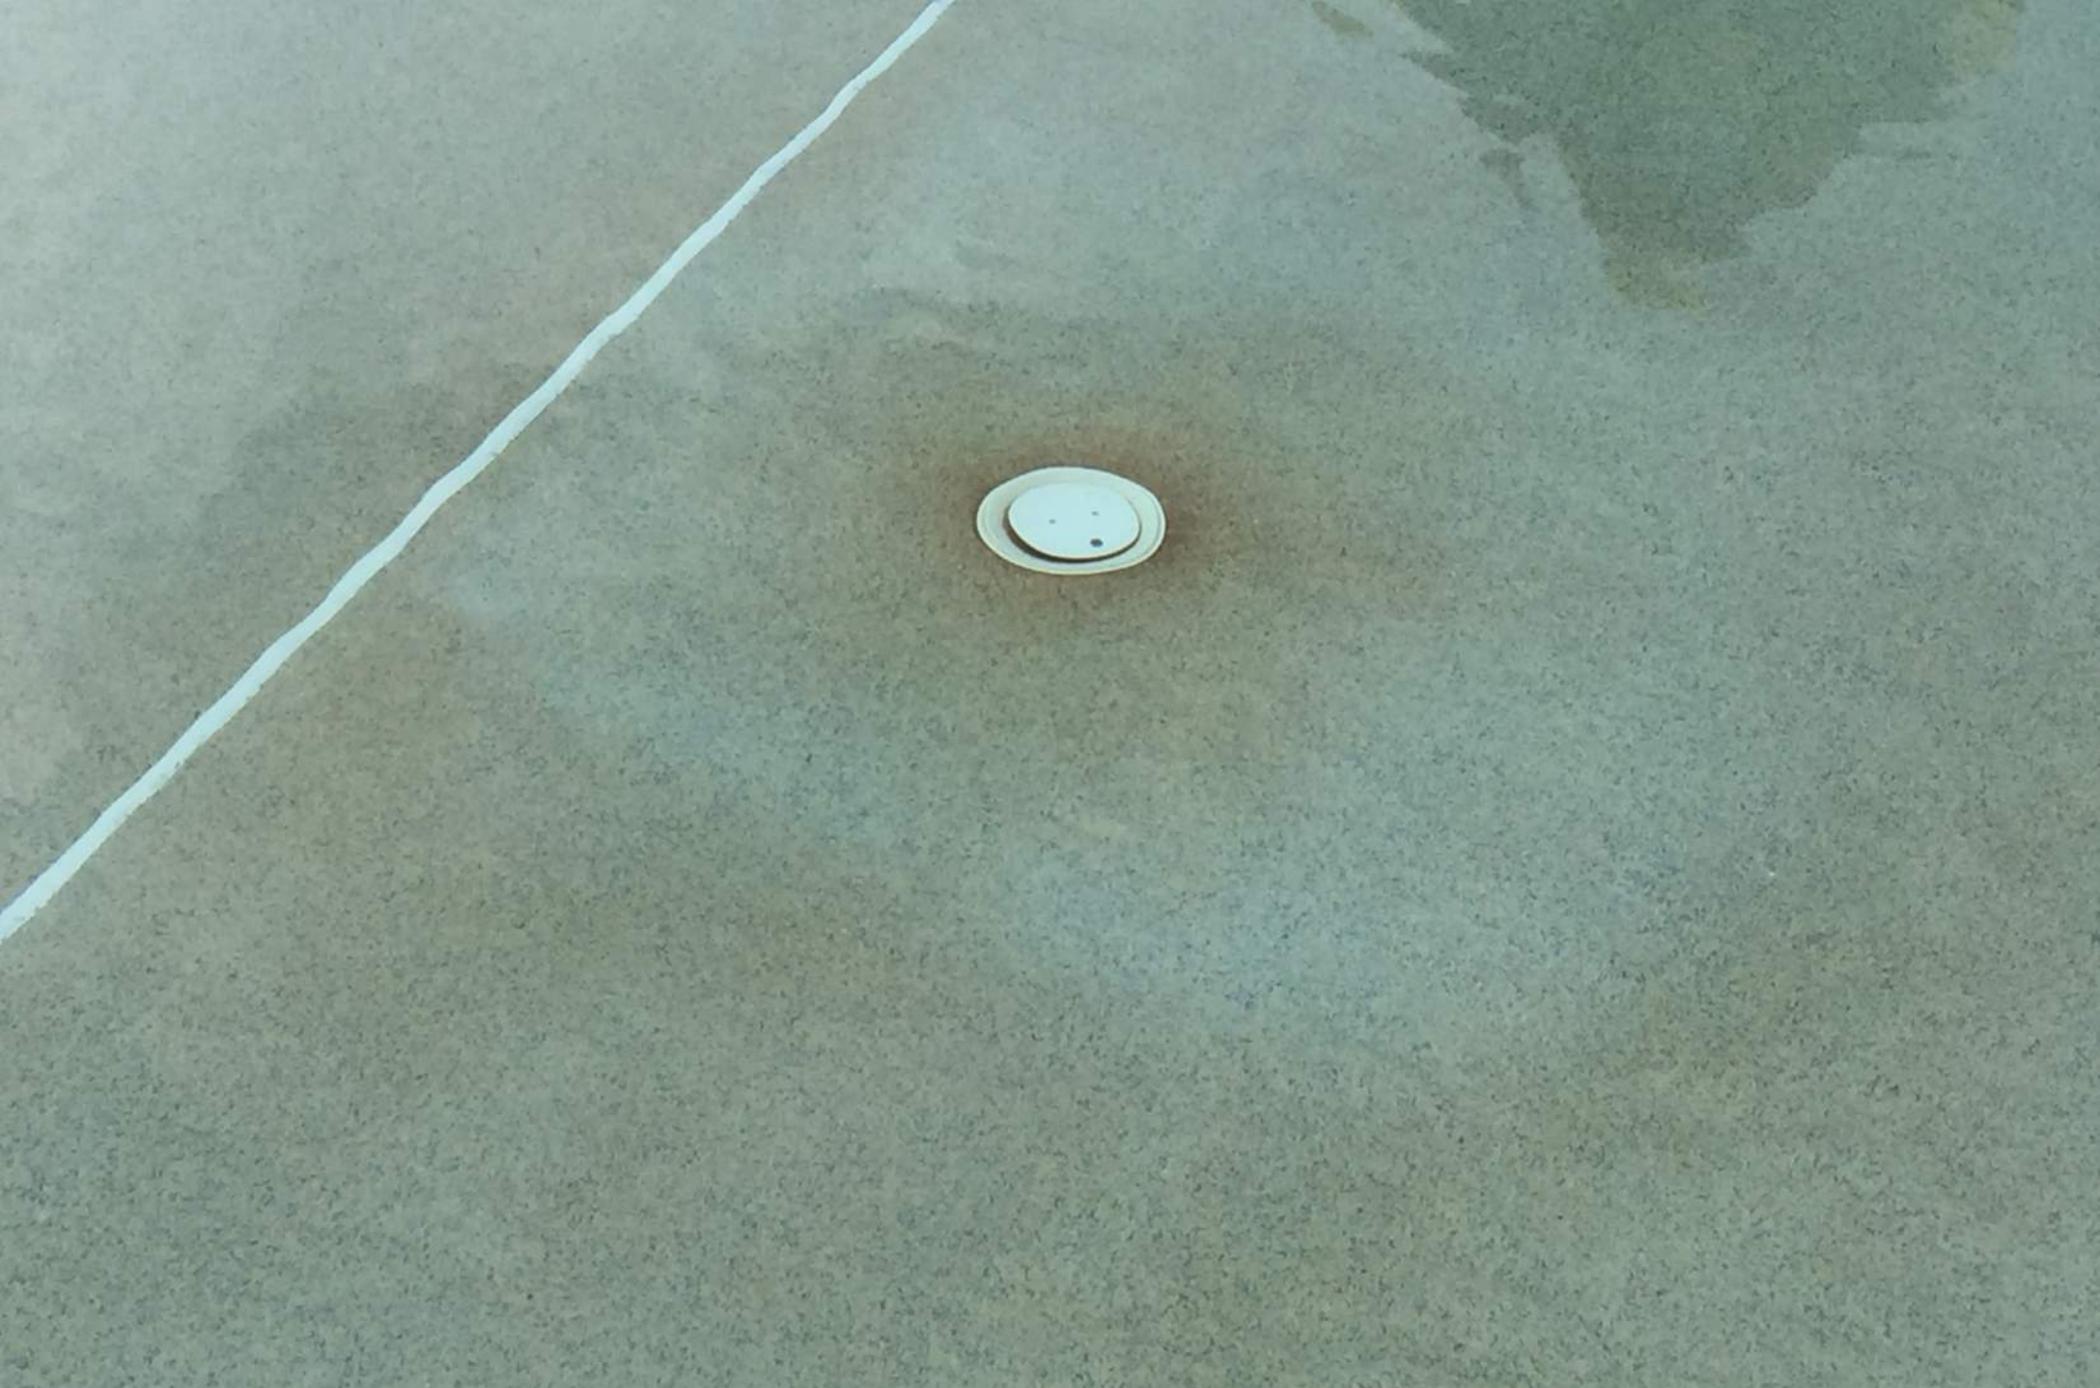
IMAGE 005

Image 005 – Pool inlet with mild staining after recent acid washing of inlet area

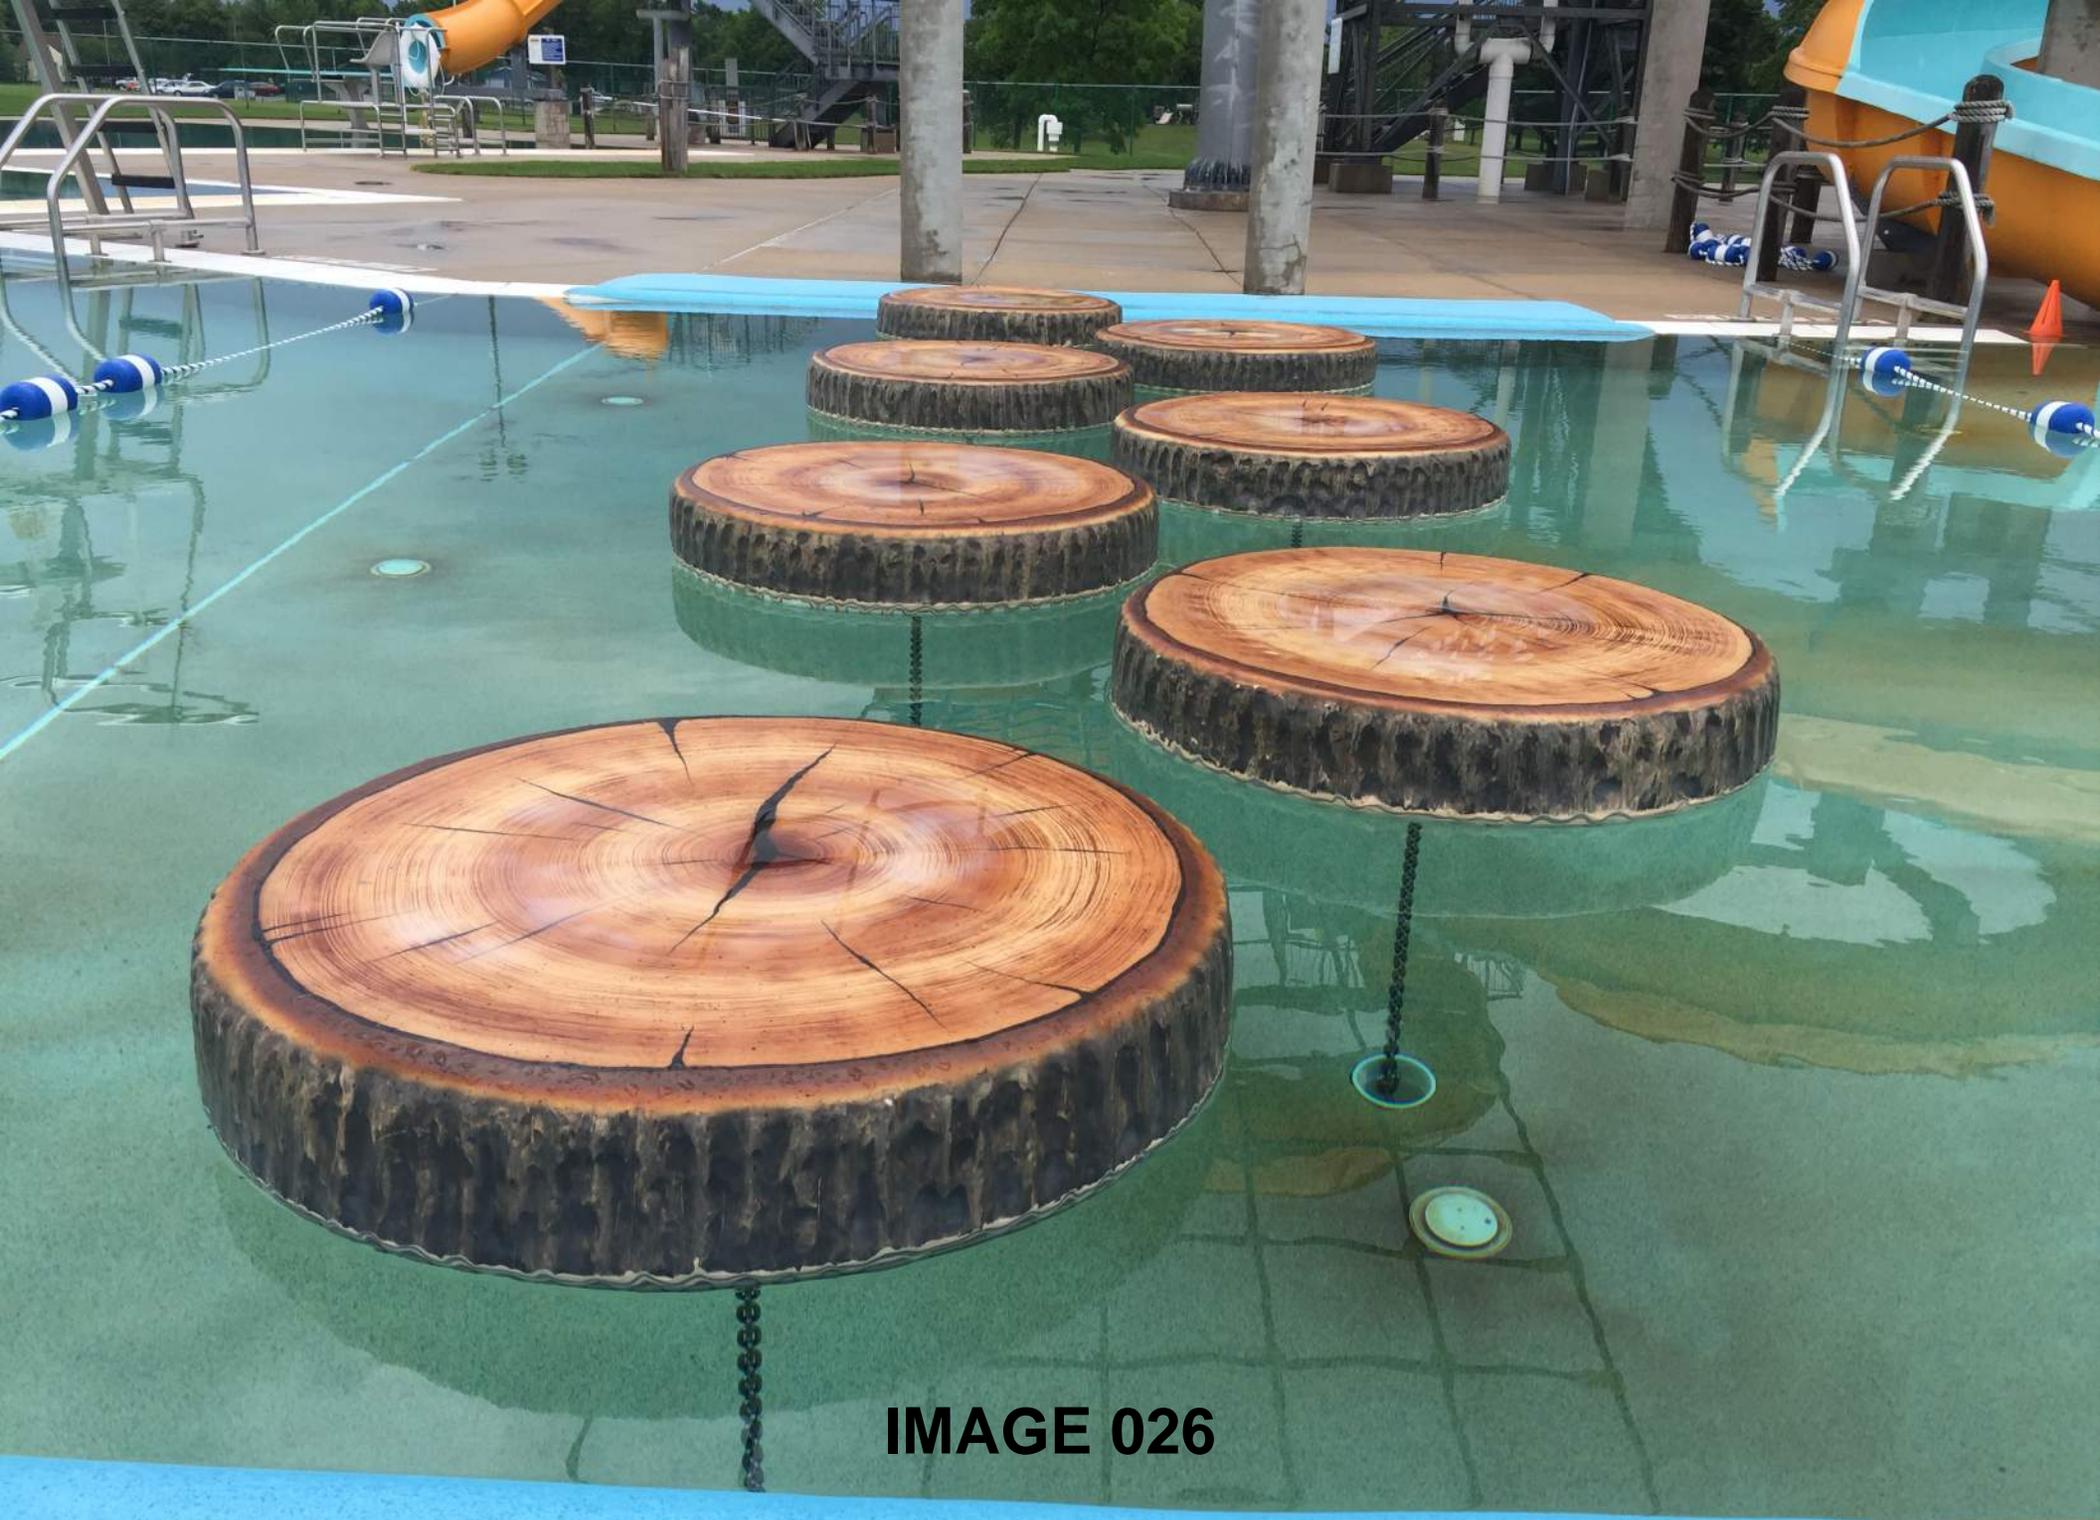
IMAGE 026

Image 026 – Floating log themed pads

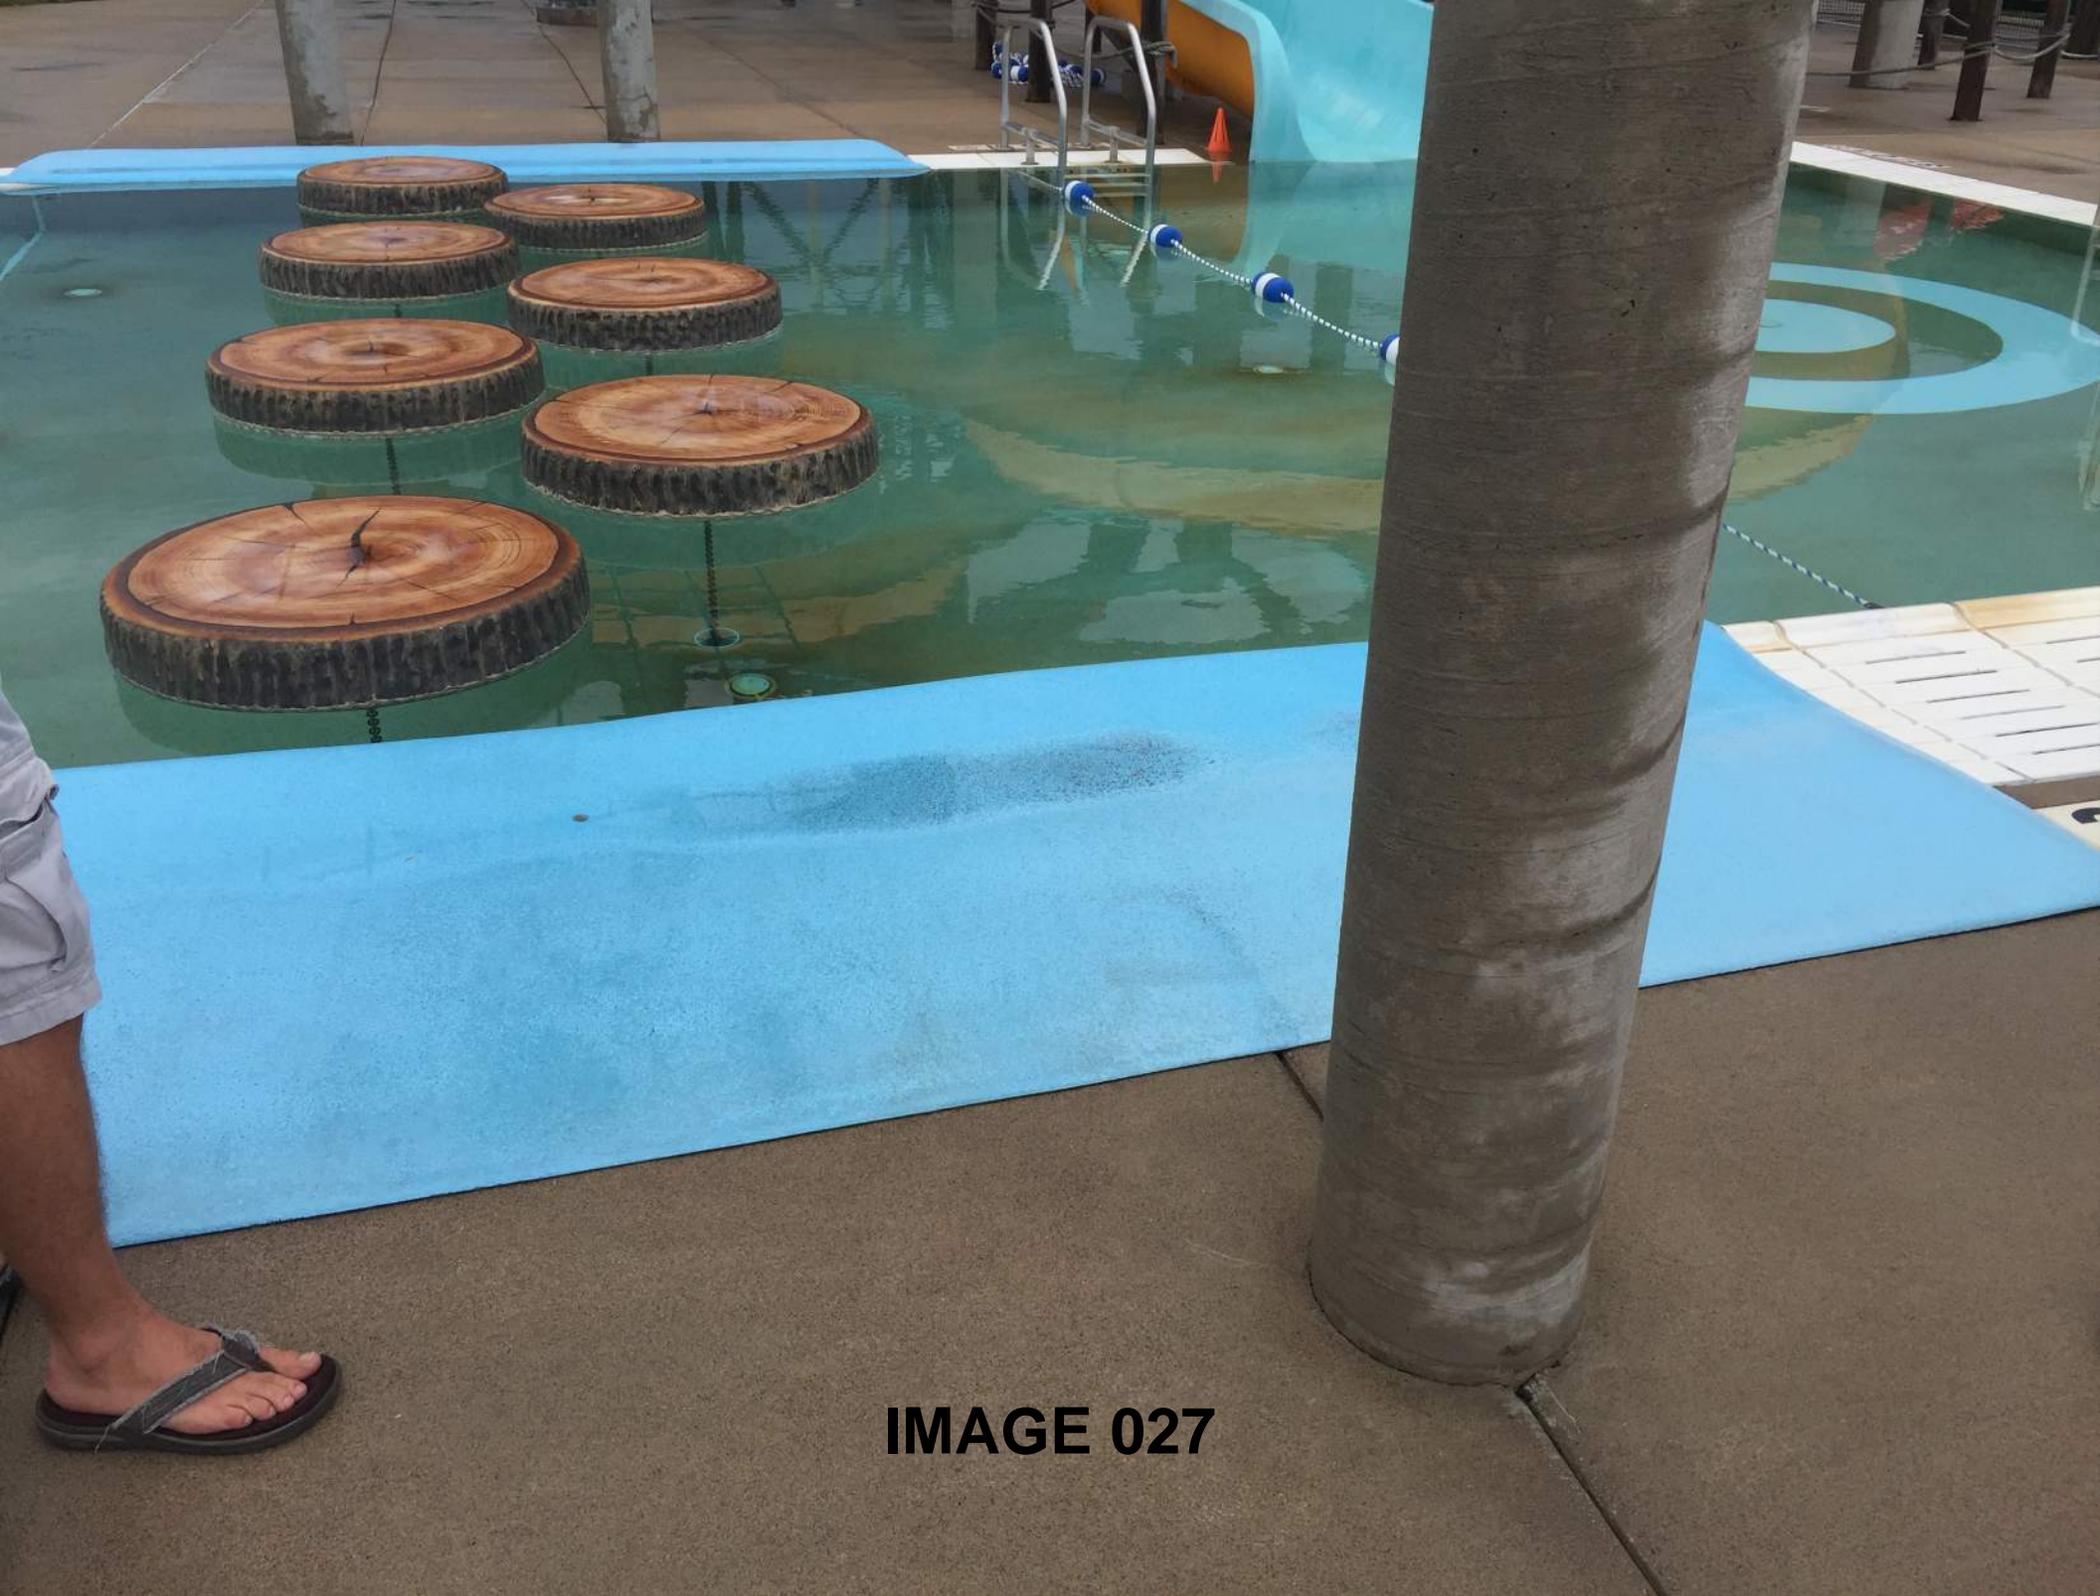
IMAGE 027

Image 027 – Safety padding on pool edge

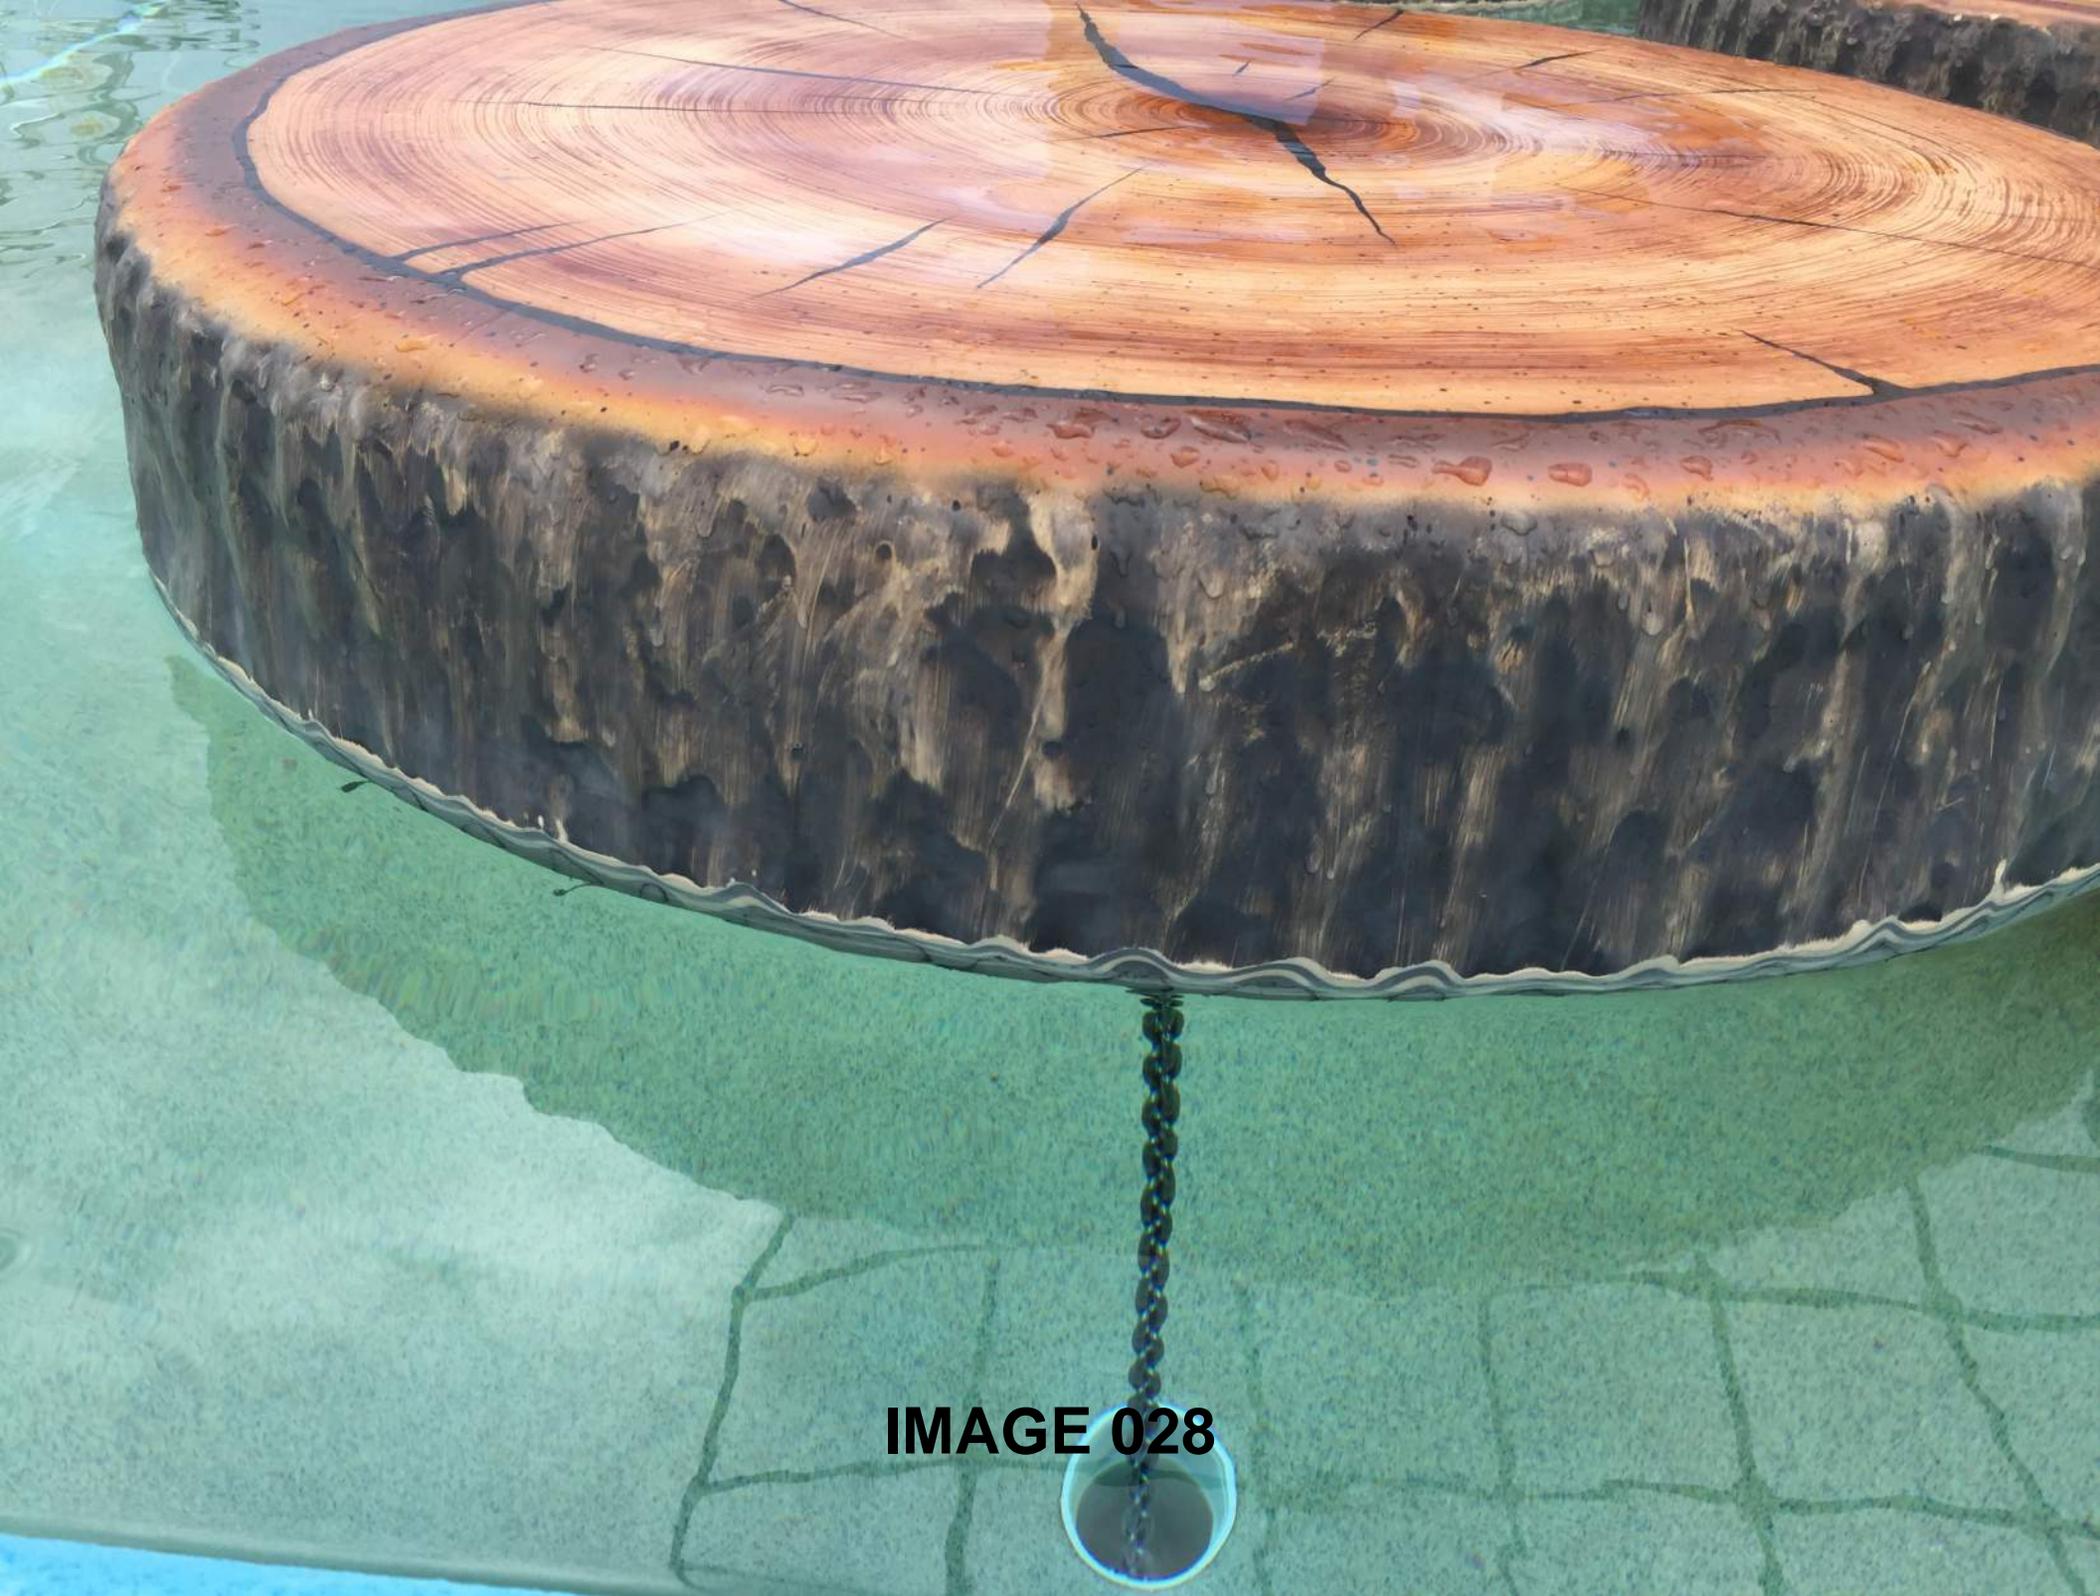
IMAGE 028

Image 028 – Close-up of floating log pad

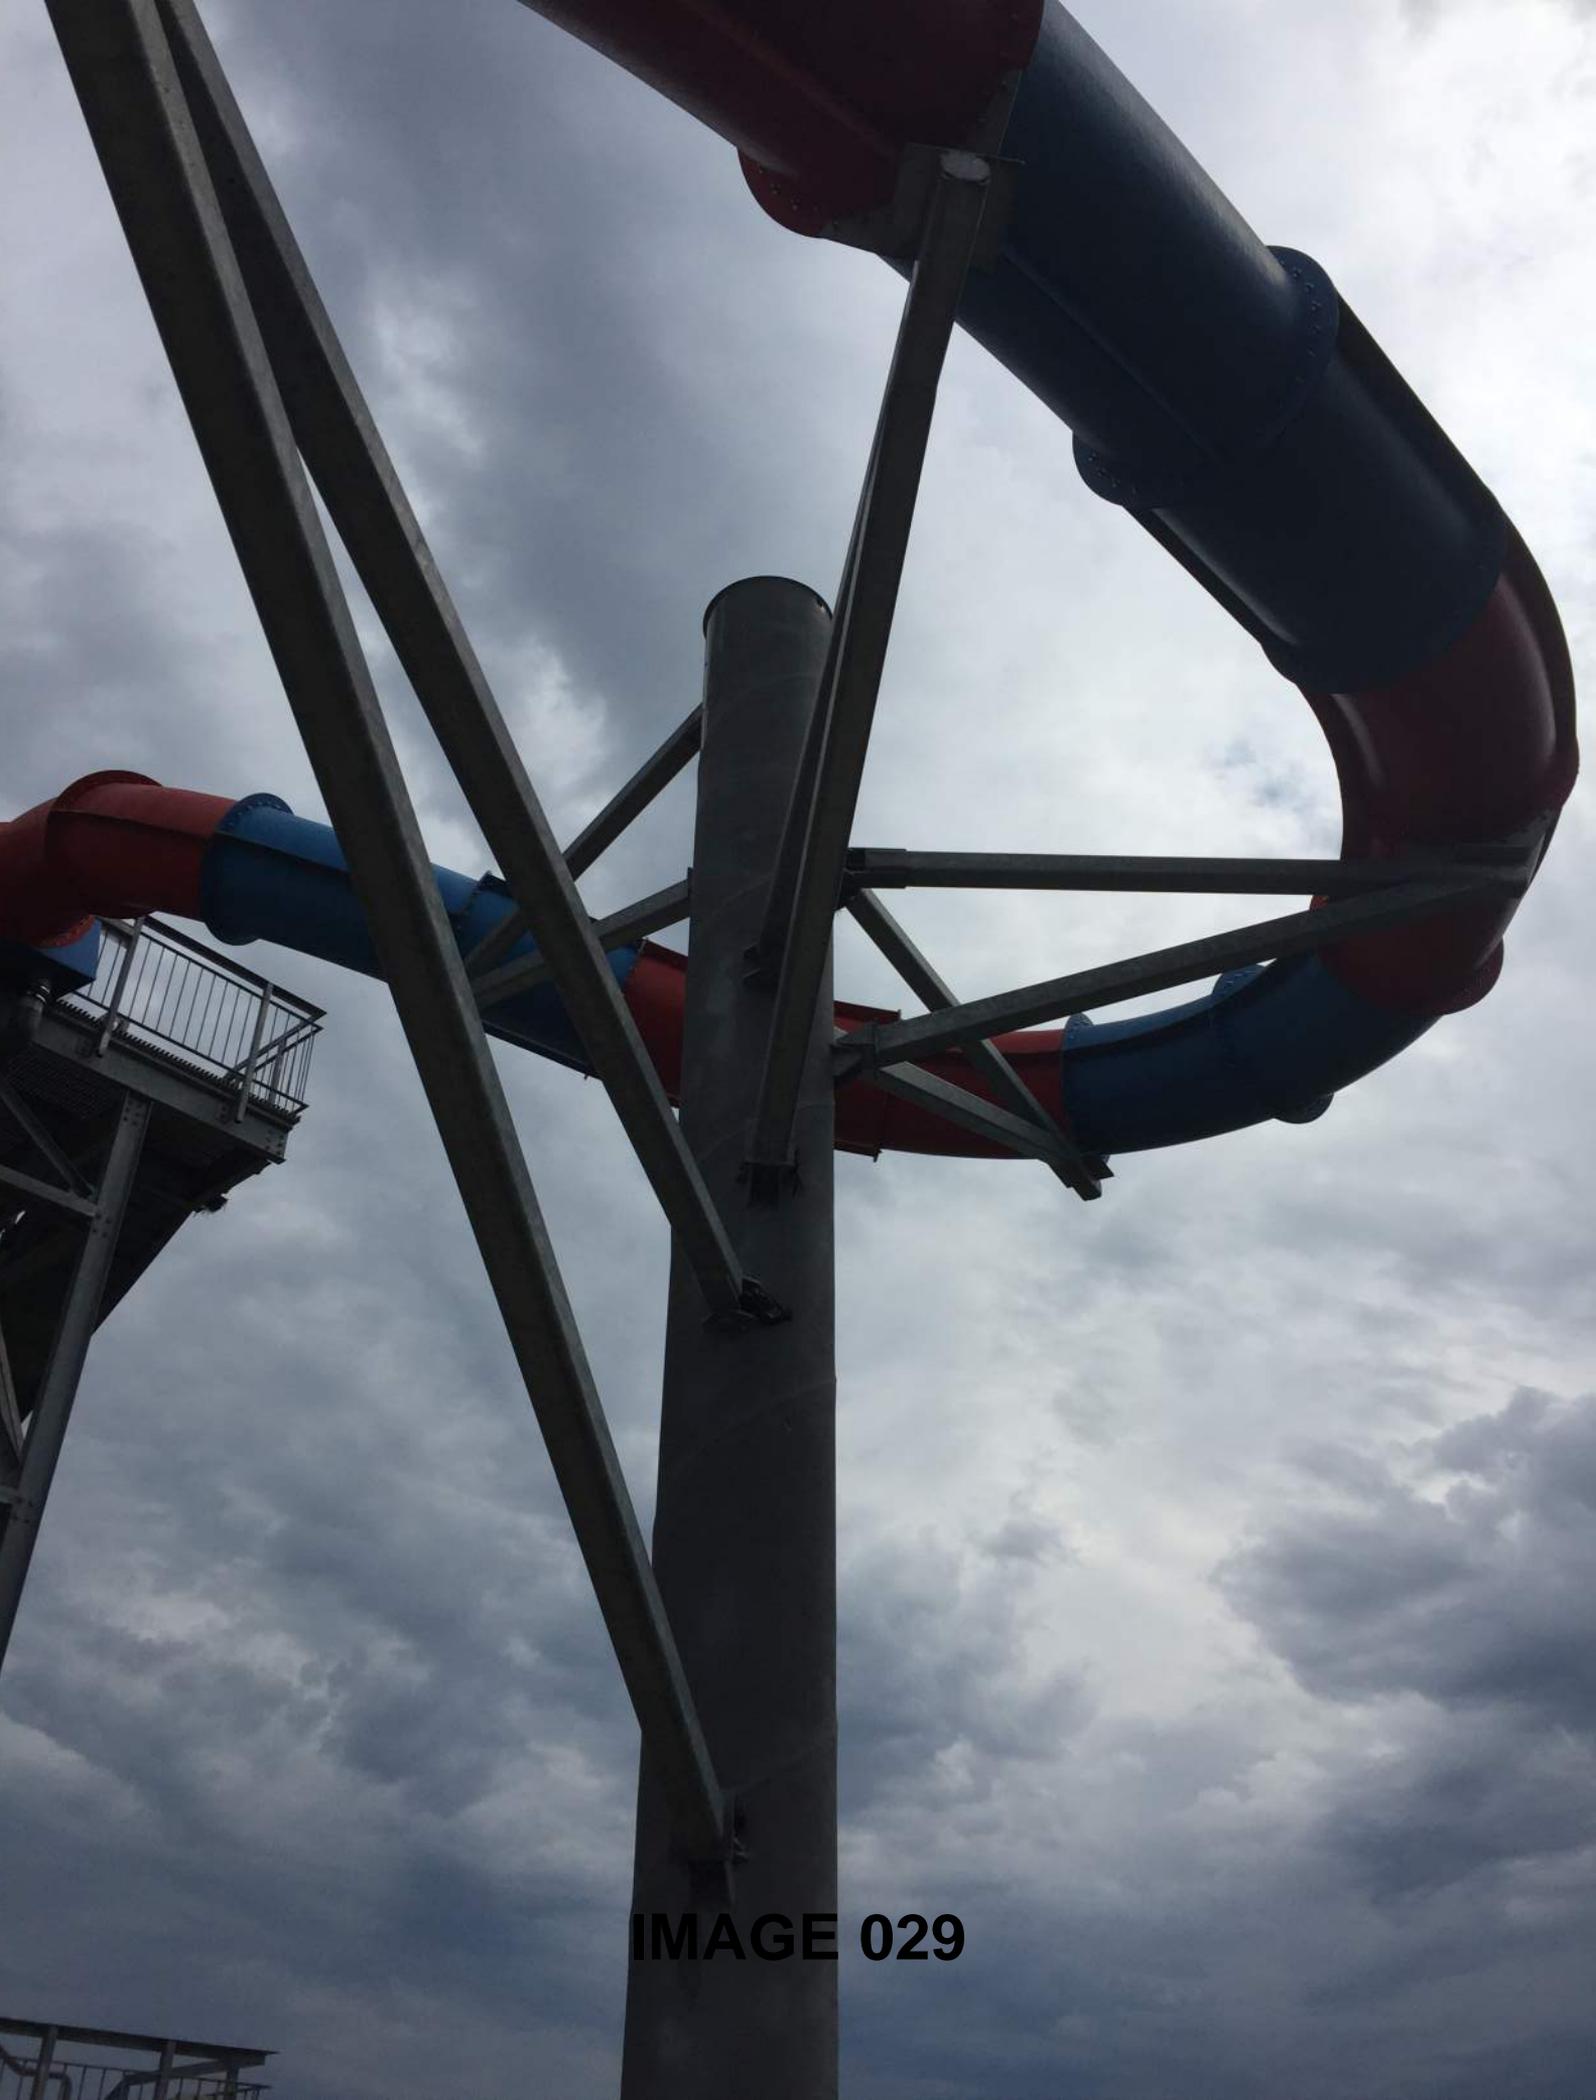
IMAGE 029

Image 029 – Speed slide support tower from beneath

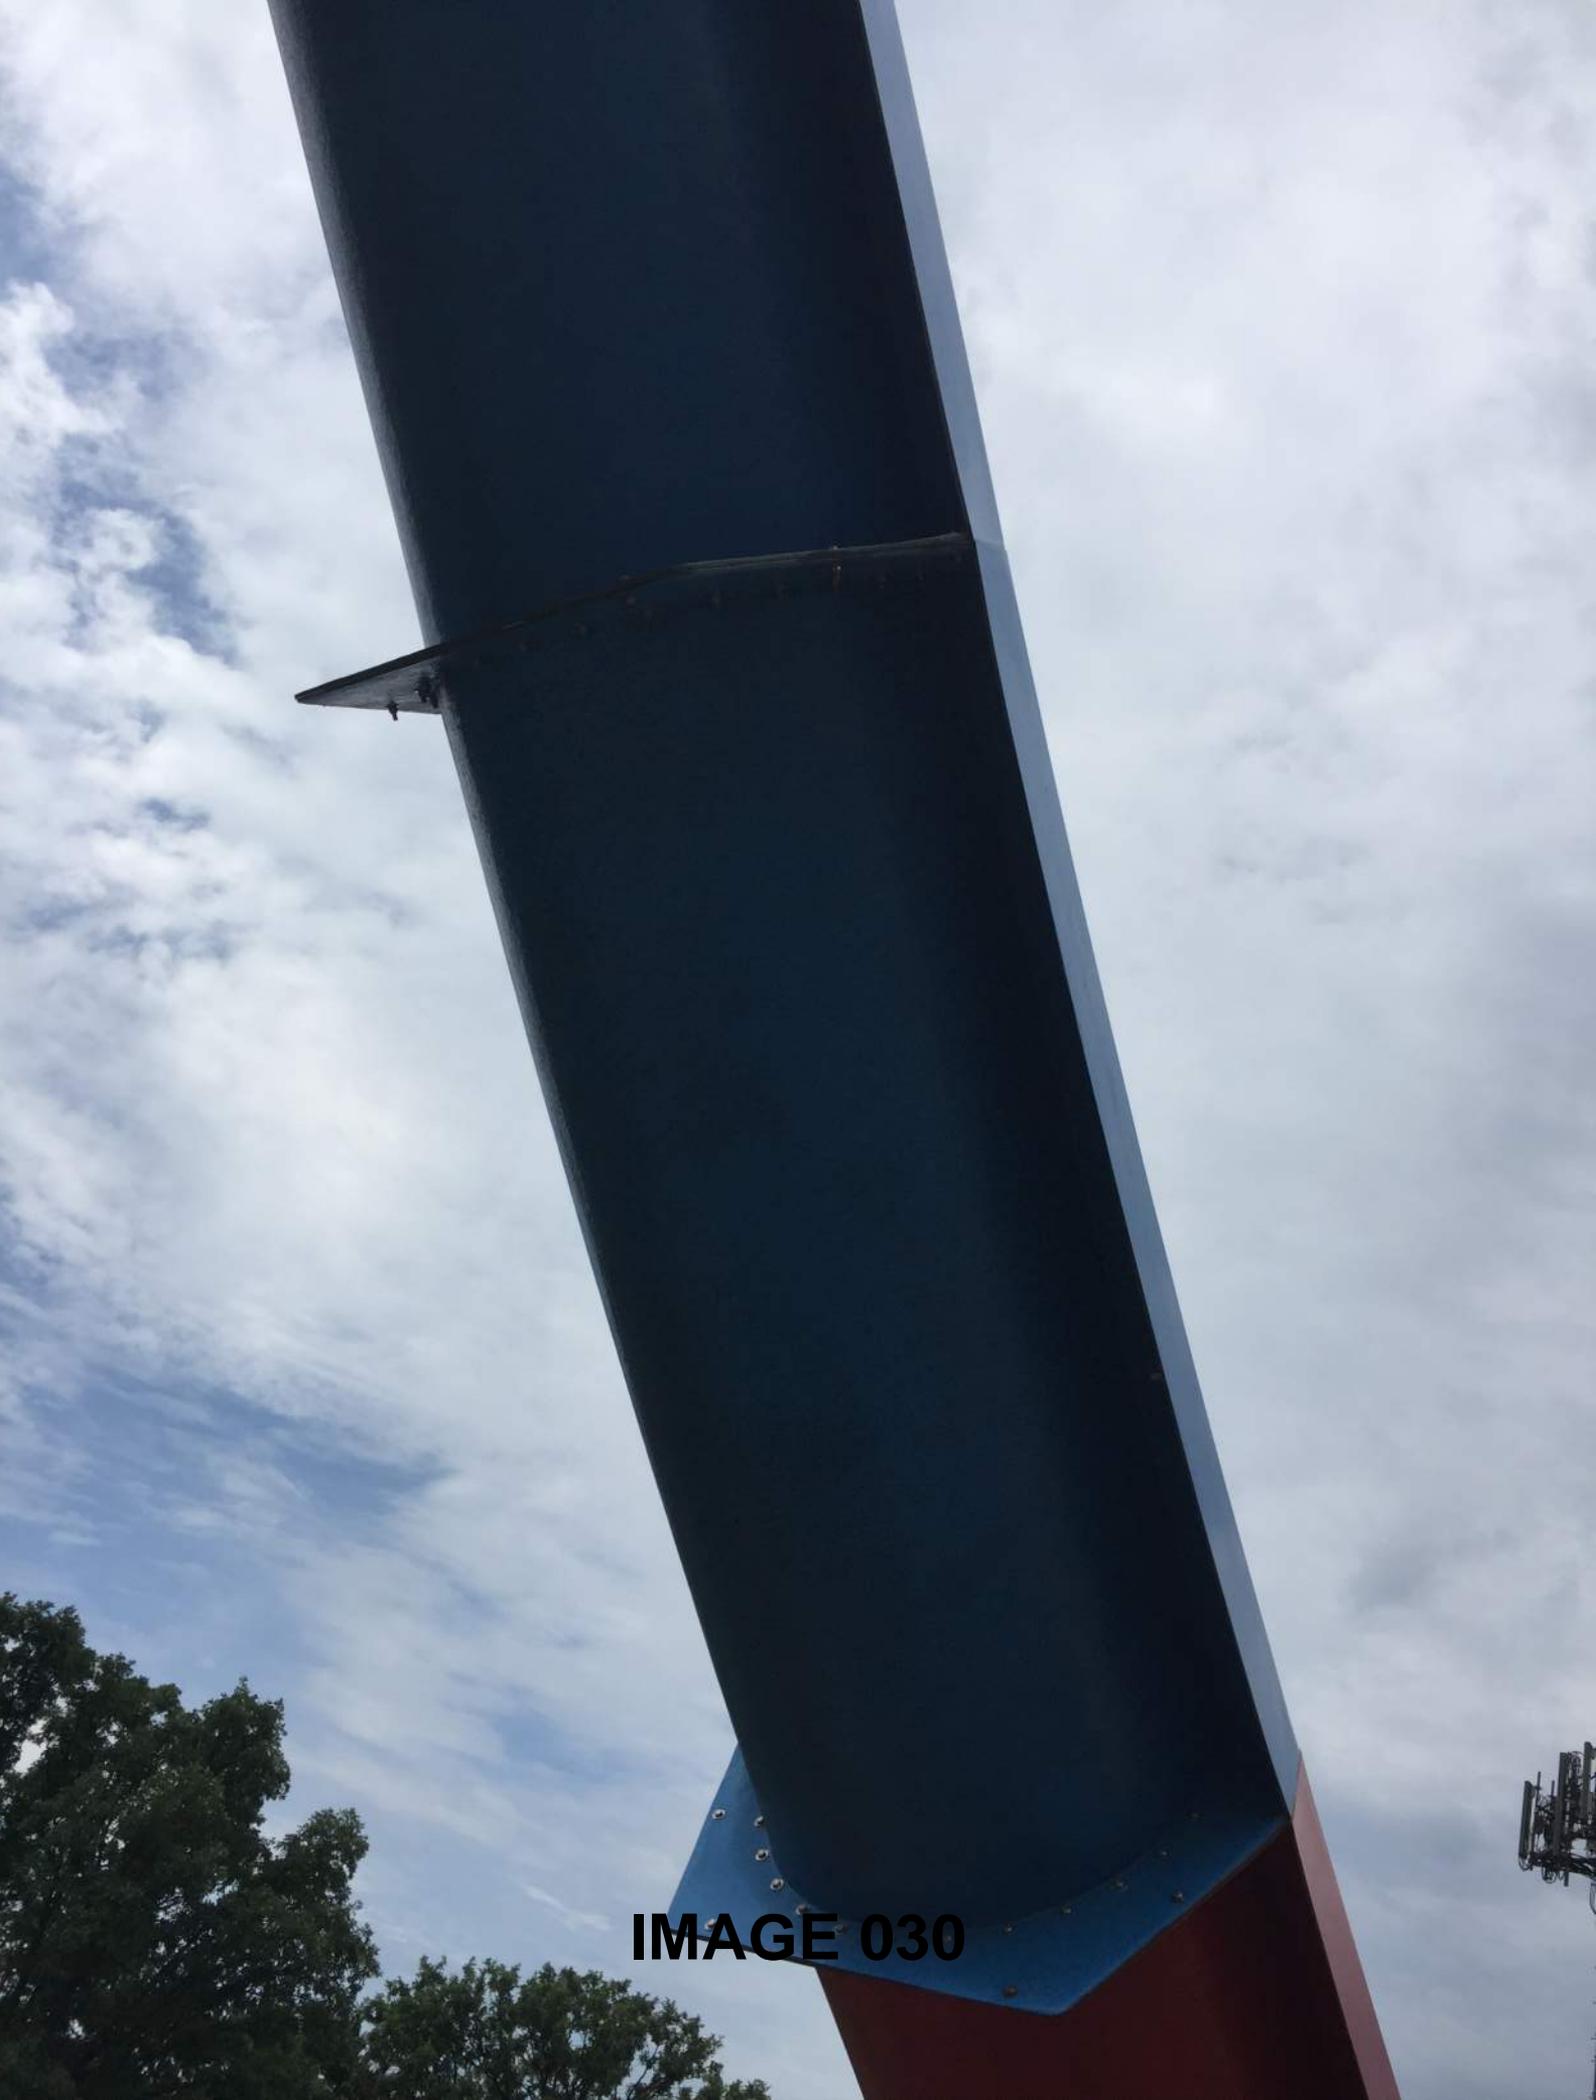
IMAGE 030

Image 030 – Speed slide open flume section from beneath

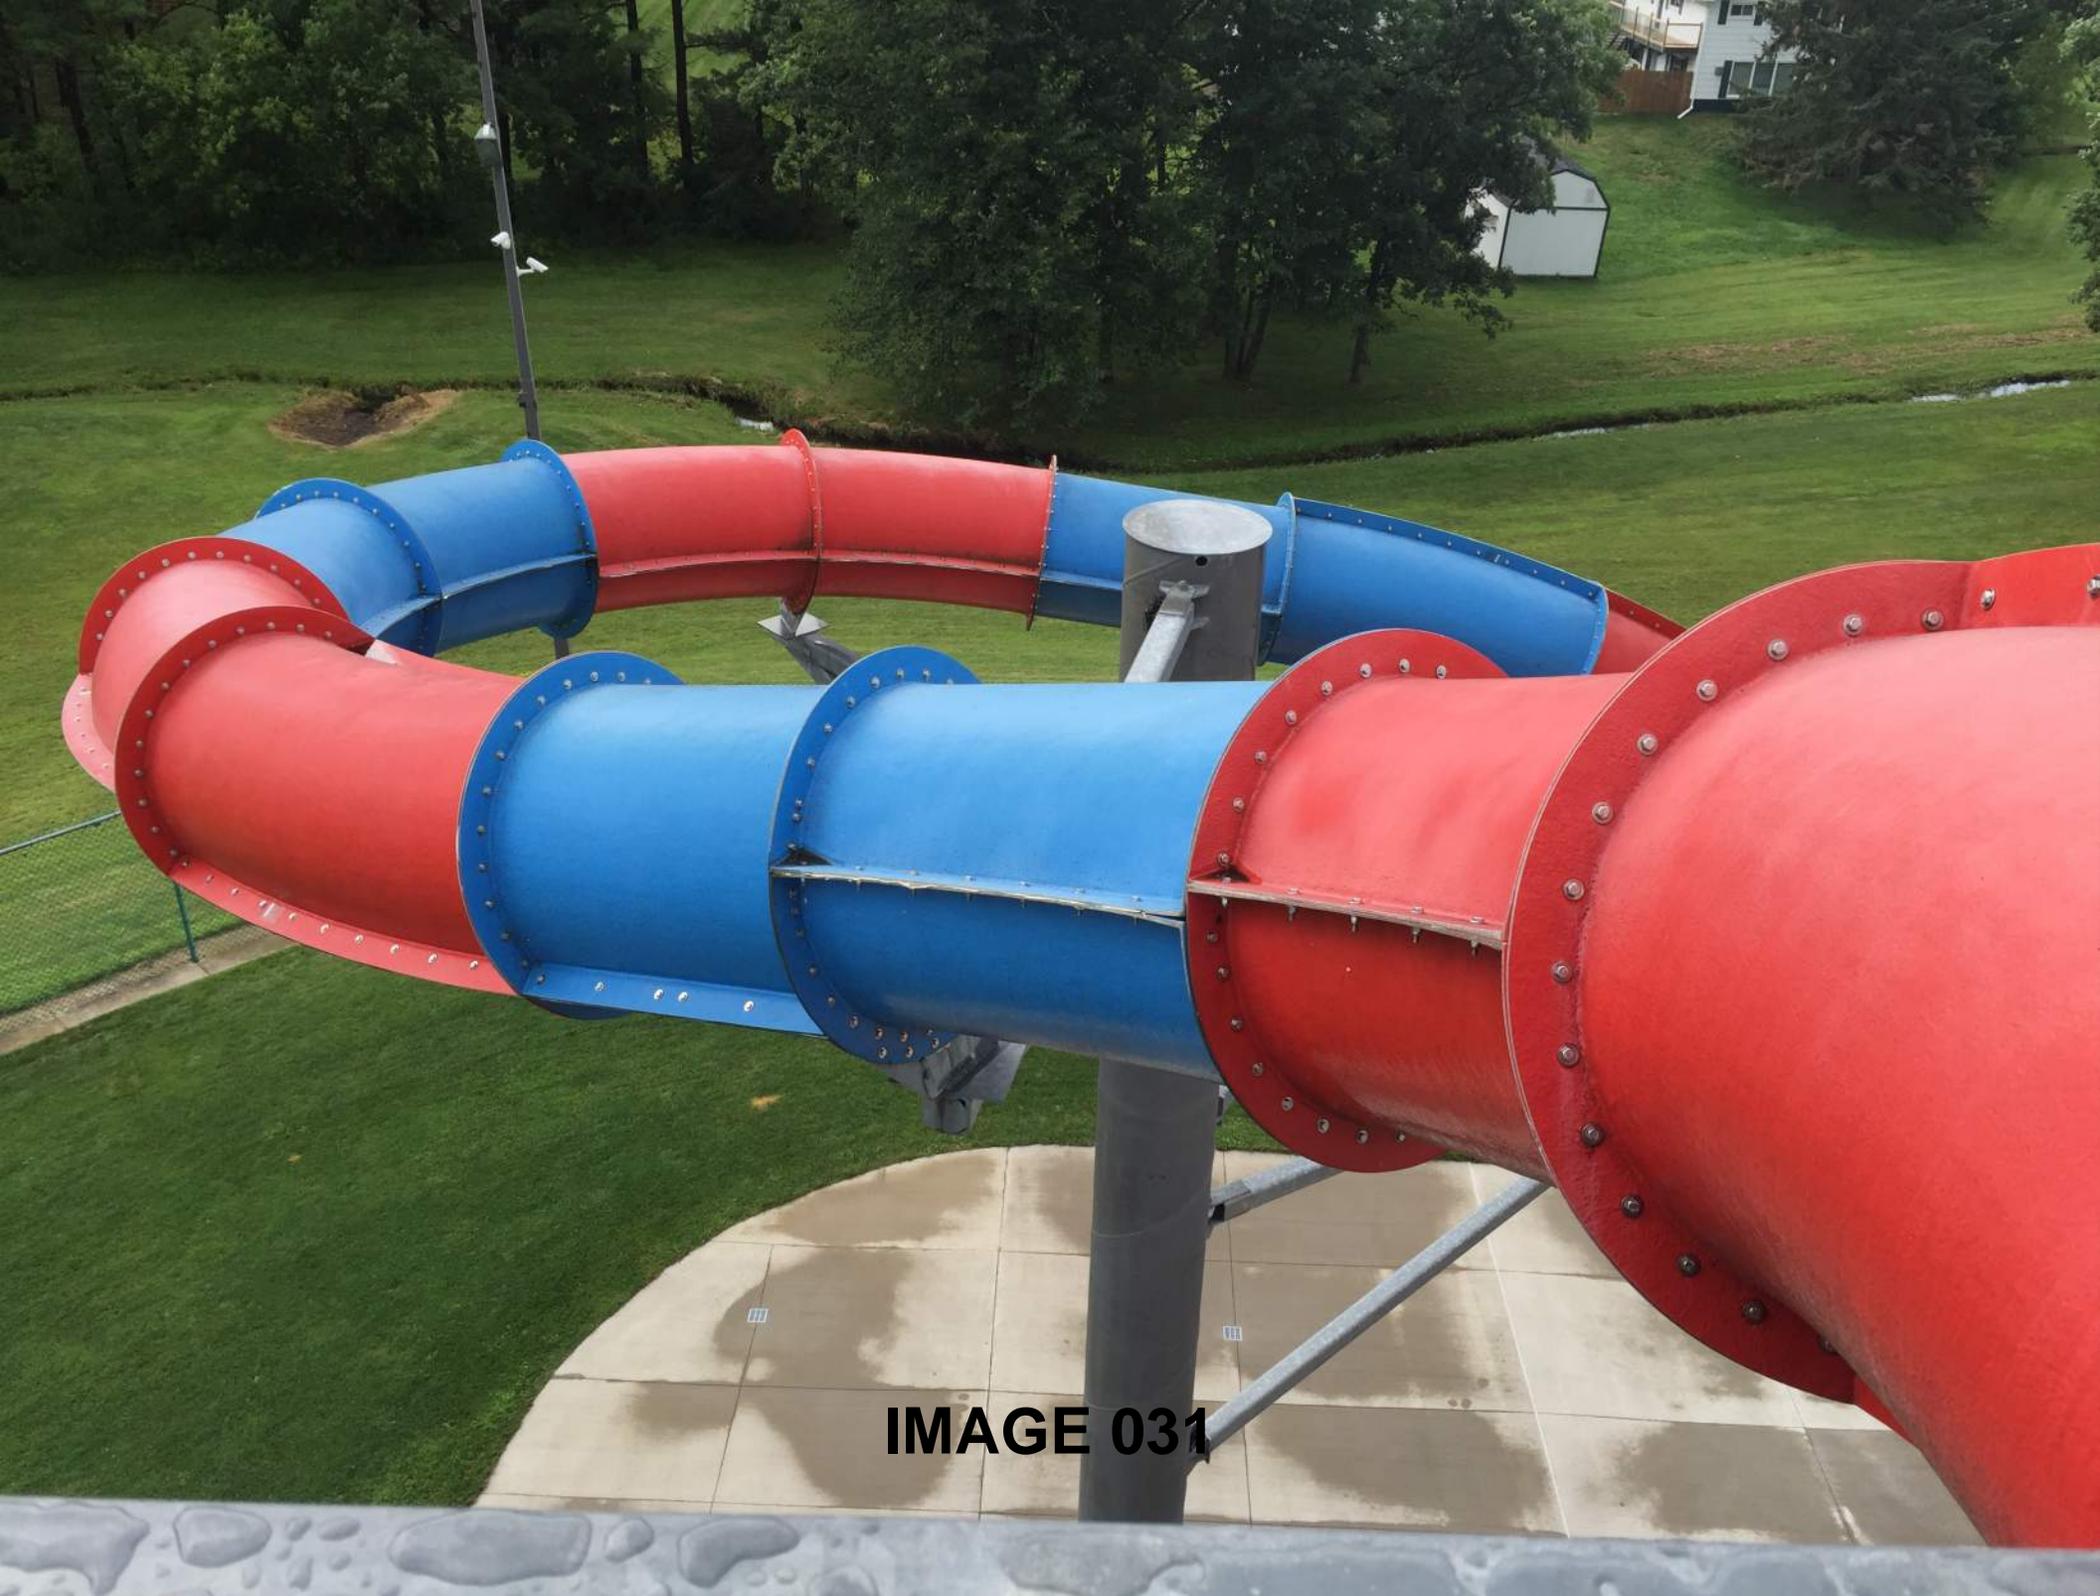
IMAGE 031

Image 031 – Speed slide closed flume section from above
