Aquatic Facility Evaluation

Weston Aquatic Center
Weston, Wisconsin

September 14, 2016

Water Technology, Inc. (WTI)
100 Park Avenue, PO Box 614
Beaver Dam, WI 53916
www.wtiworld.com

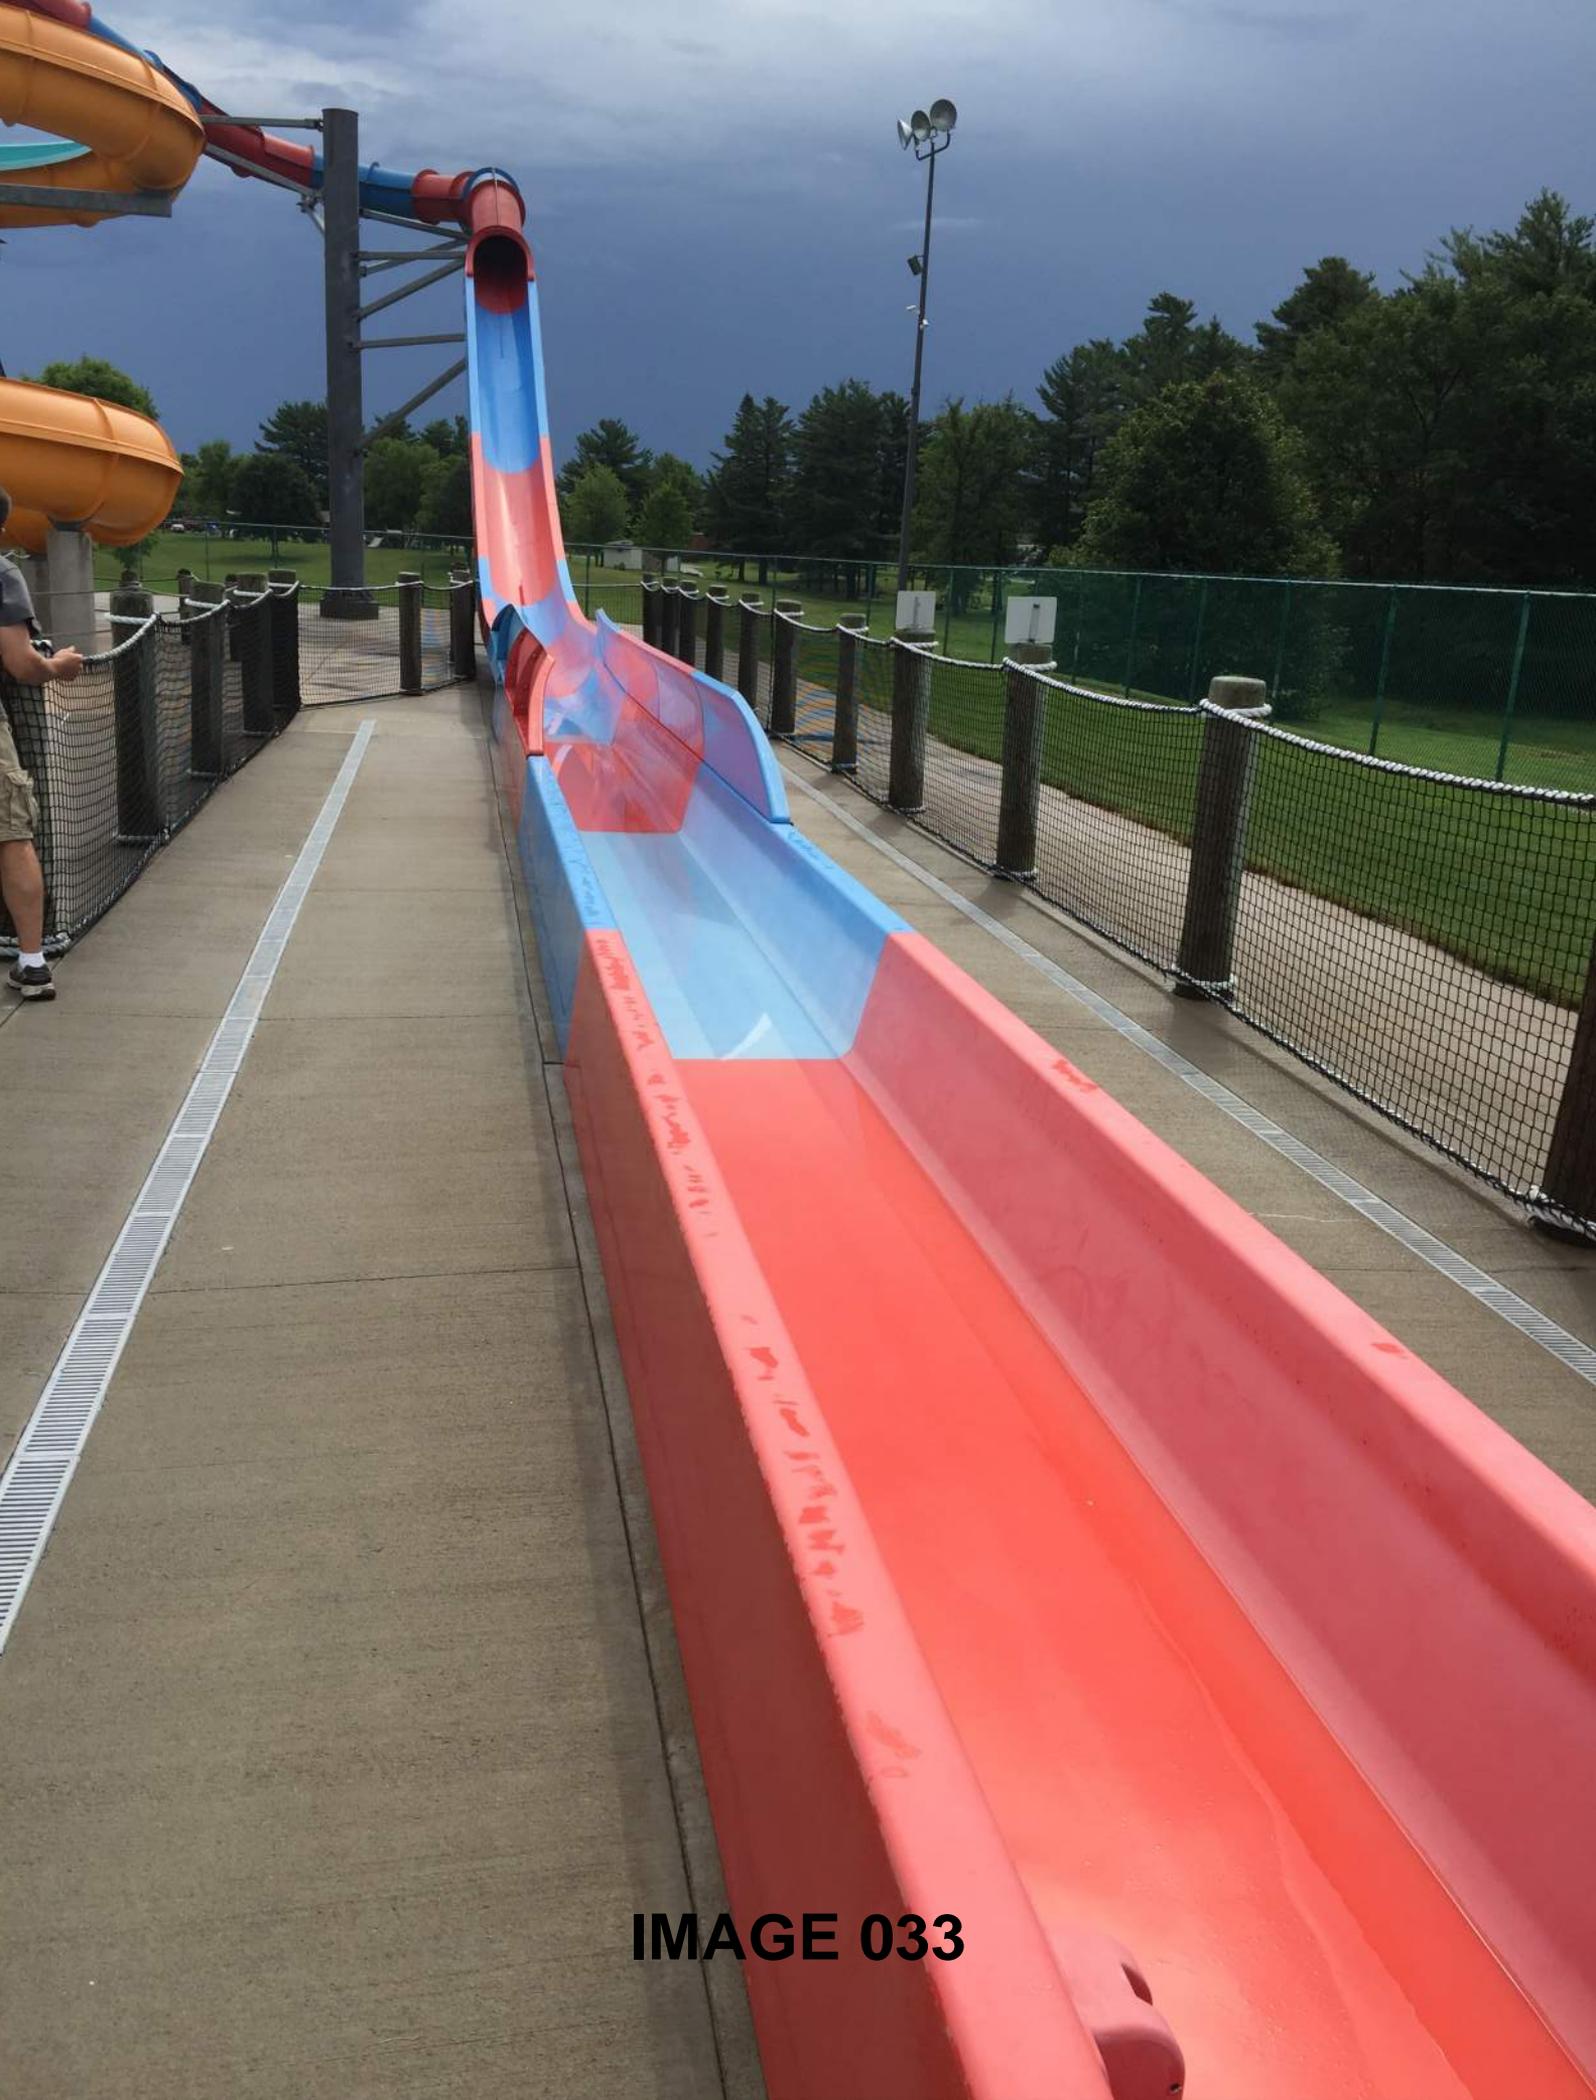
IMAGE 033

Image 033 – Speed slide runout with deck drain on side

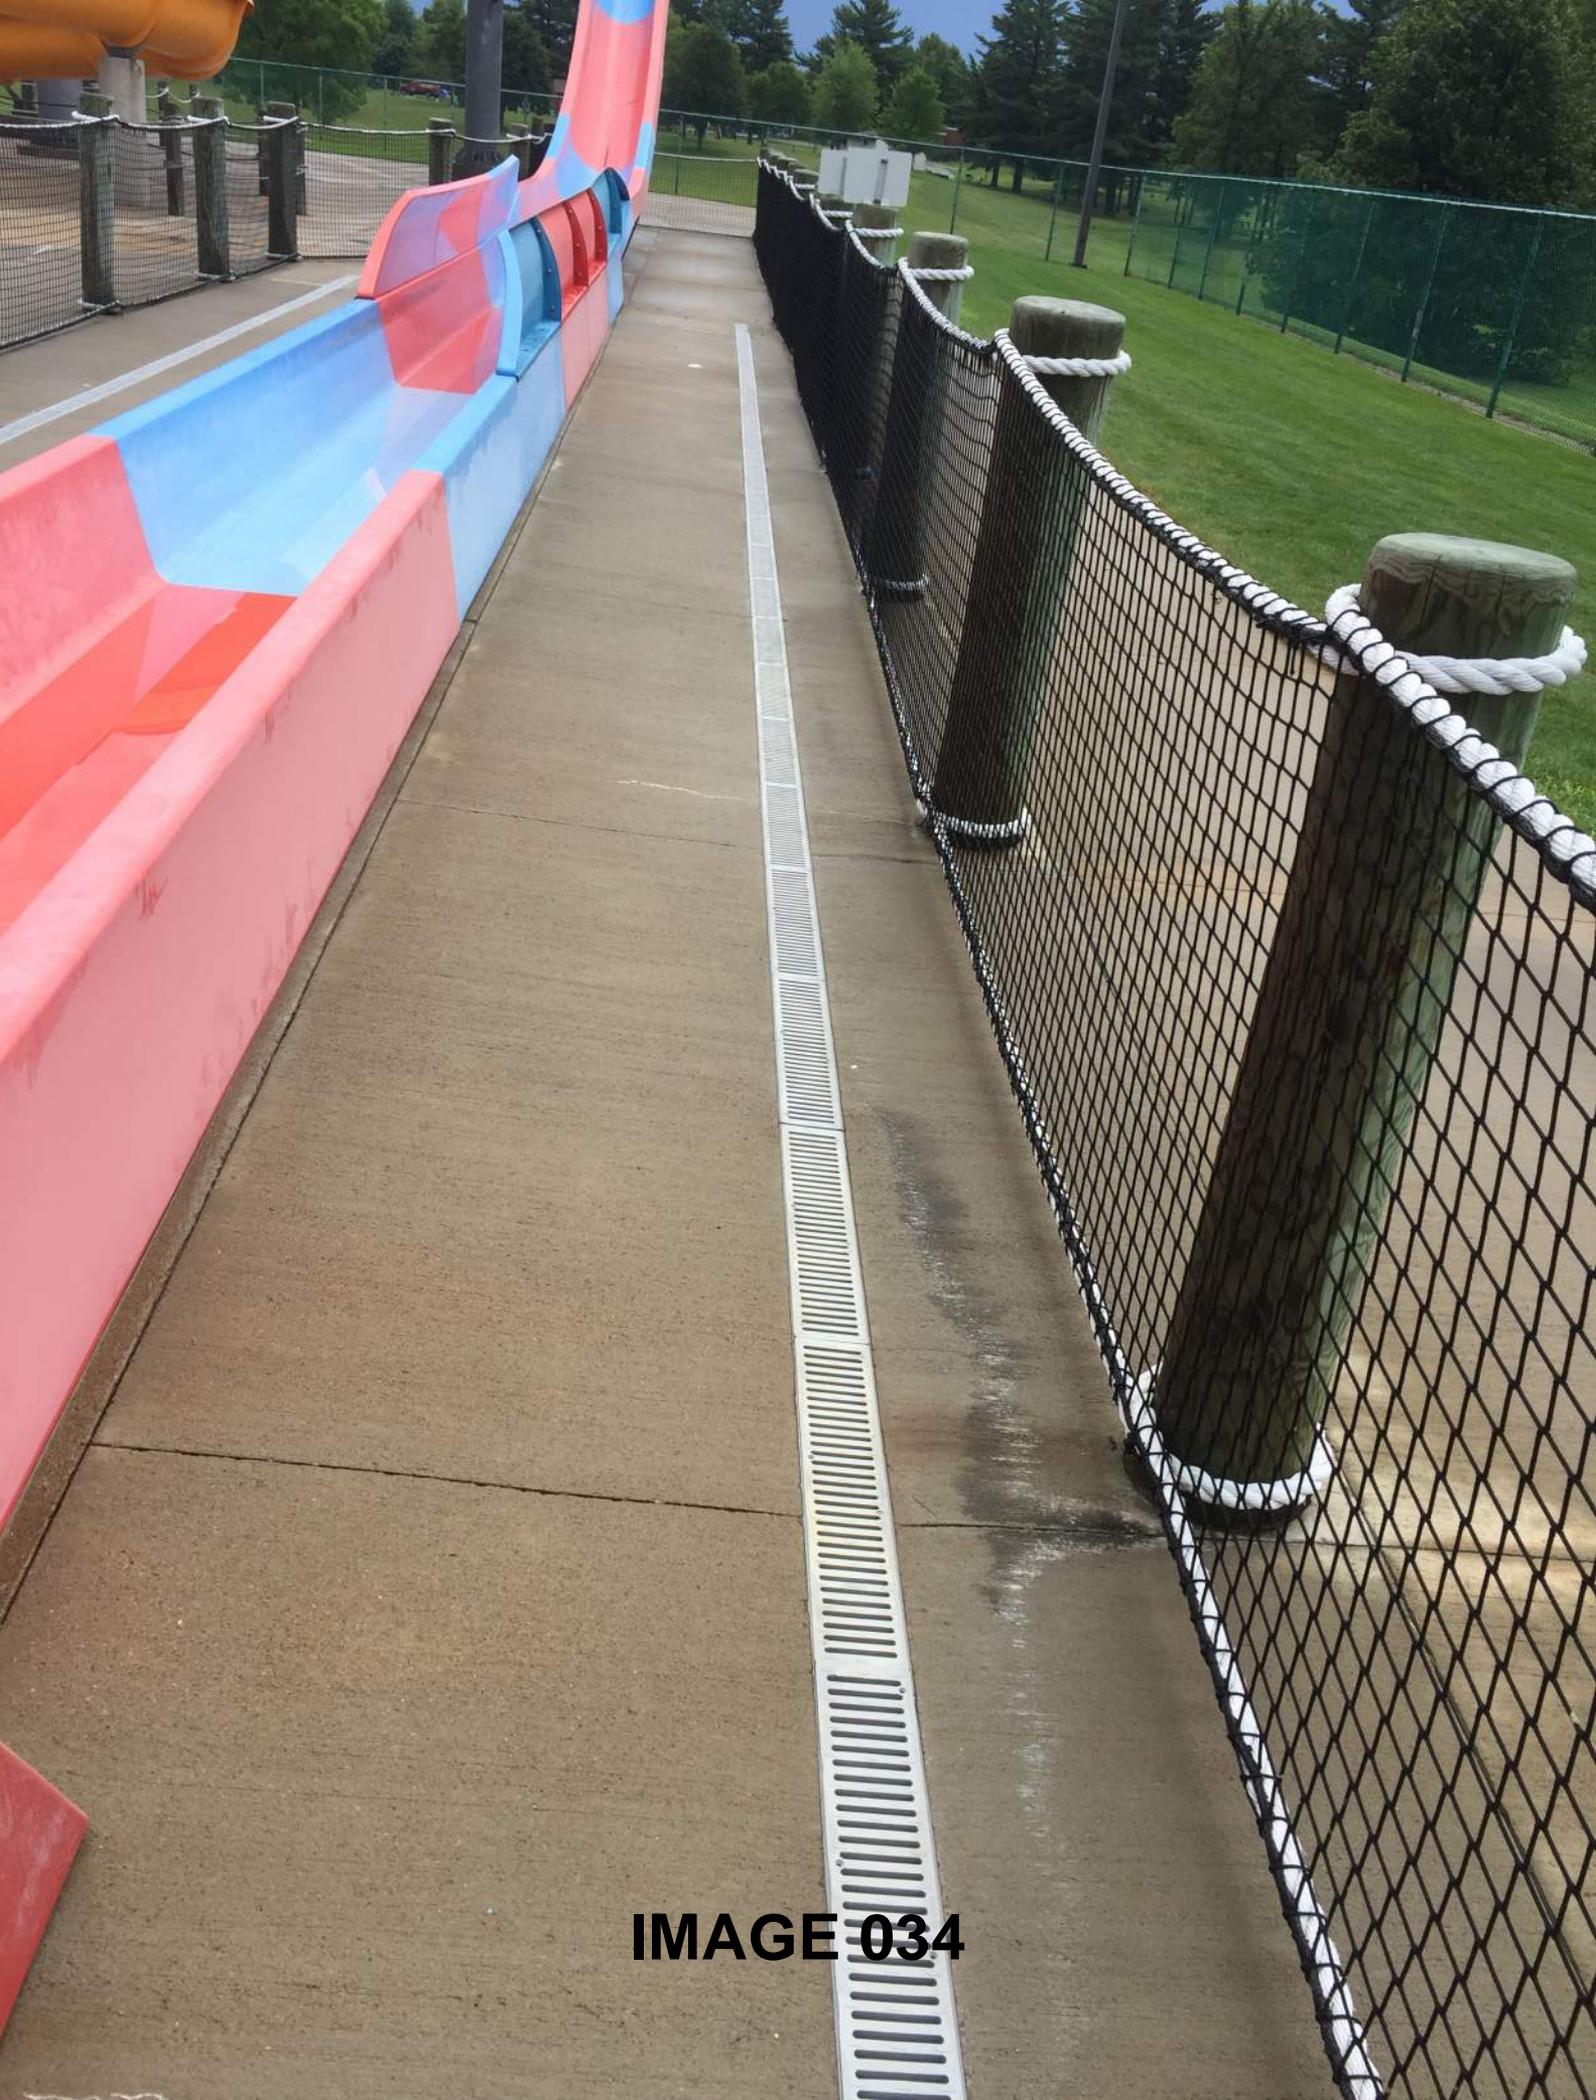
IMAGE 034

Image 034 – Speed slide runout with deck drain on side

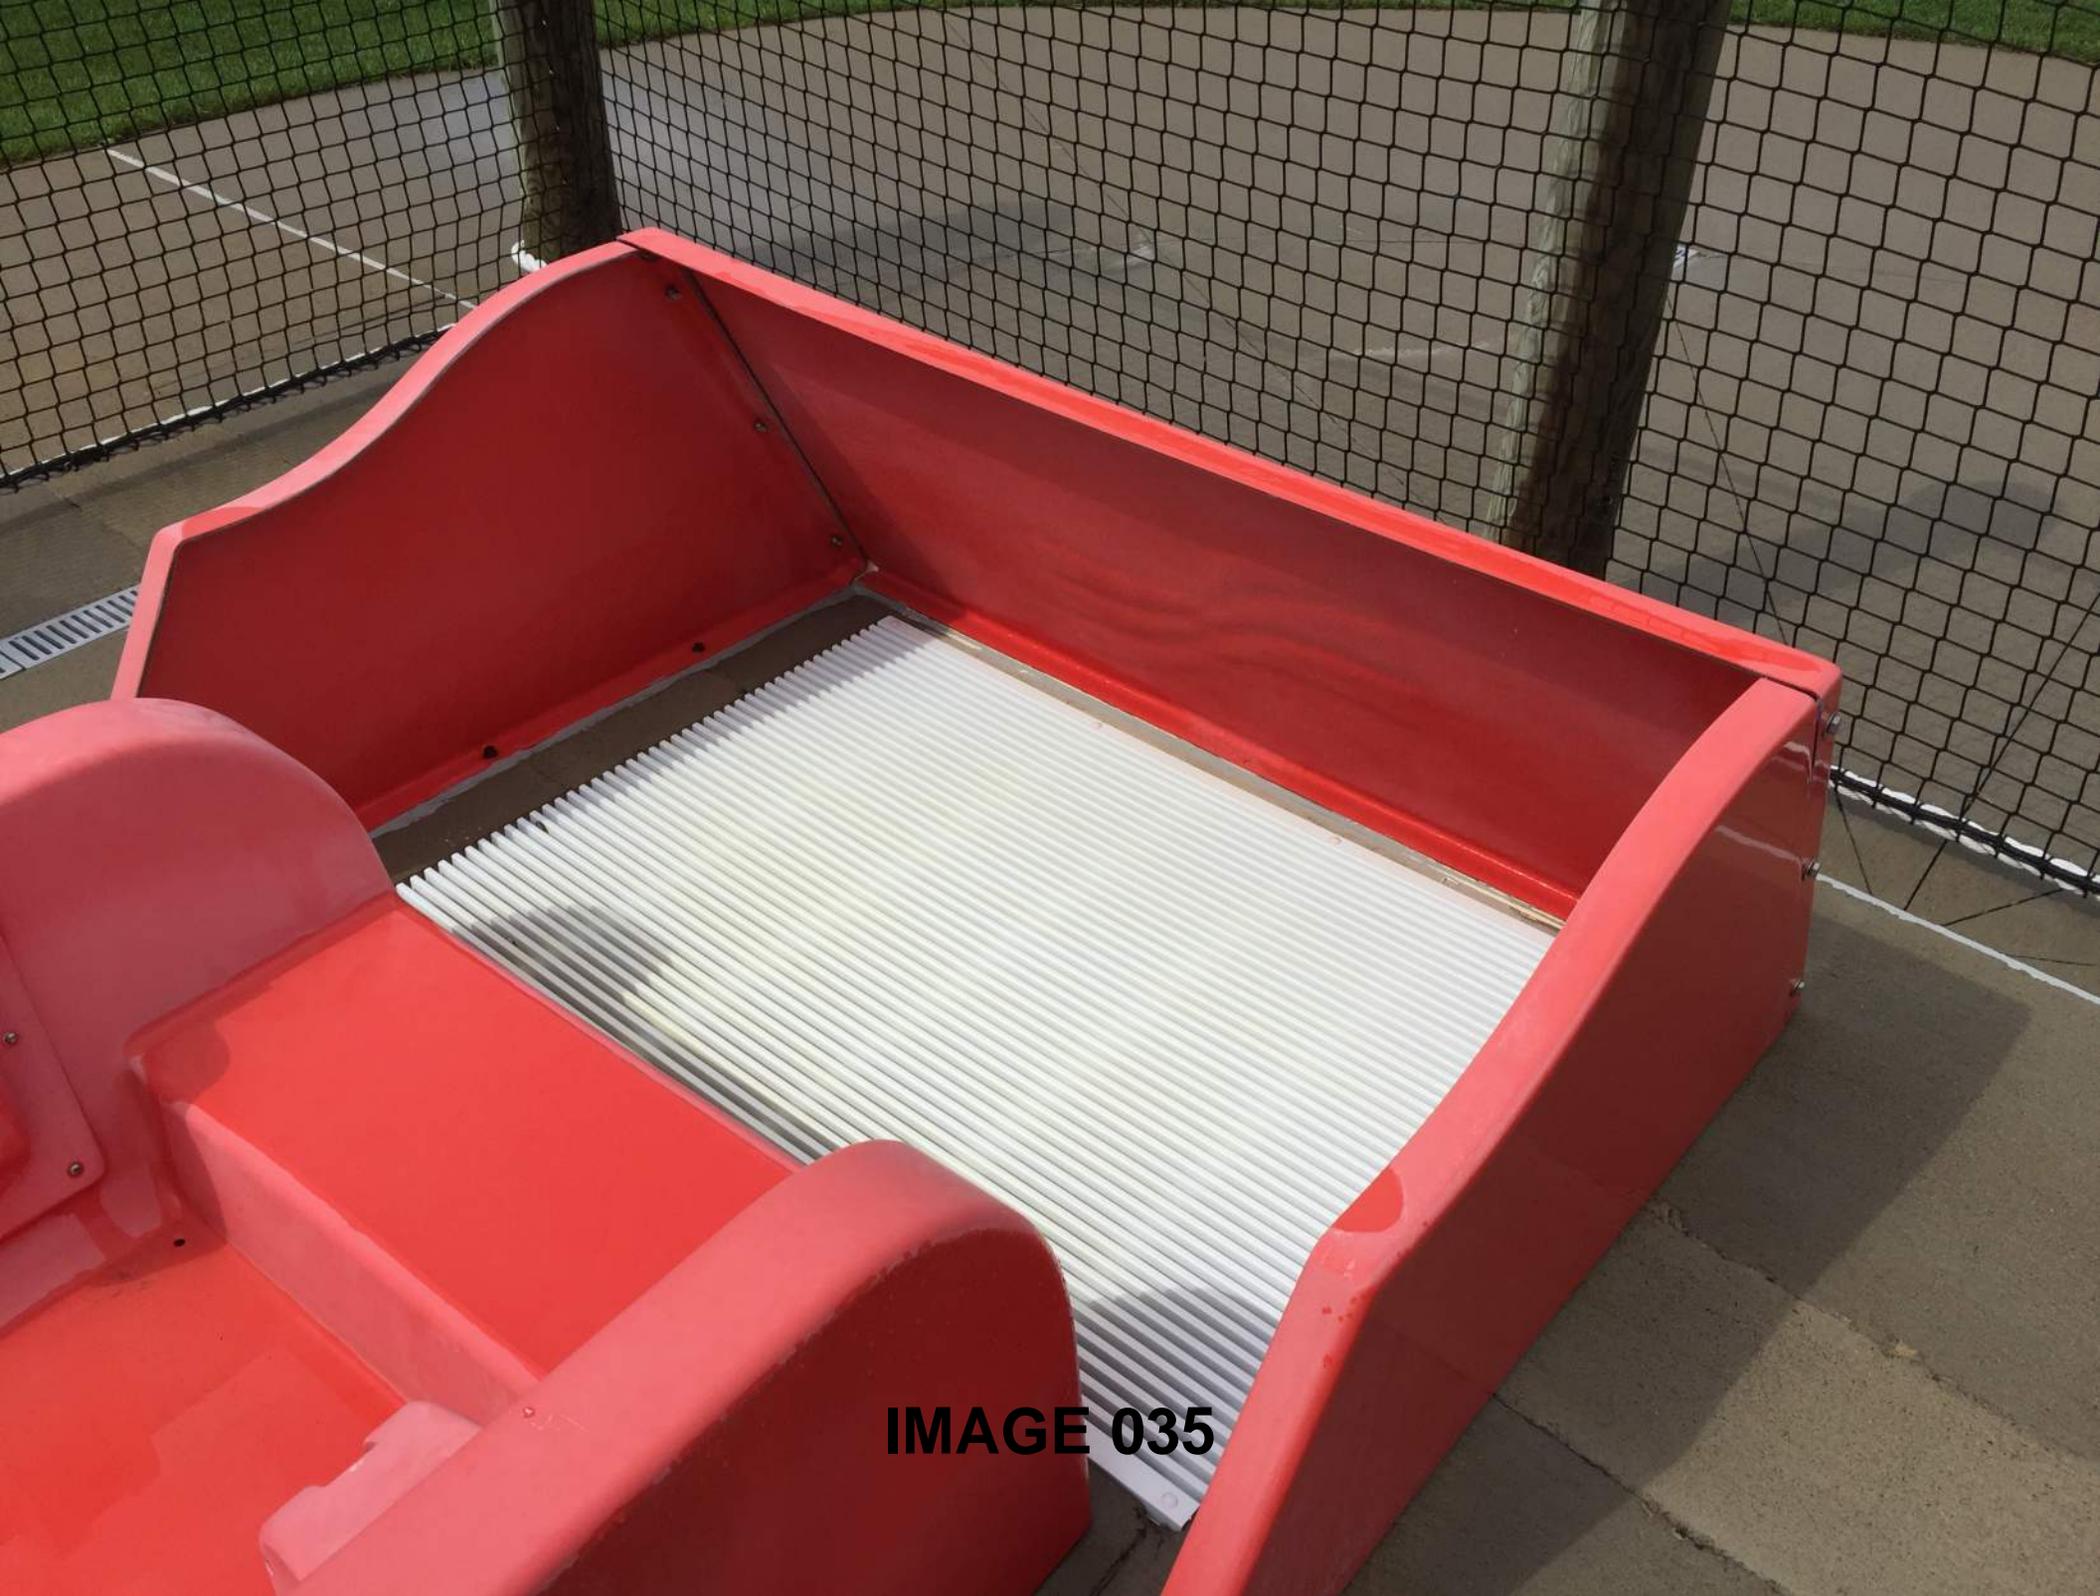
IMAGE 035

Image 035 – Speed slide runout surge containing drain

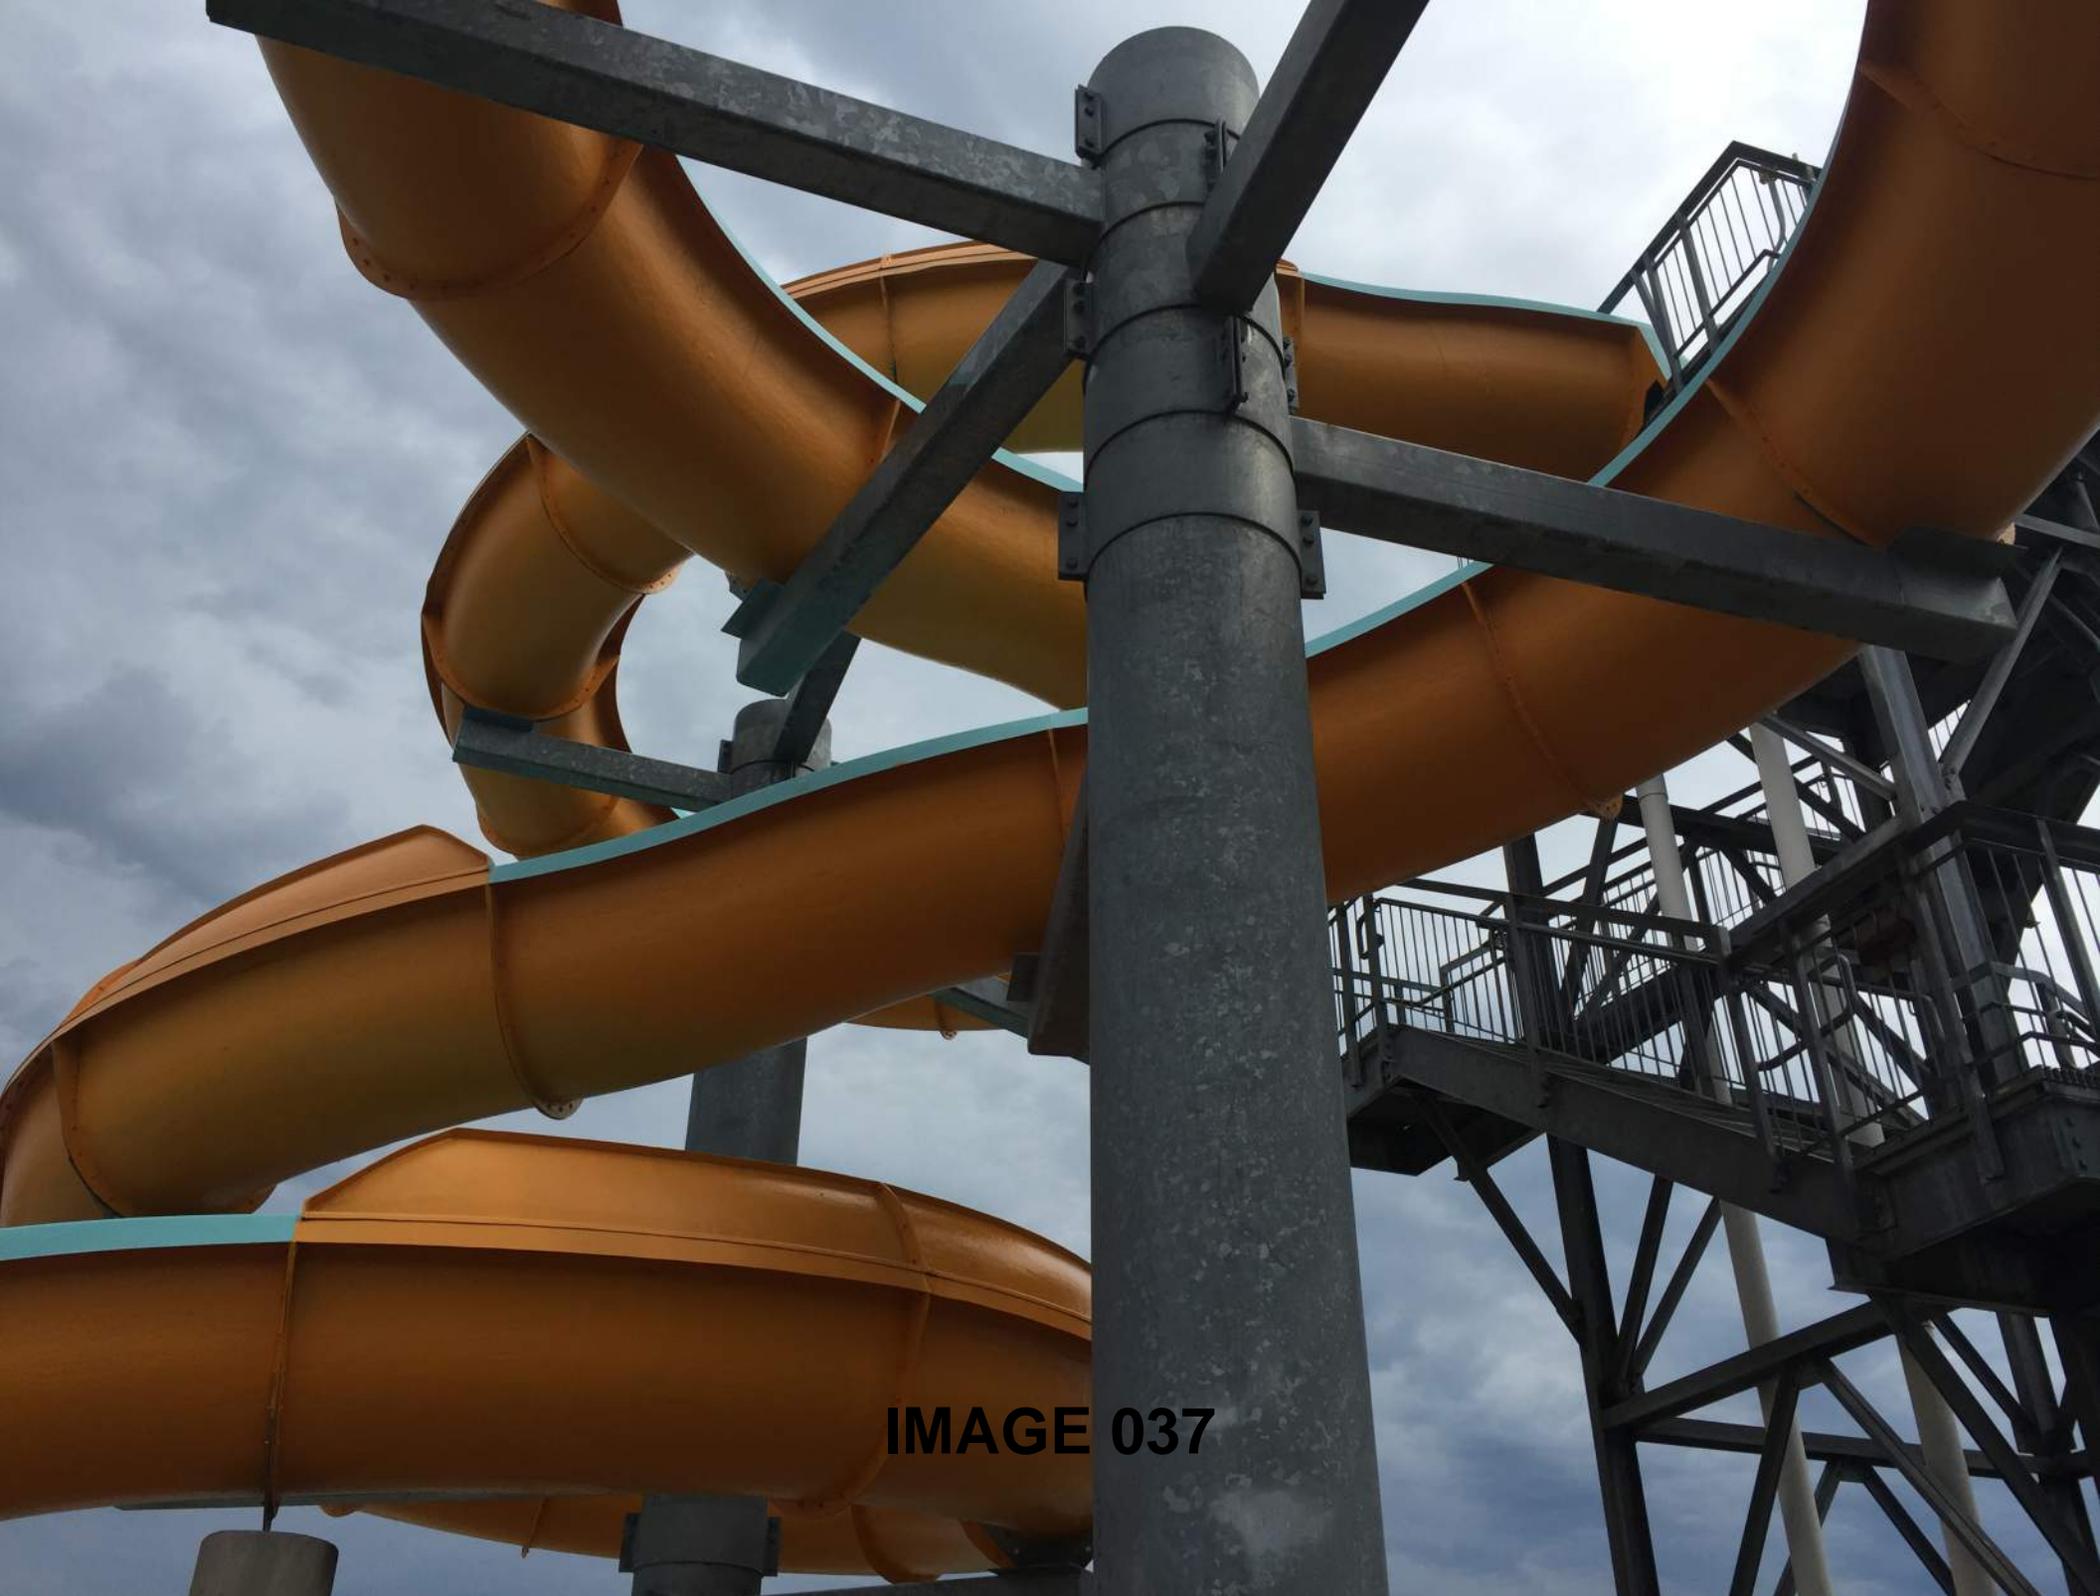
IMAGE 037

Image 037 – Serpentine slide support tower from beneath

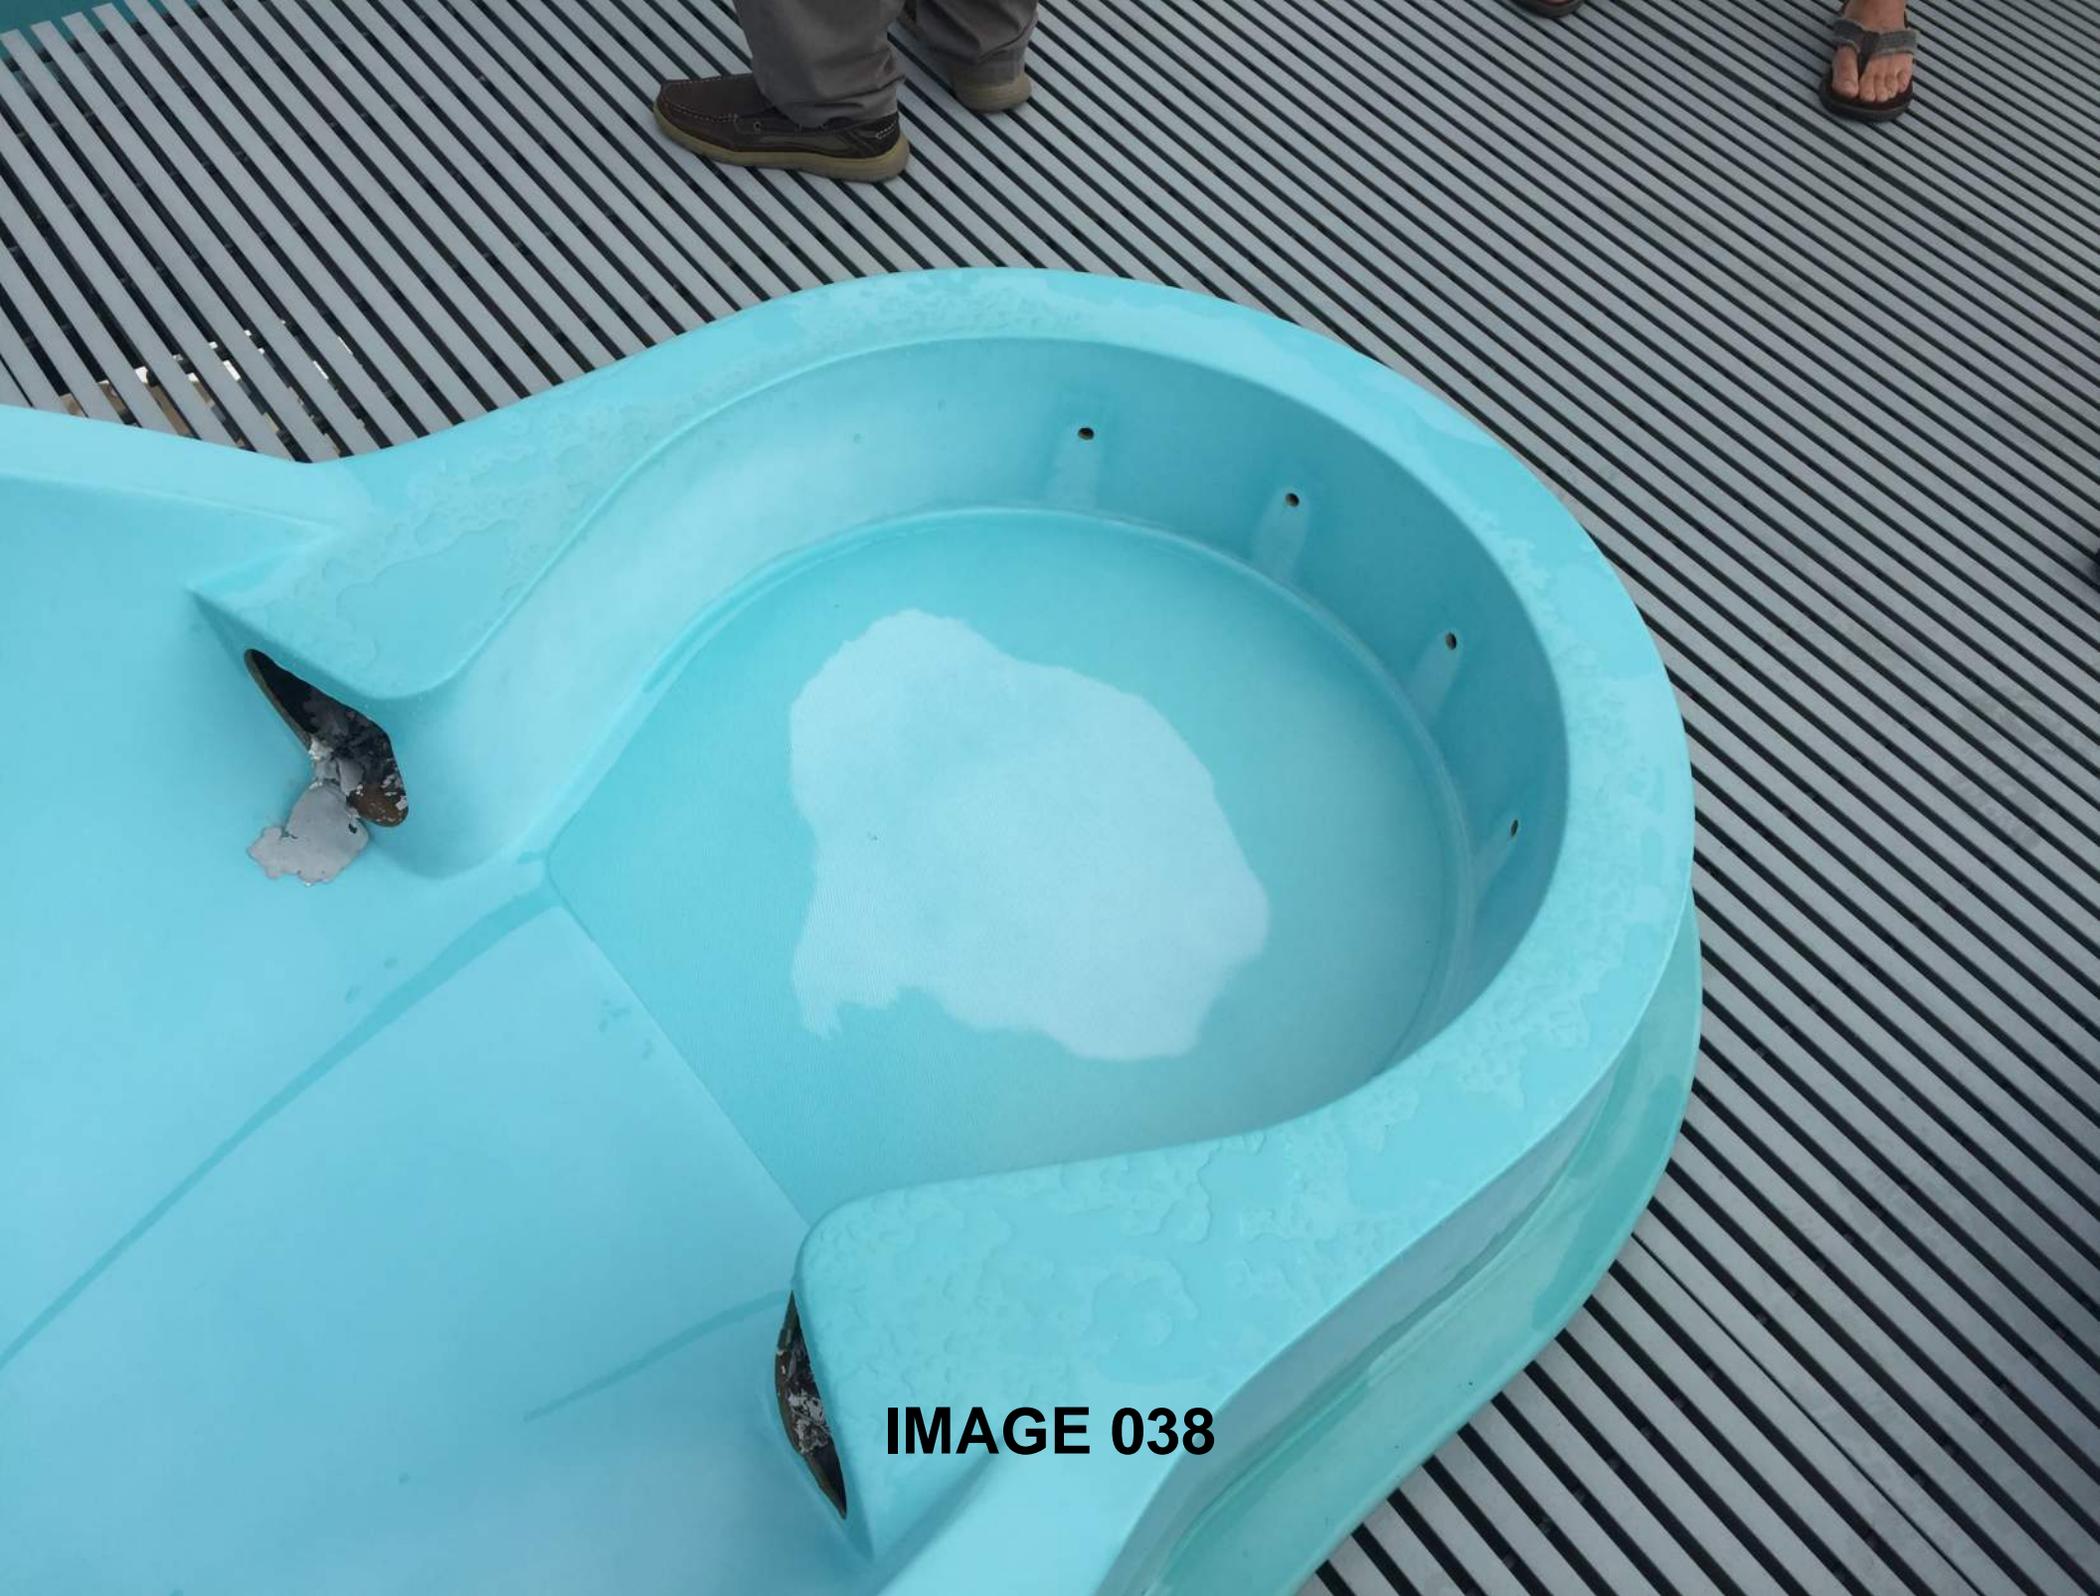
IMAGE 038

Image 038 – Serpentine slide starting tub from tower platform

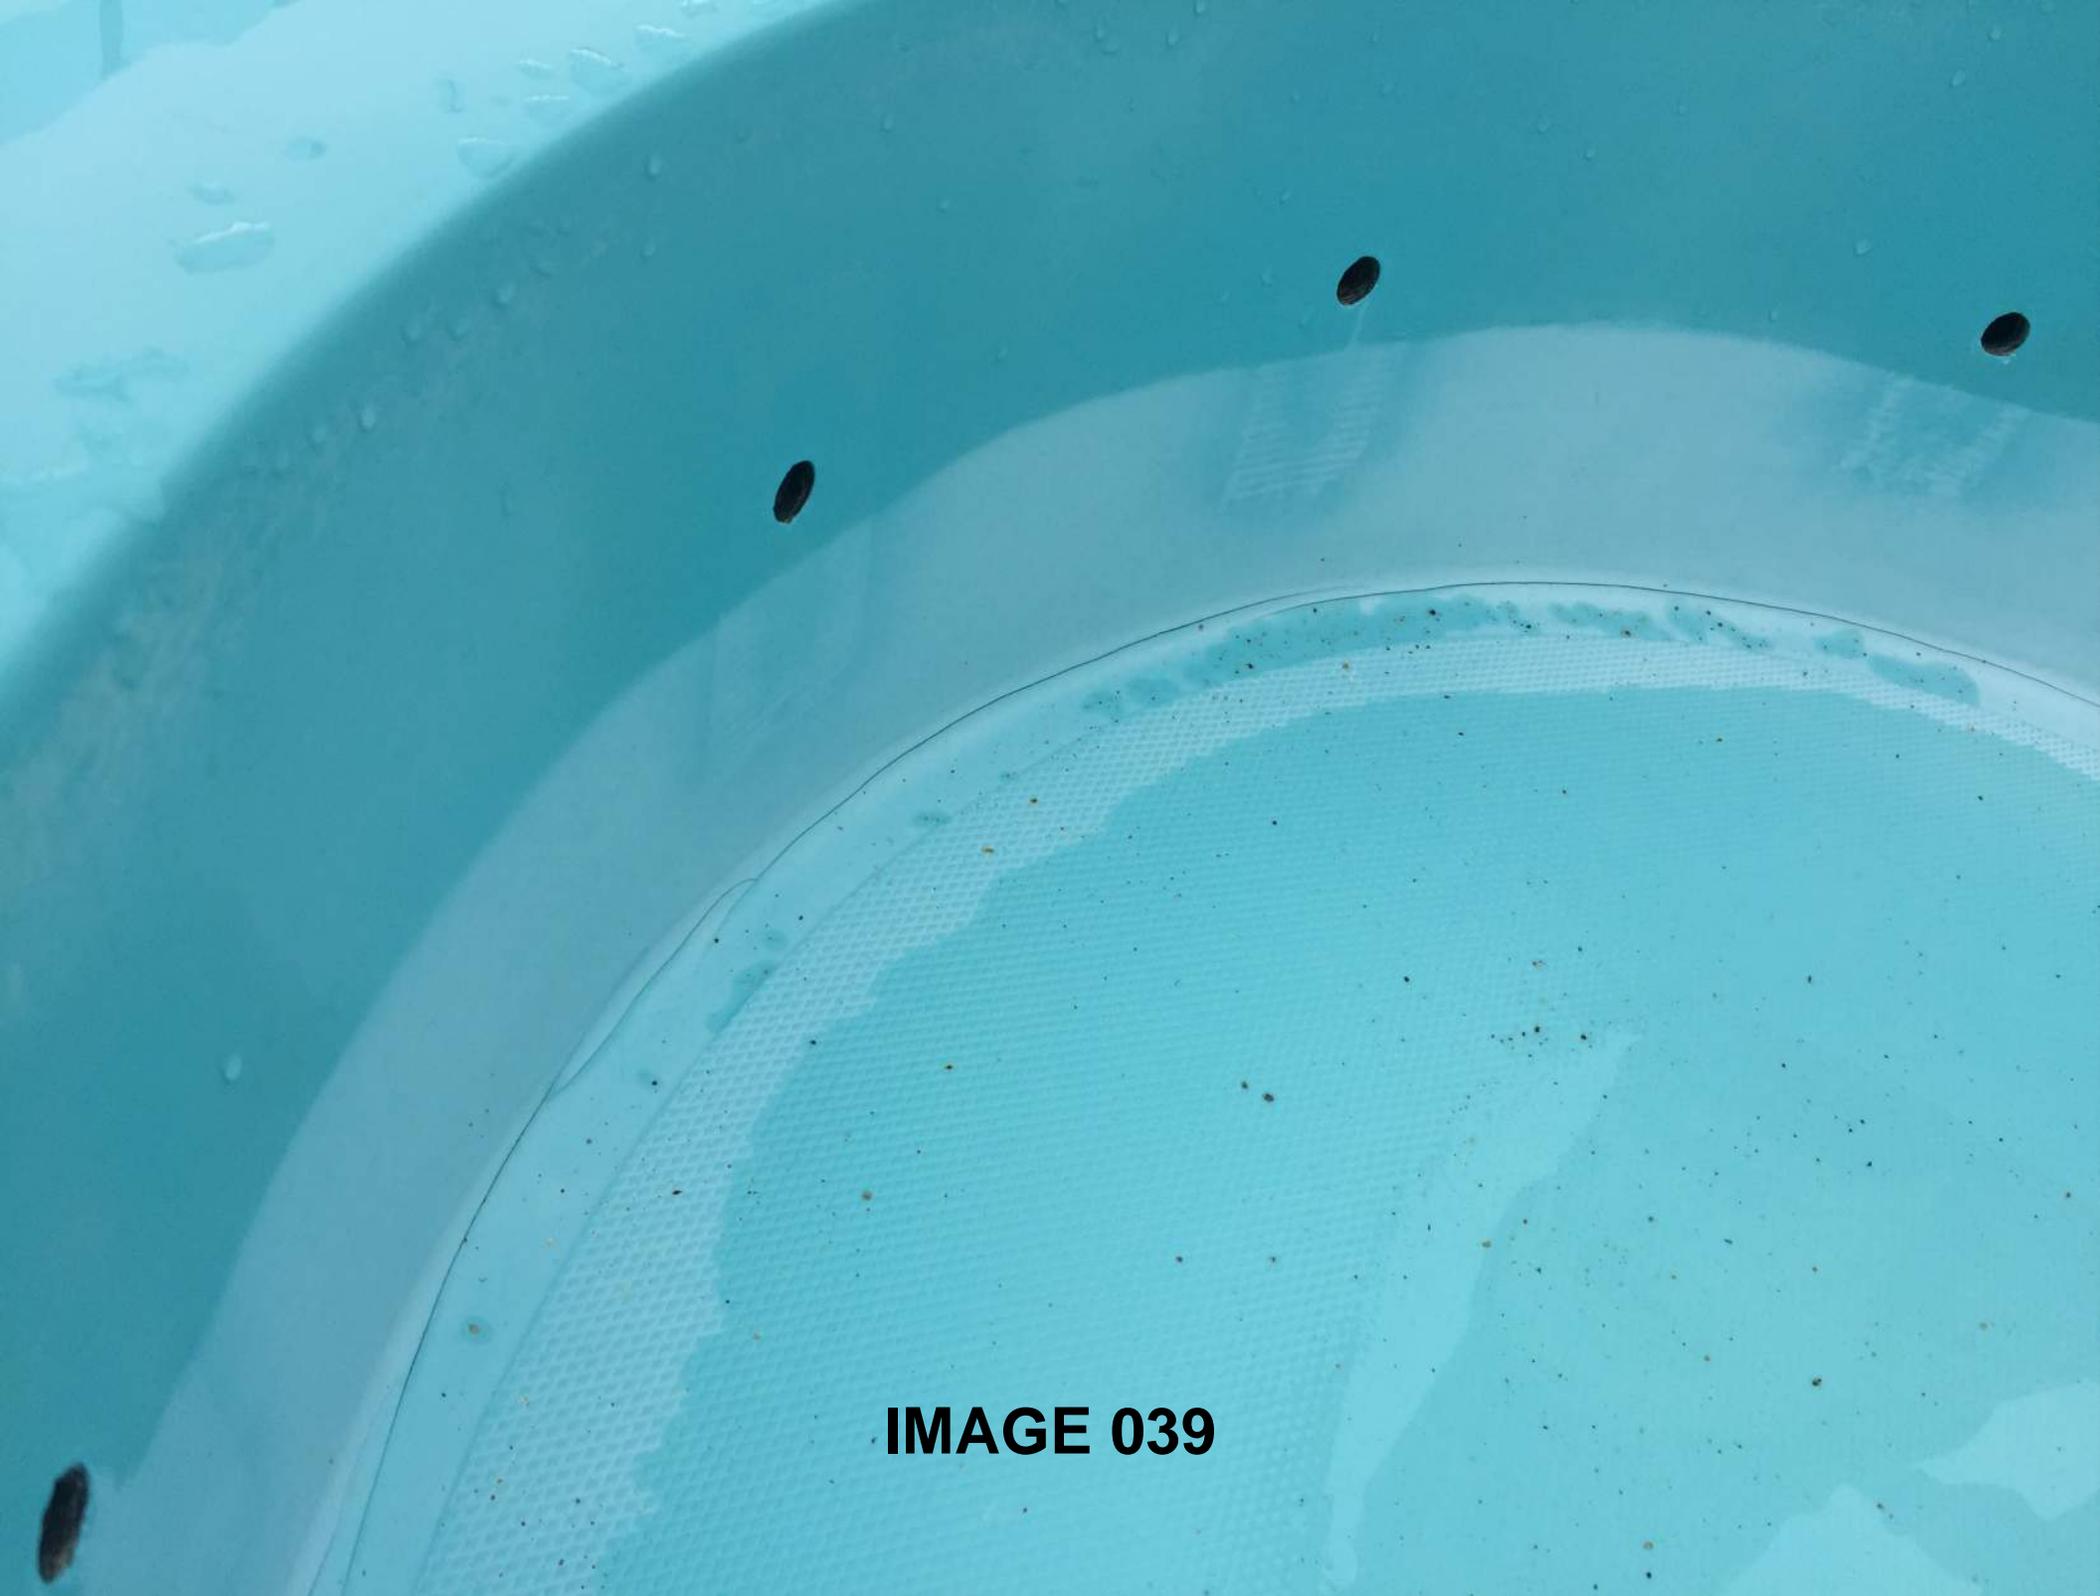
IMAGE 039

Image 039 – Serpentine slide starting tub inner rim cracking
