Aquatic Facility Evaluation

Weston Aquatic Center
Weston, Wisconsin

September 14, 2016

Water Technology, Inc. (WTI)
100 Park Avenue, PO Box 614
Beaver Dam, WI 53916
www.wtiworld.com

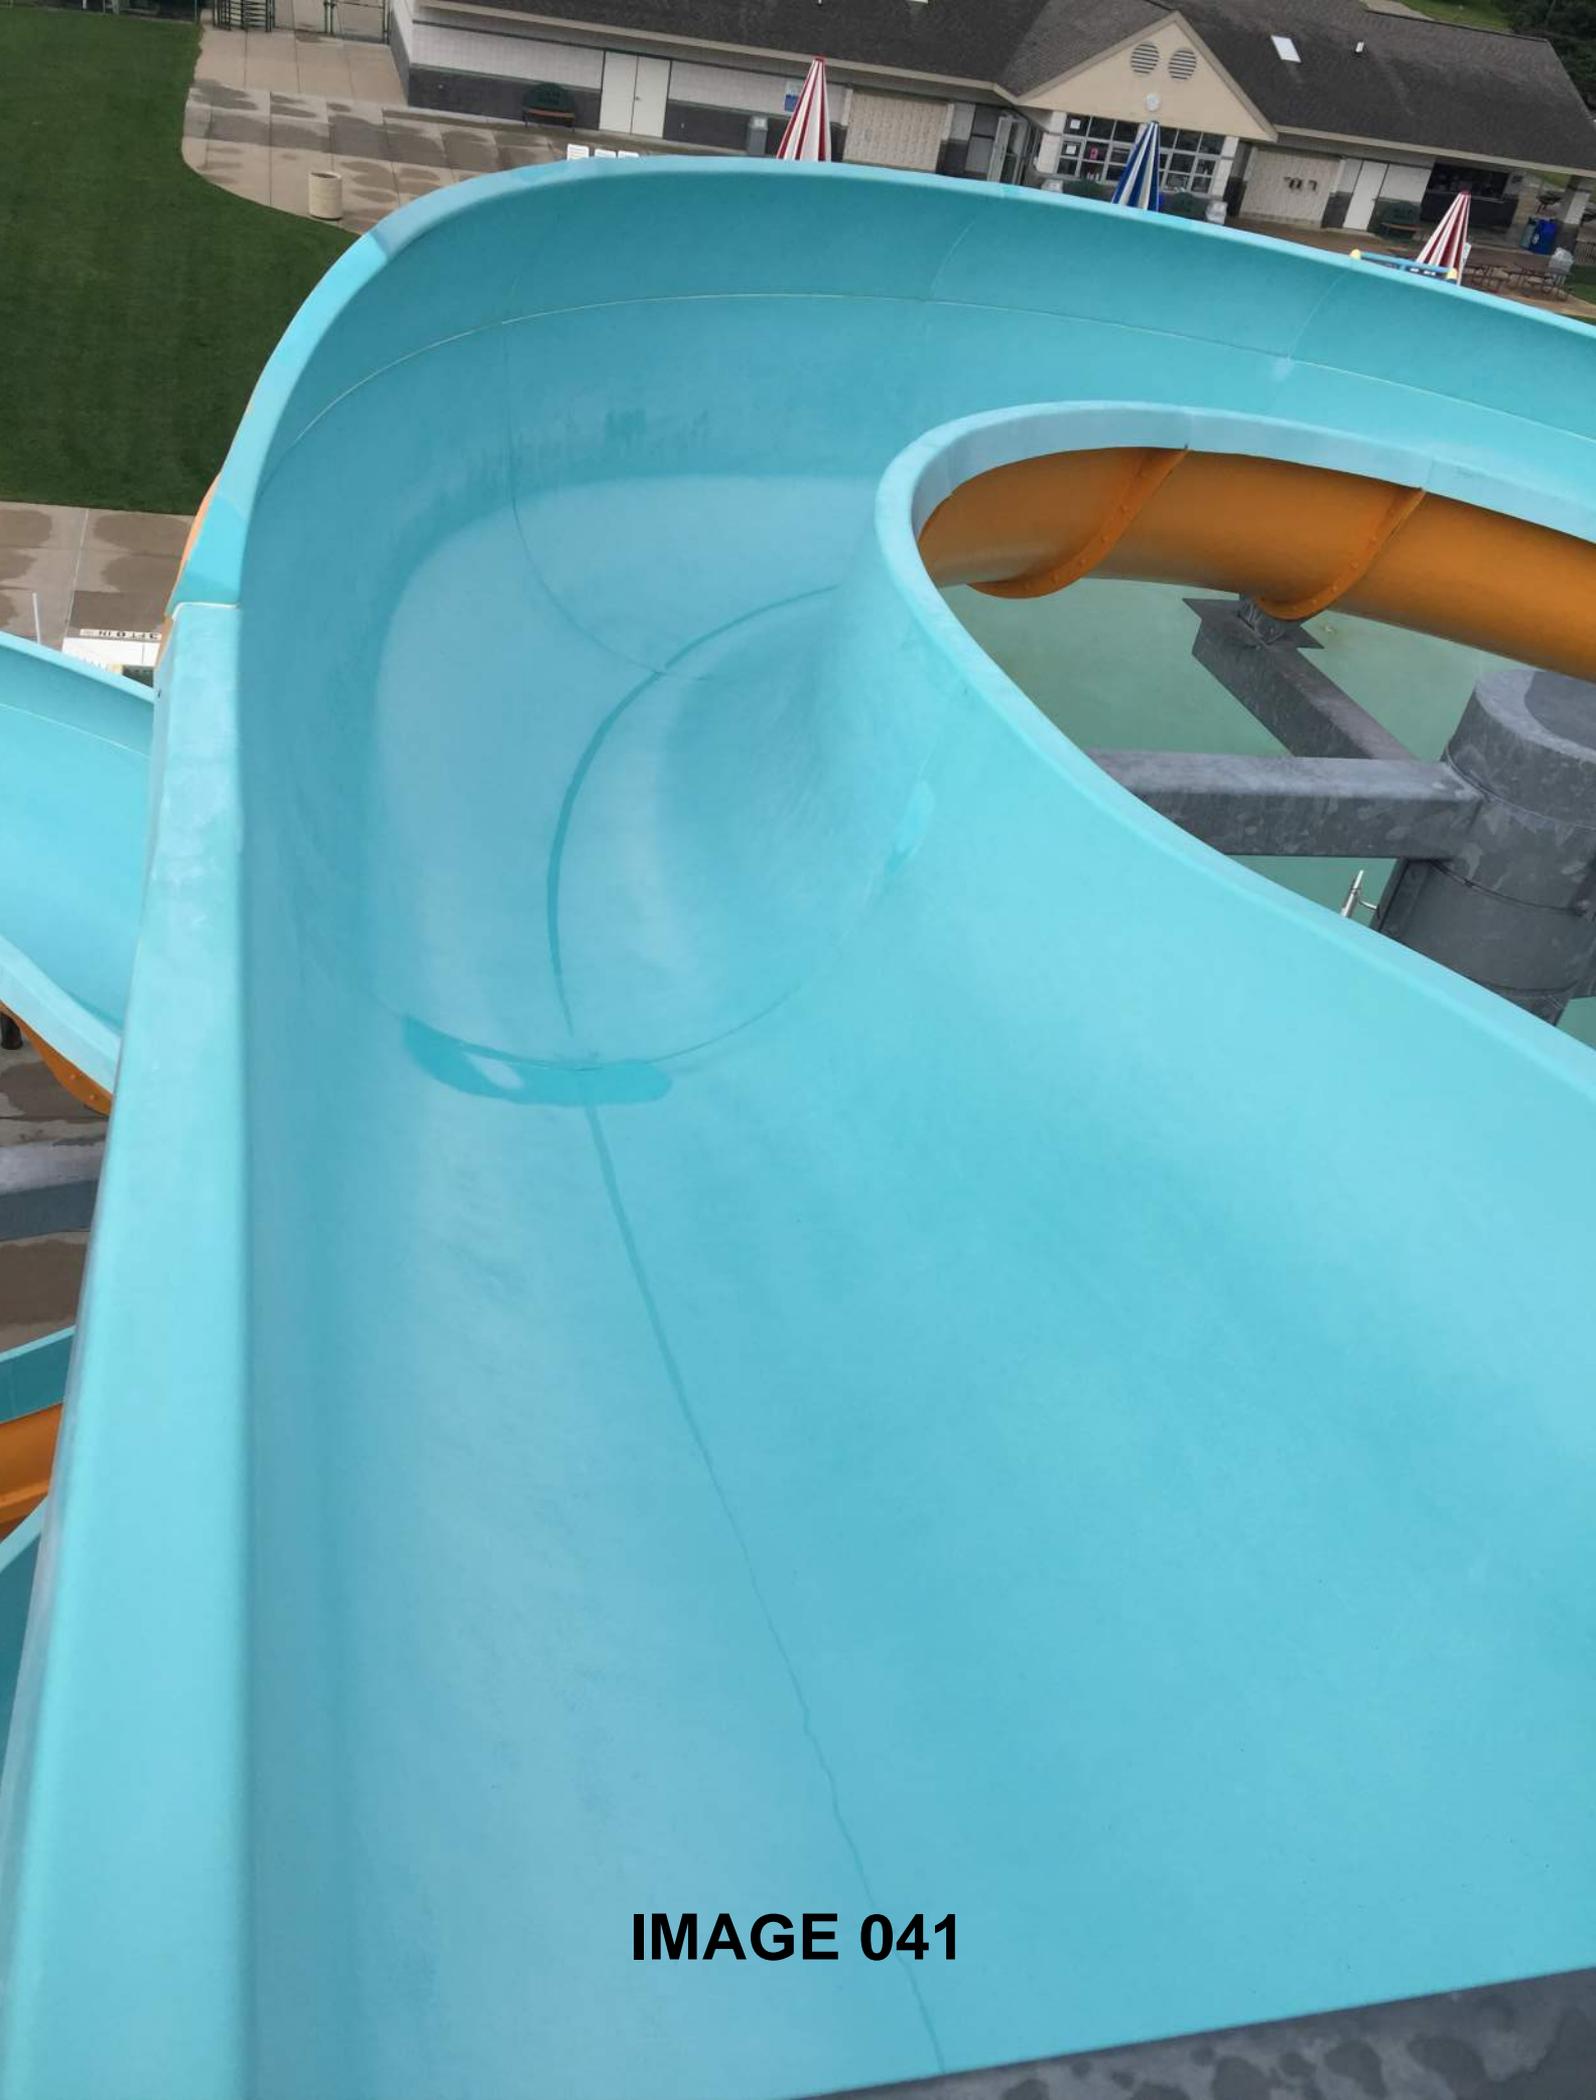
IMAGE 041

Image 041 – Inside of serpentine slide flume

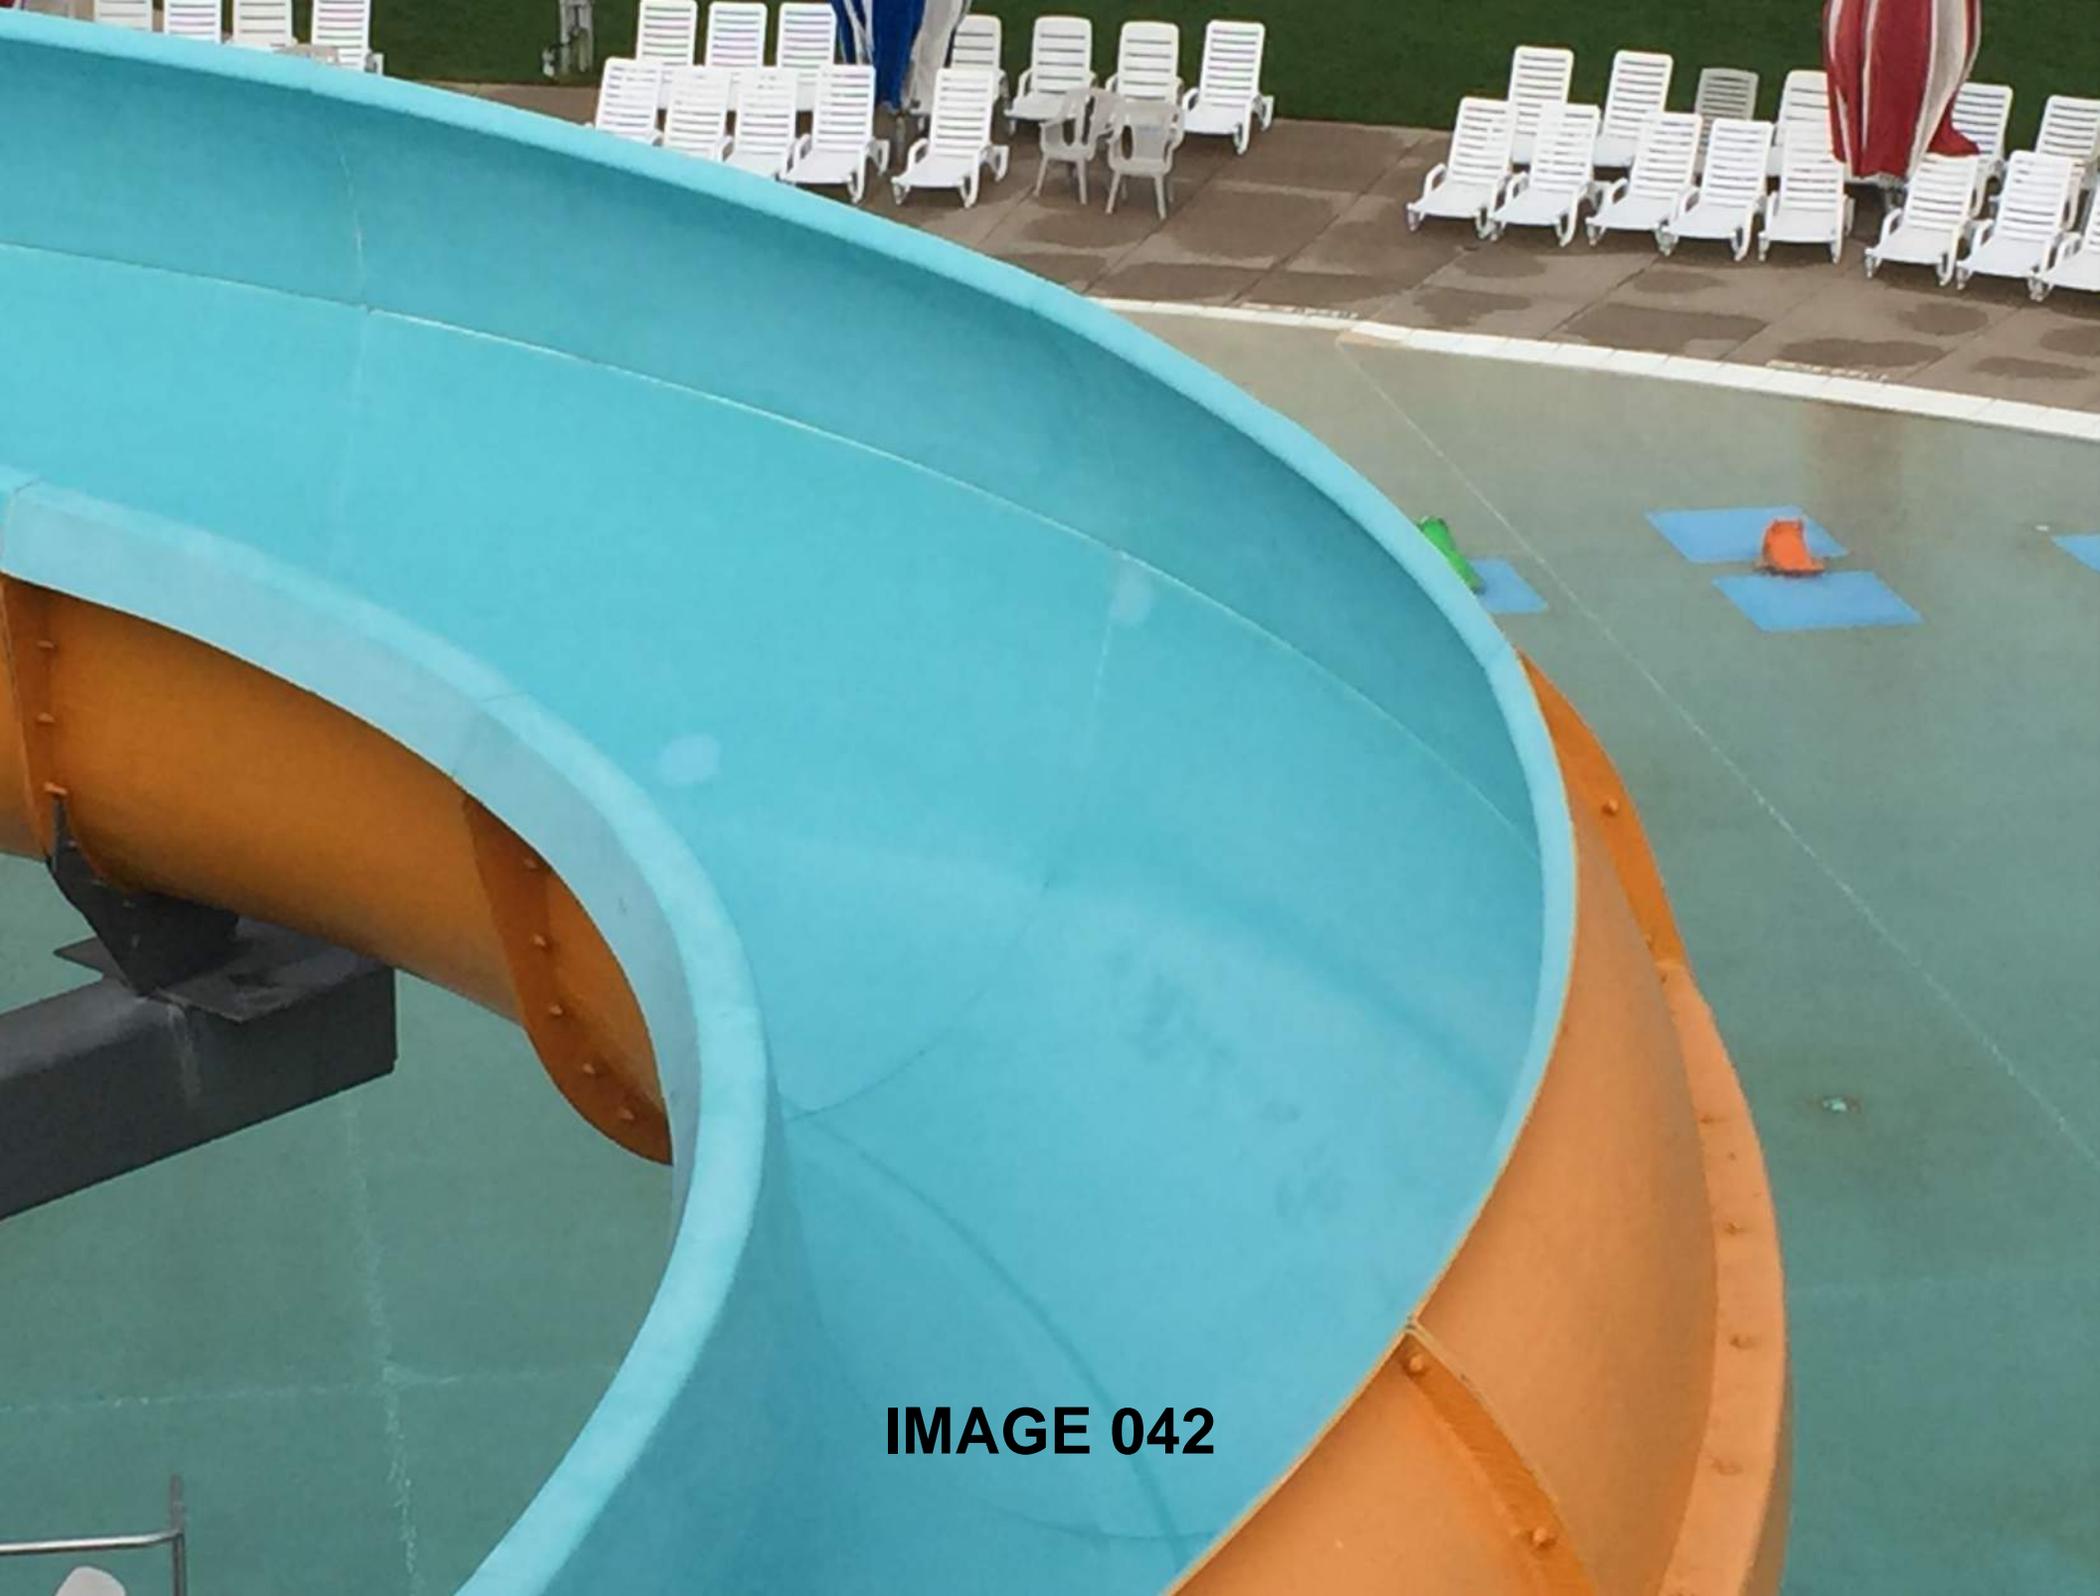
IMAGE 042

Image 042 – Inside of serpentine slide flume

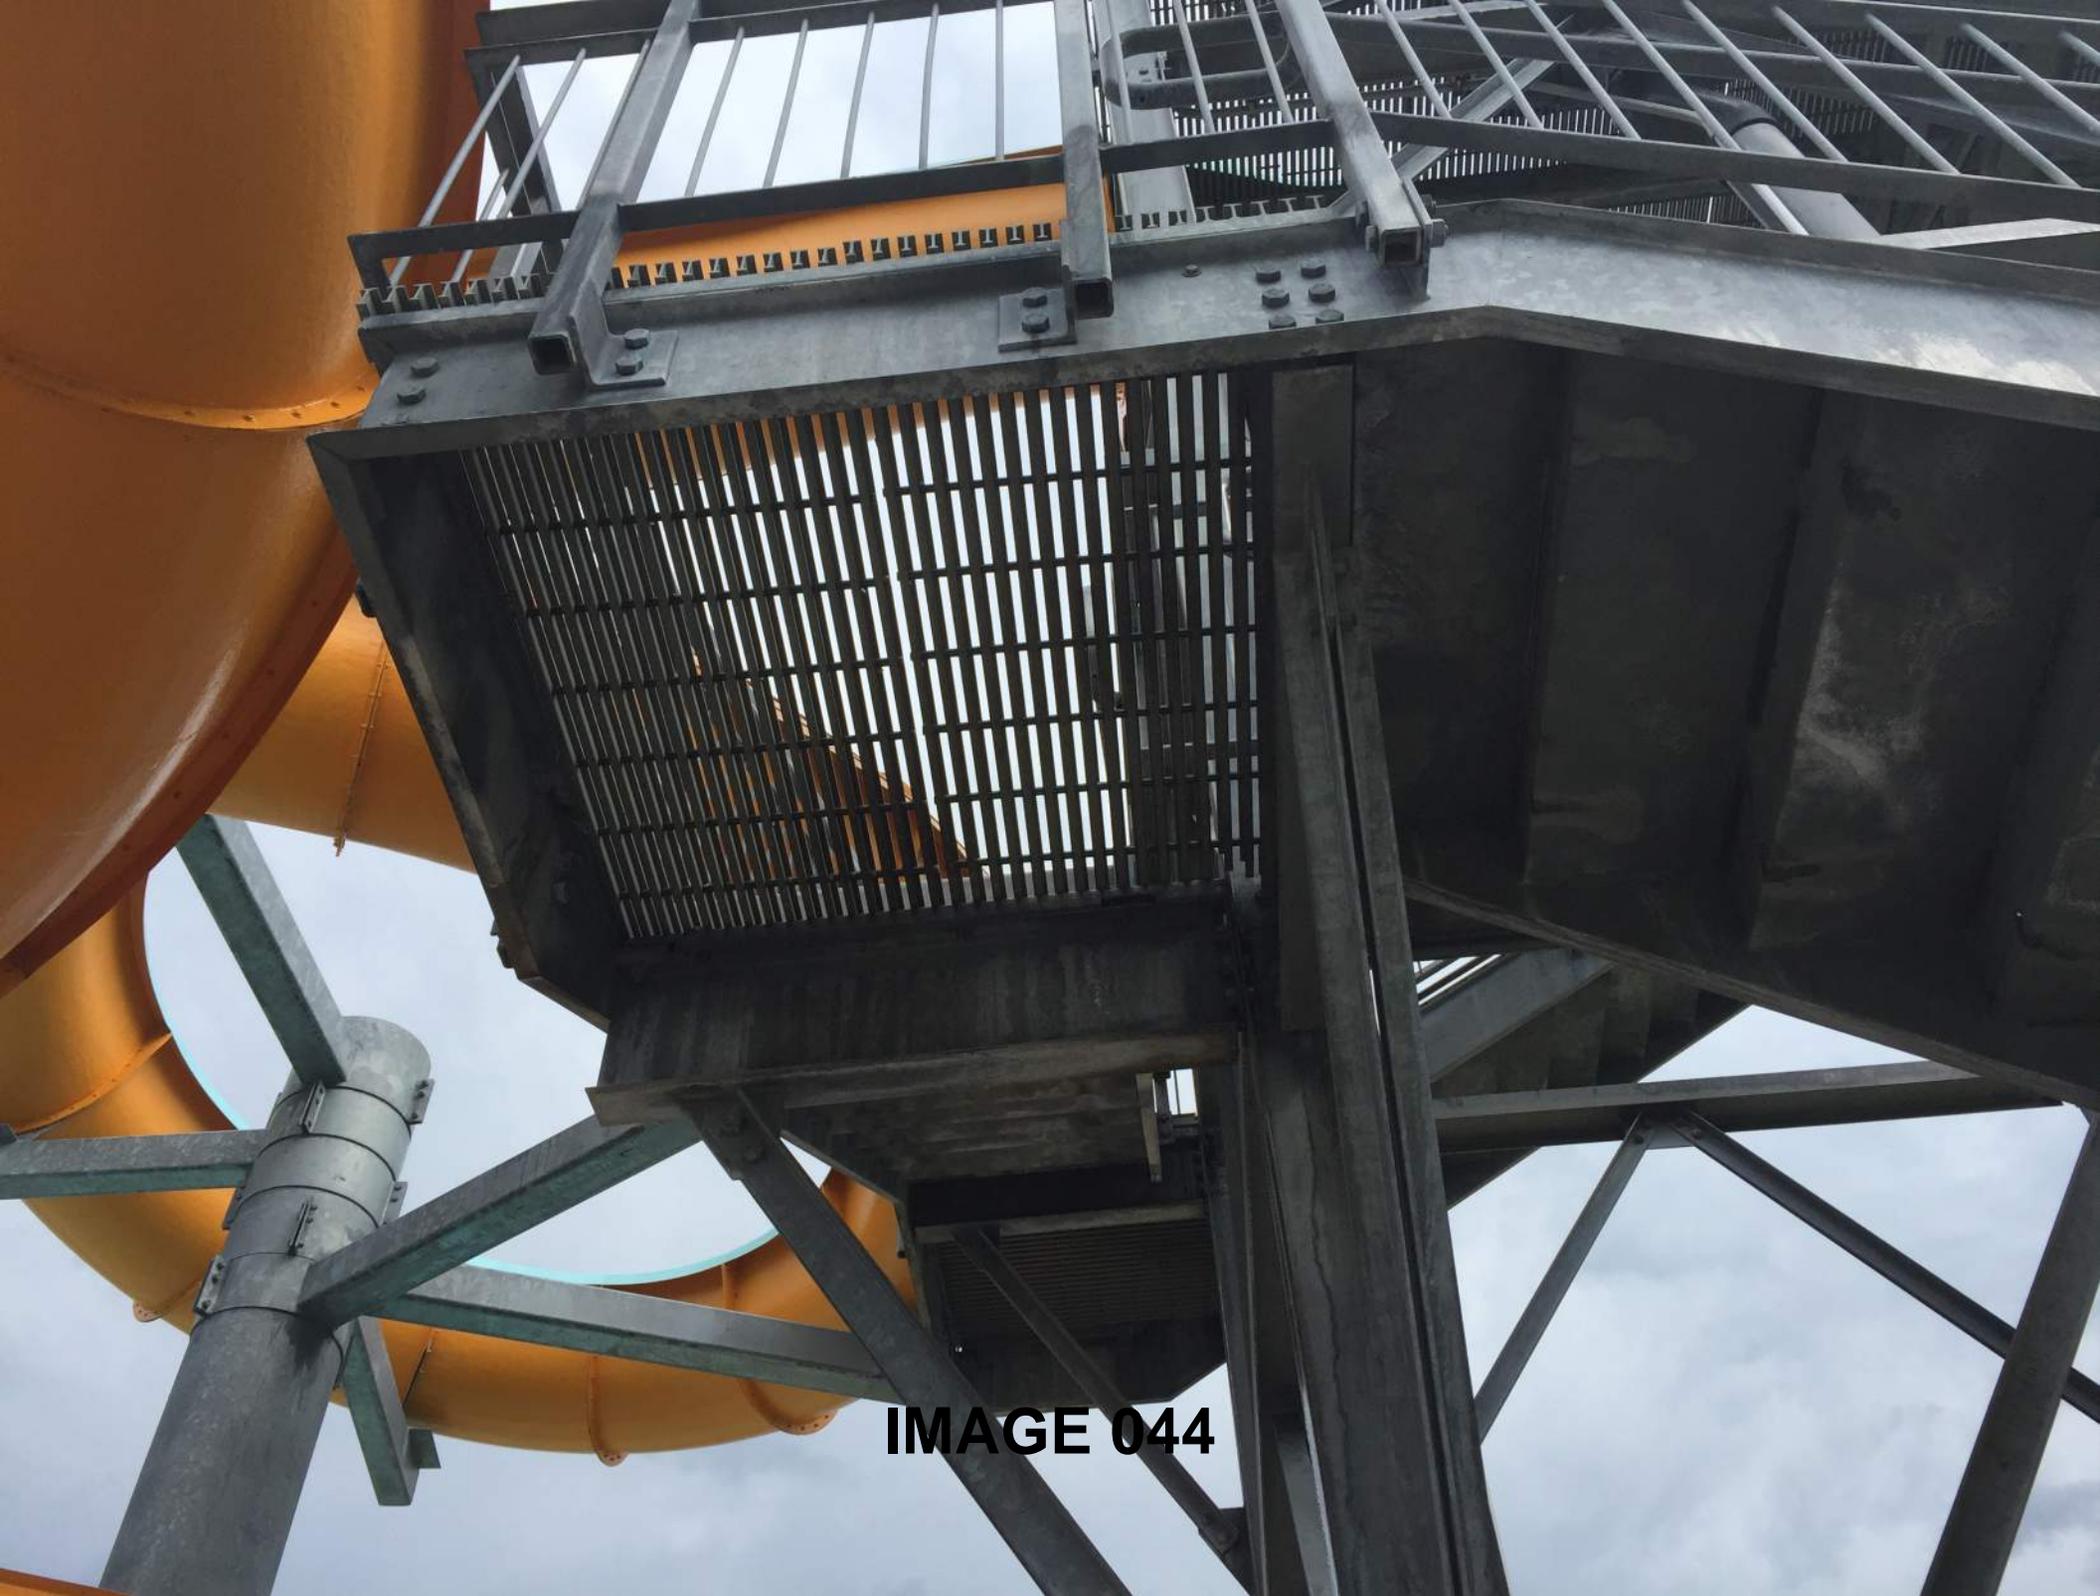
IMAGE 044

Image 044 – Bottom of slide tower stair platform

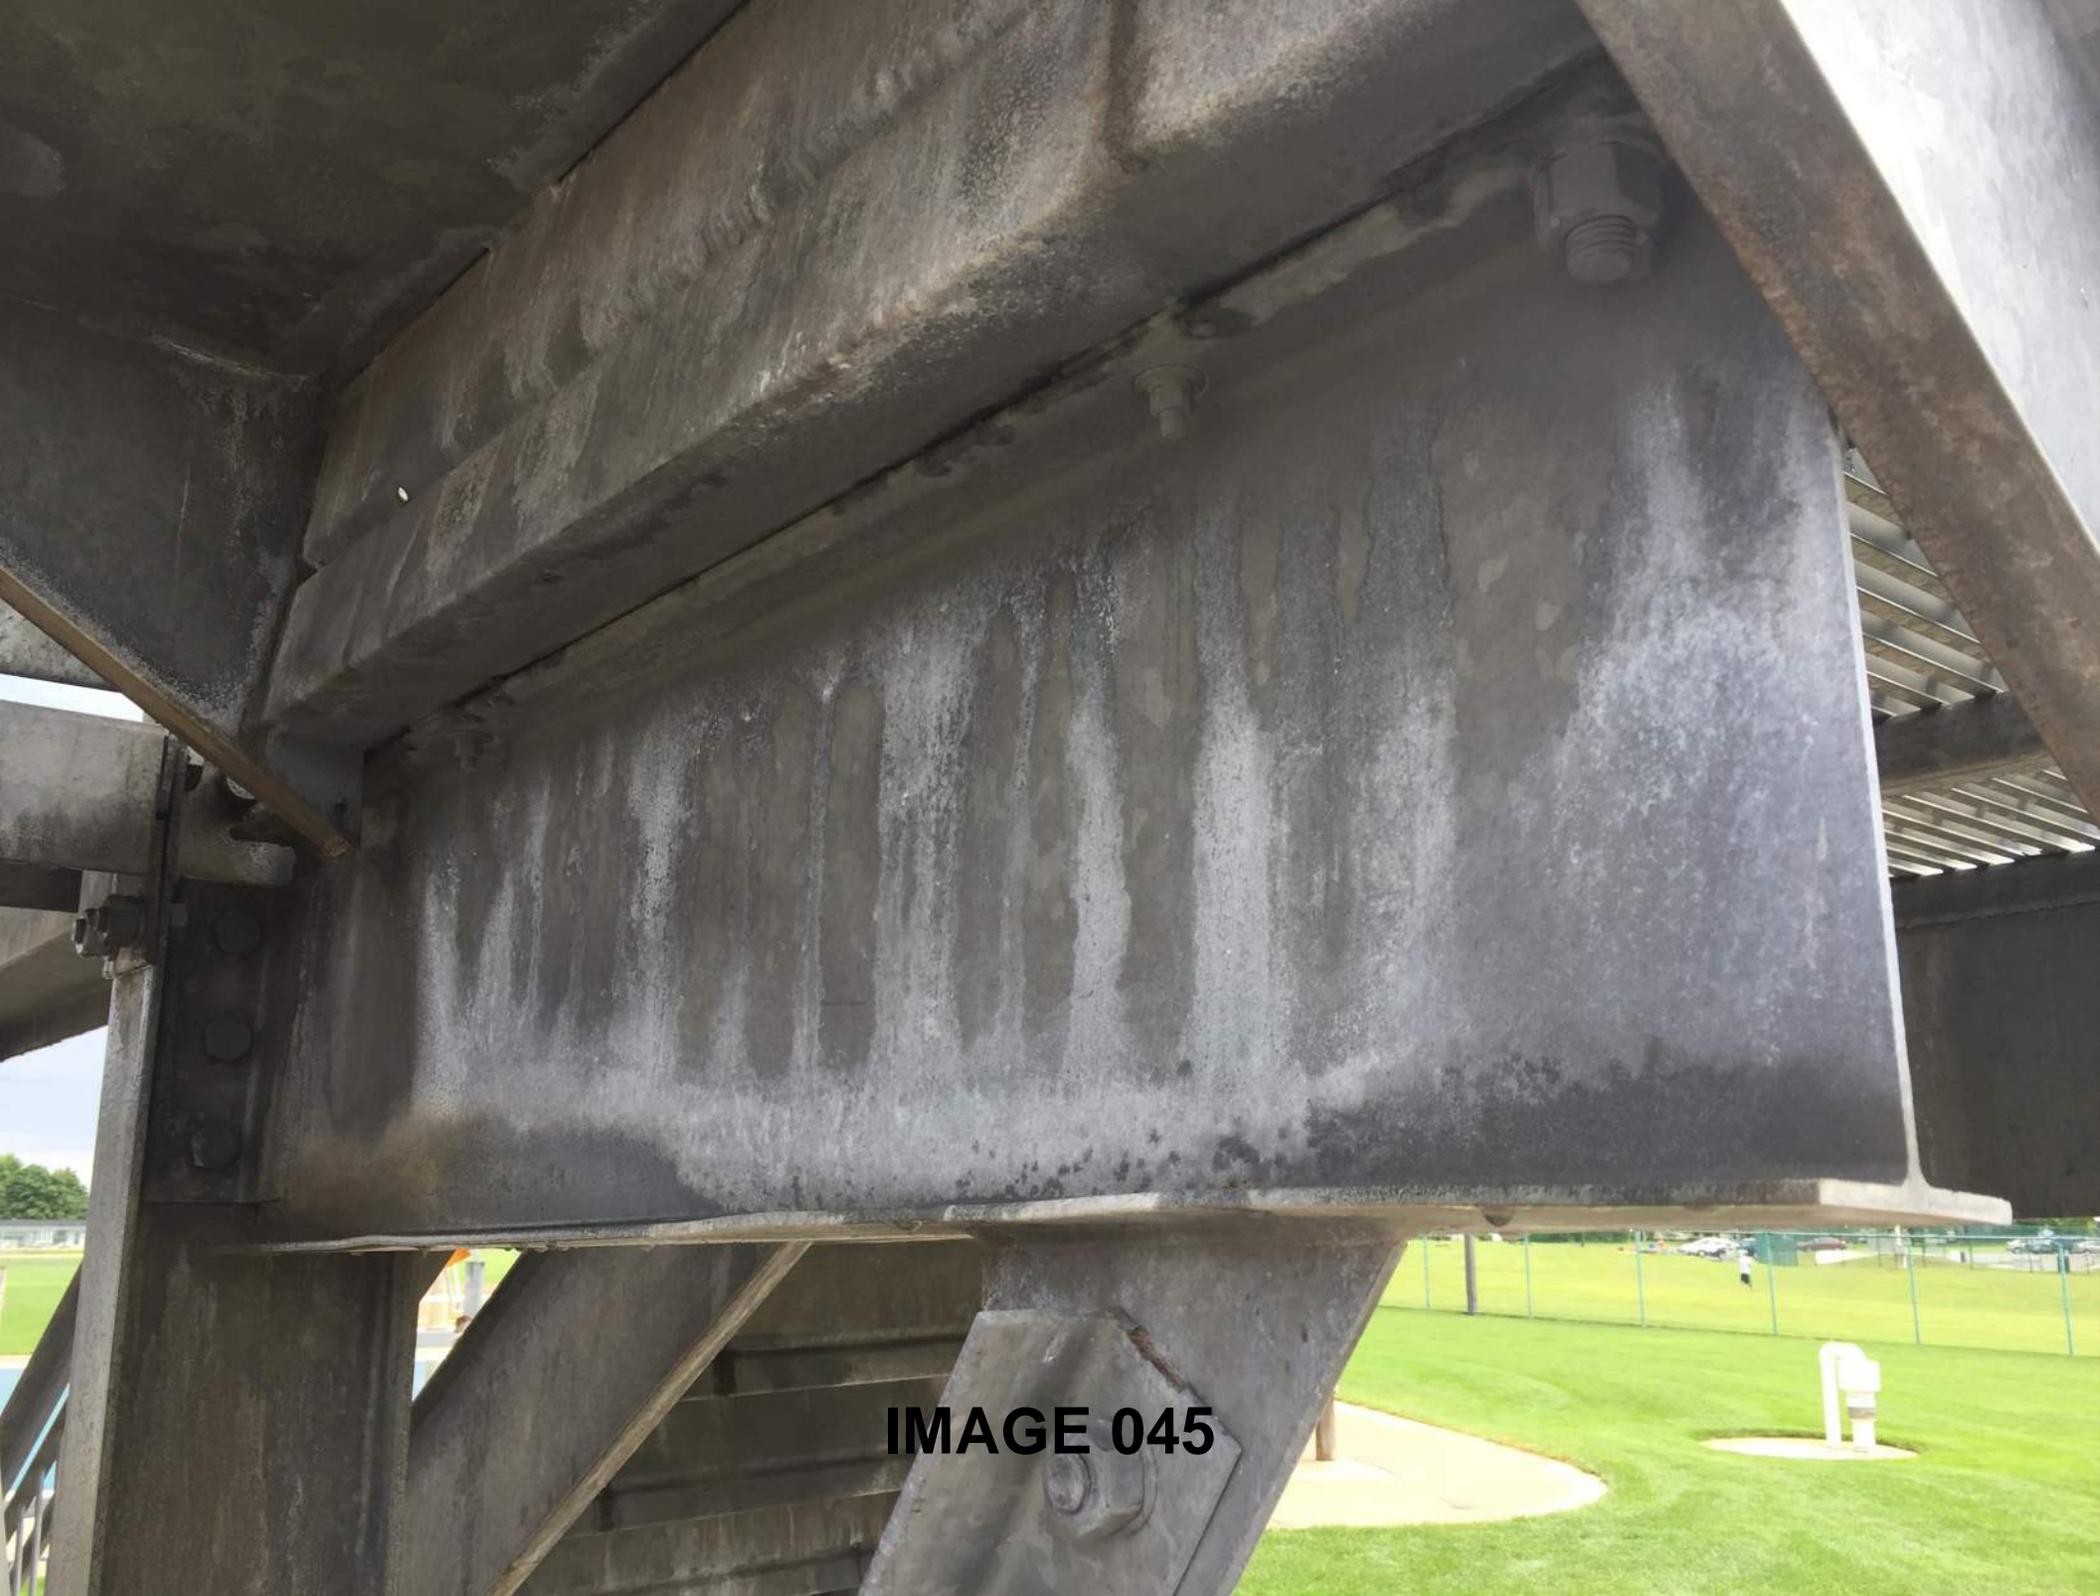
IMAGE 045

Image 045 – Slide tower surface corrosion

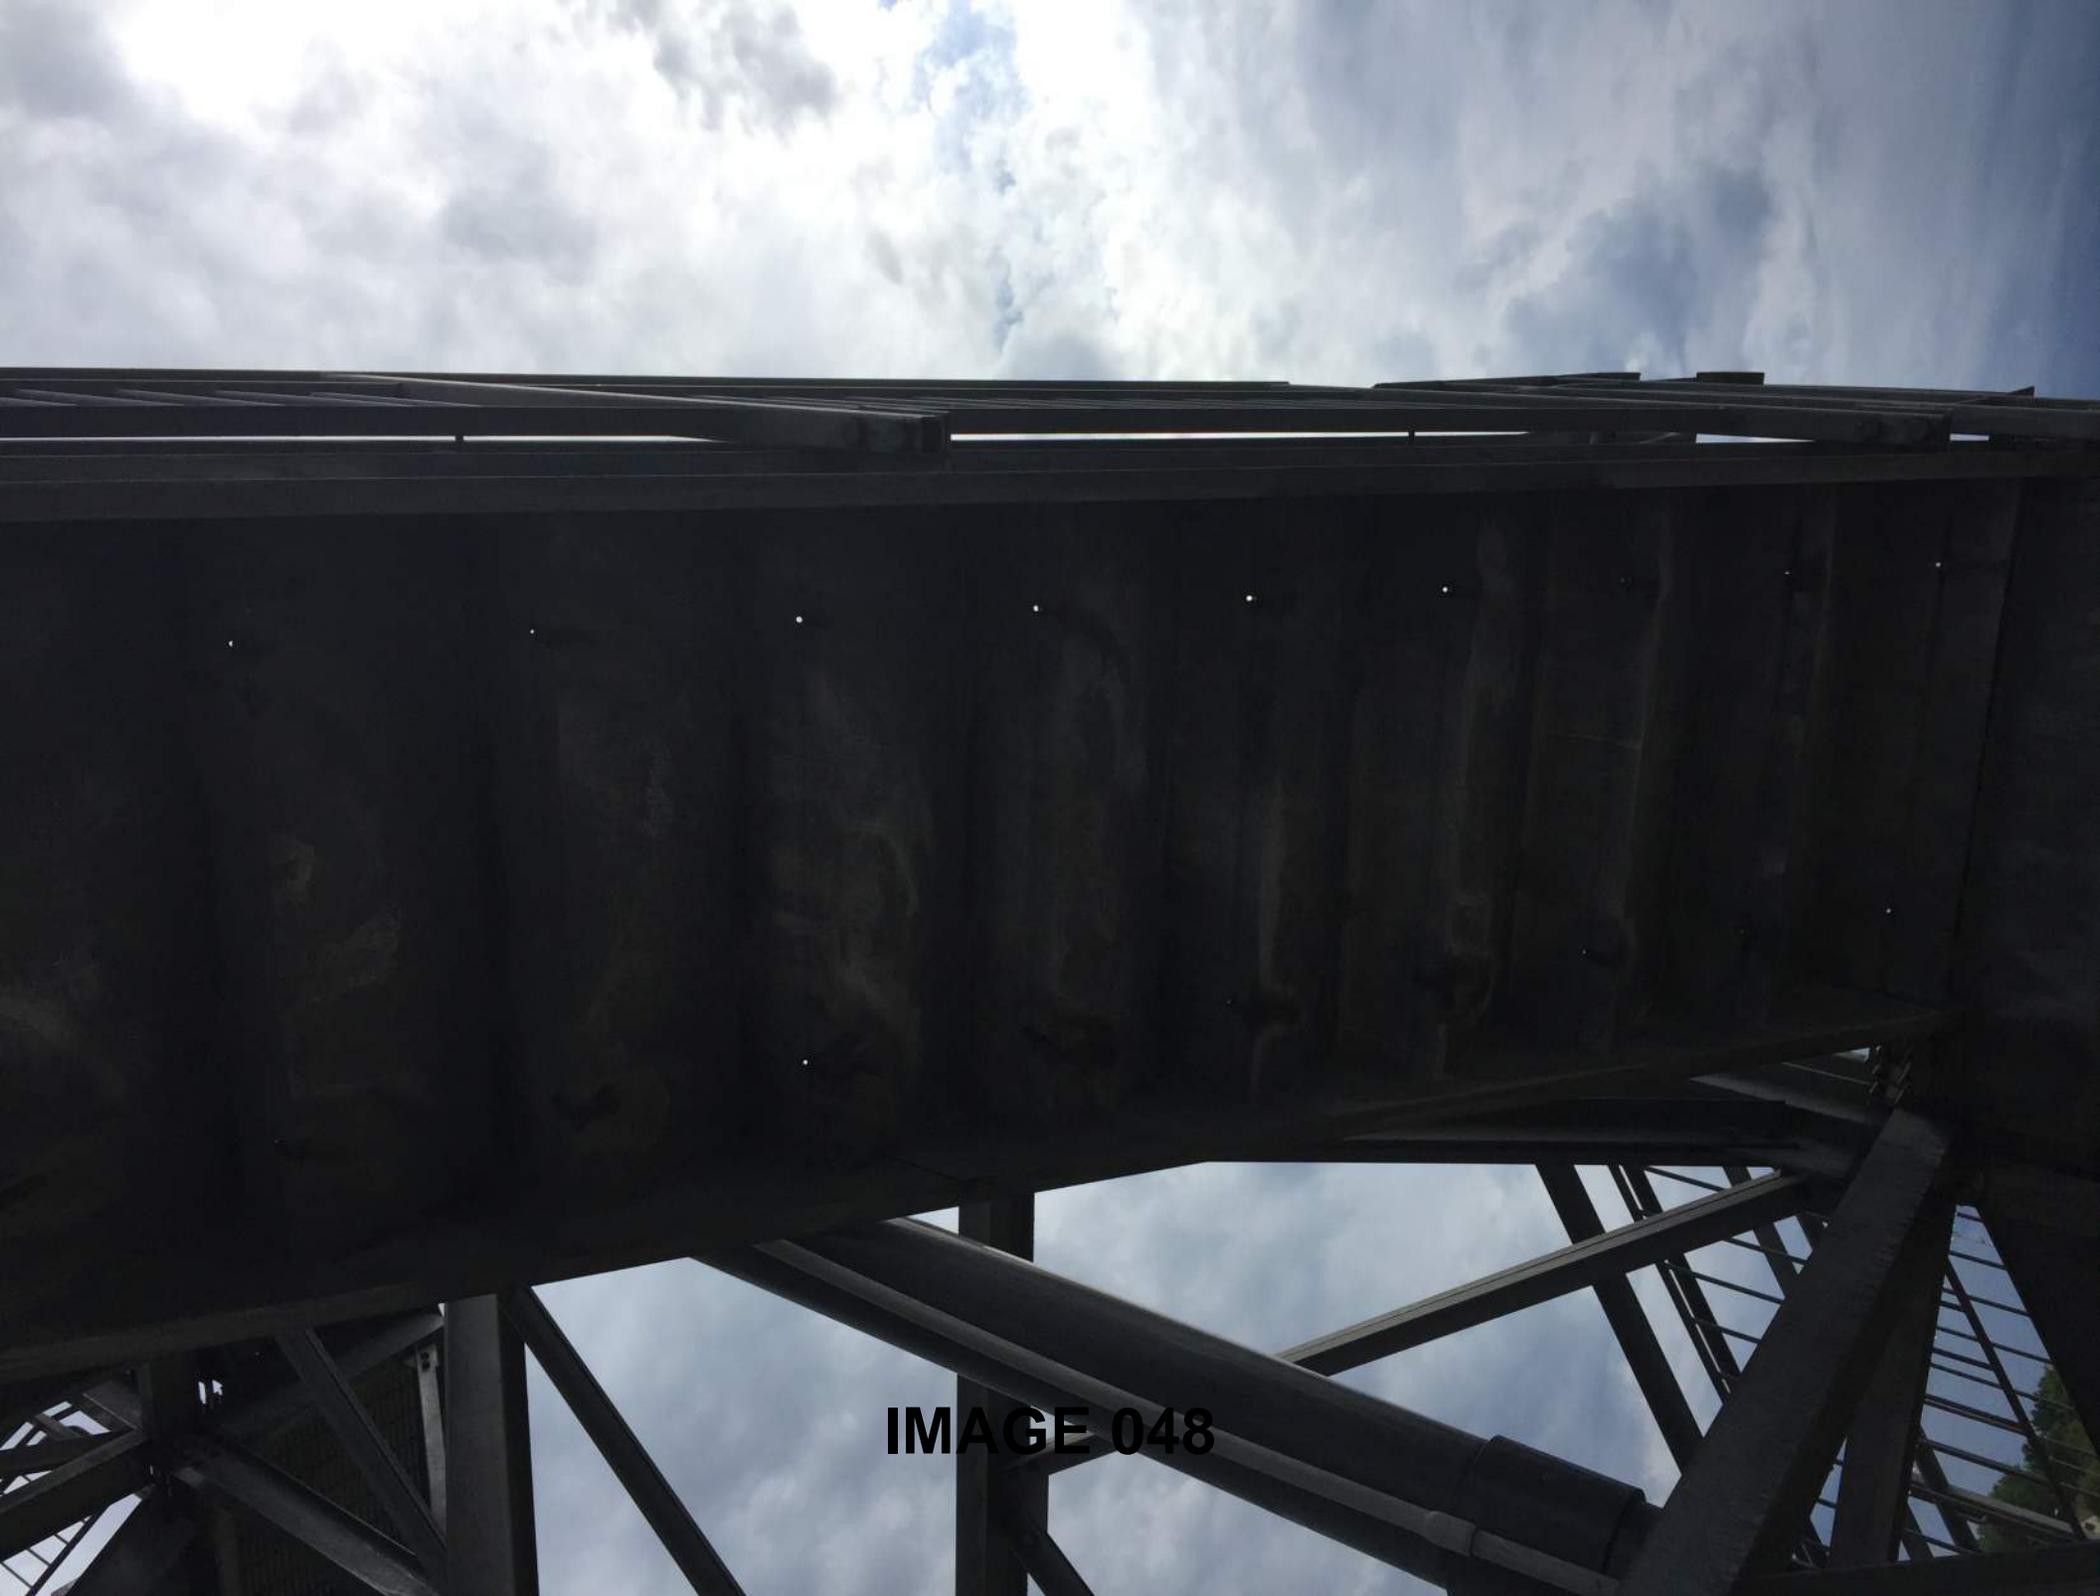
IMAGE 048

Image 048 – Bottom of slide tower stair treads

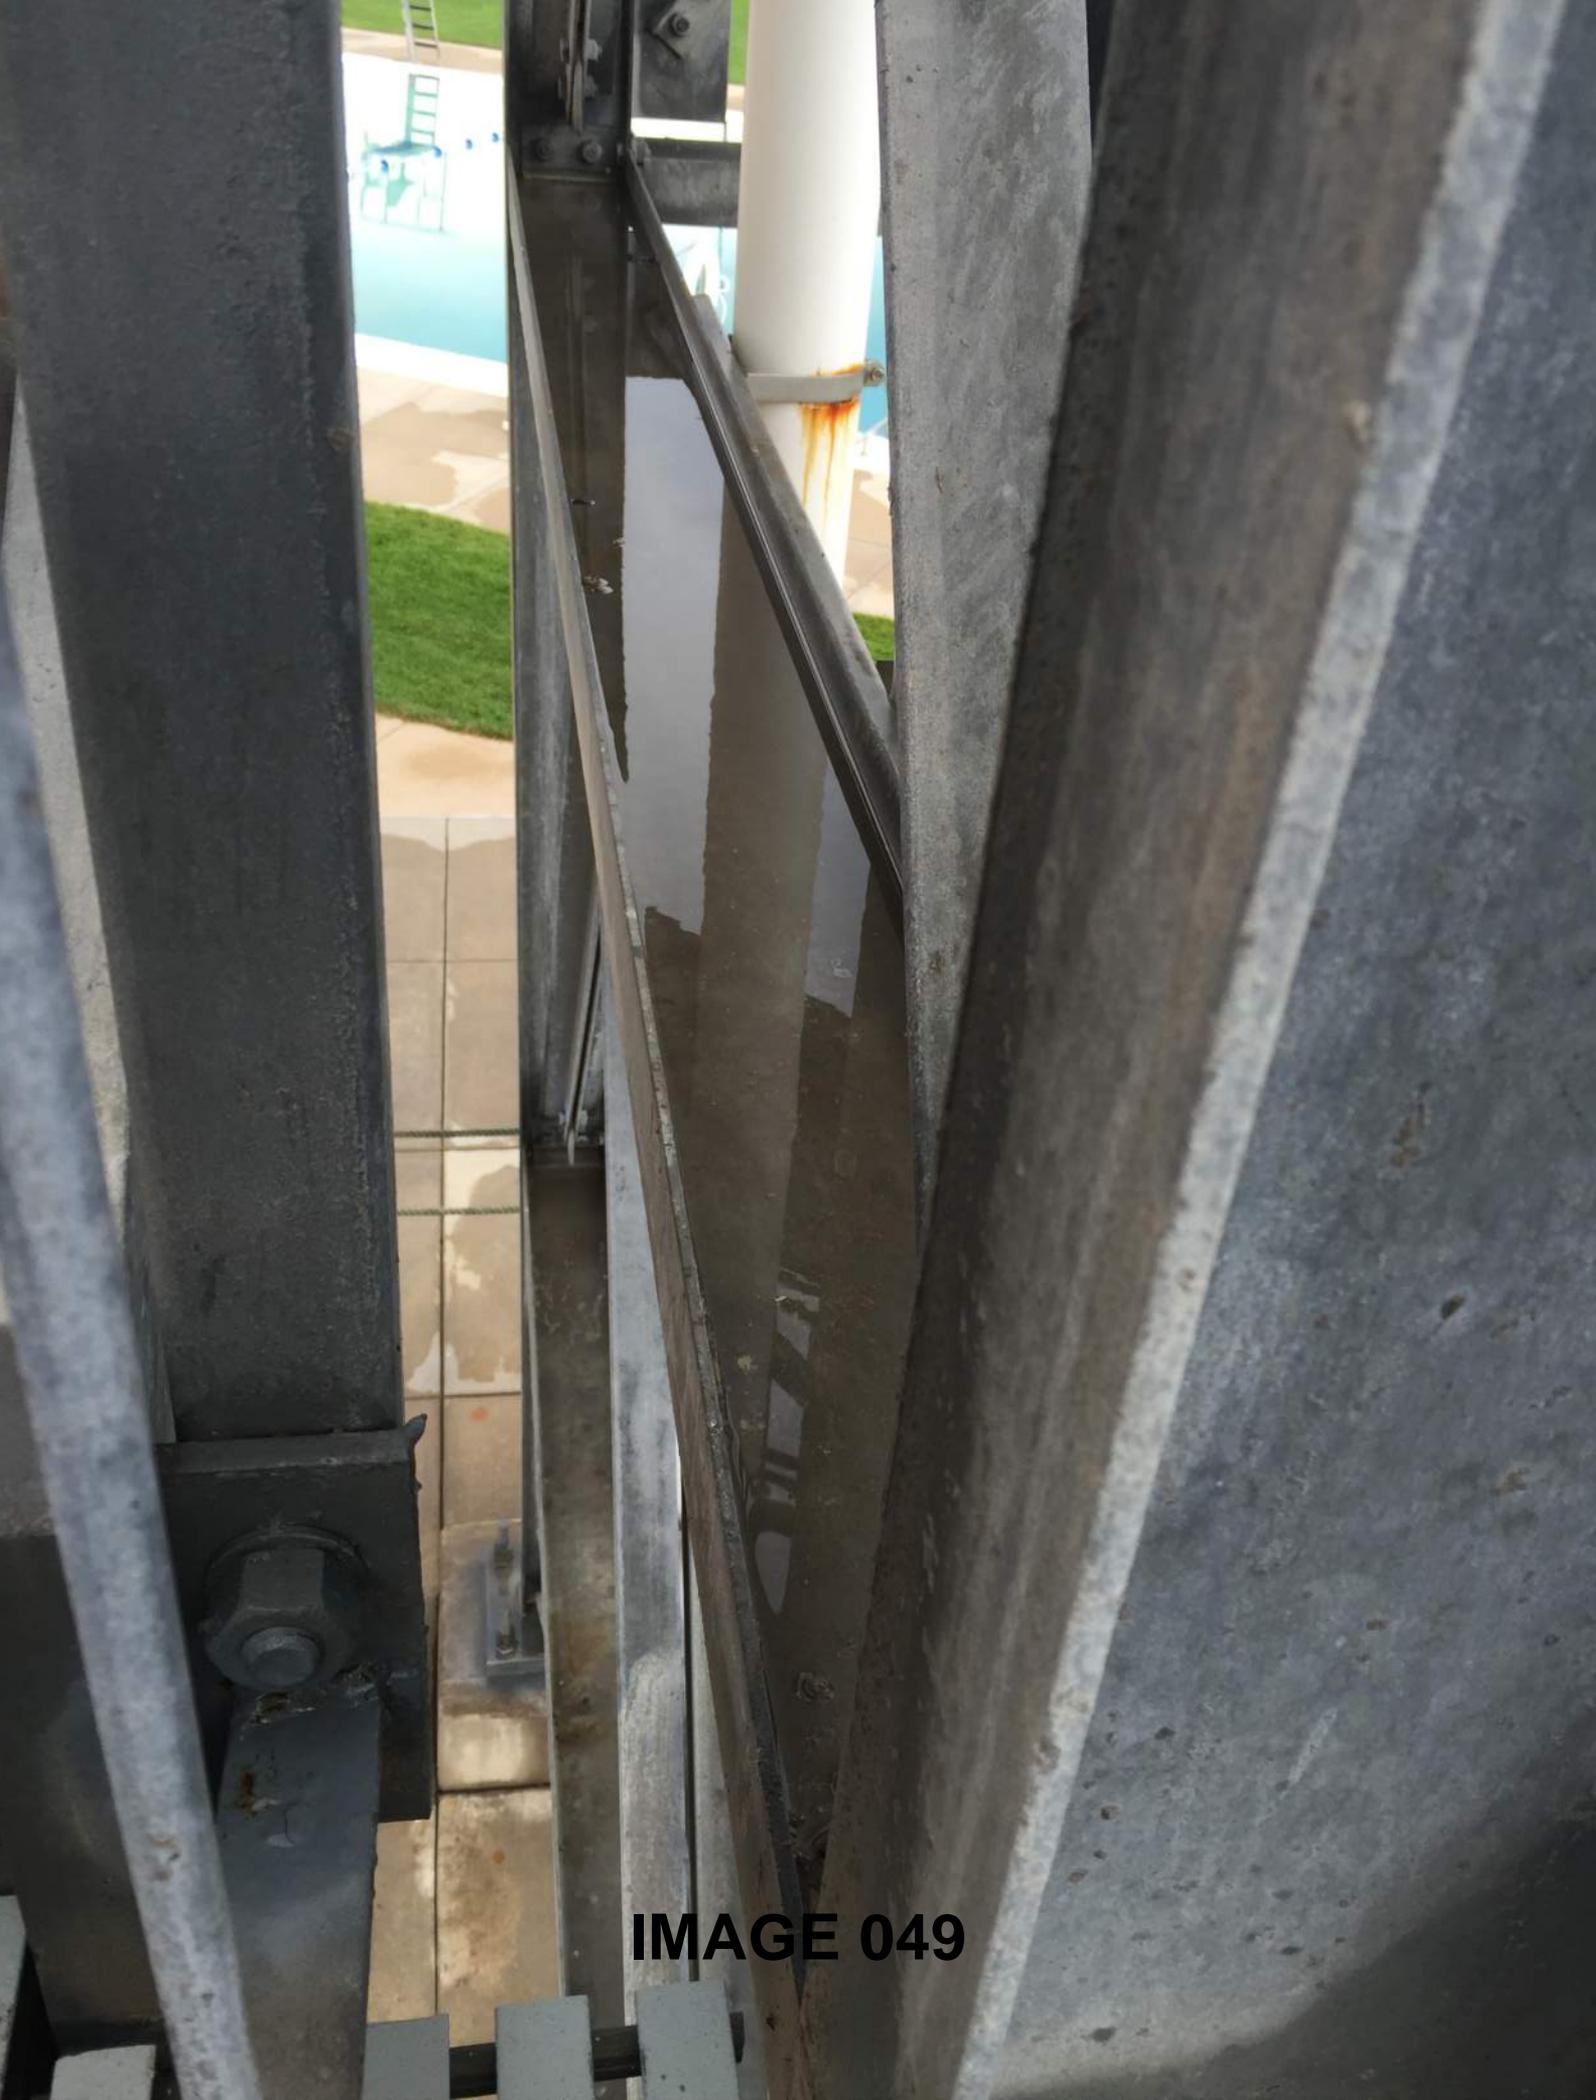
IMAGE 049

Image 049 – Slide tower I-beam collecting water
