Aquatic Facility Evaluation

Weston Aquatic Center
Weston, Wisconsin

September 14, 2016

Water Technology, Inc. (WTI)
100 Park Avenue, PO Box 614
Beaver Dam, WI 53916
www.wtiworld.com

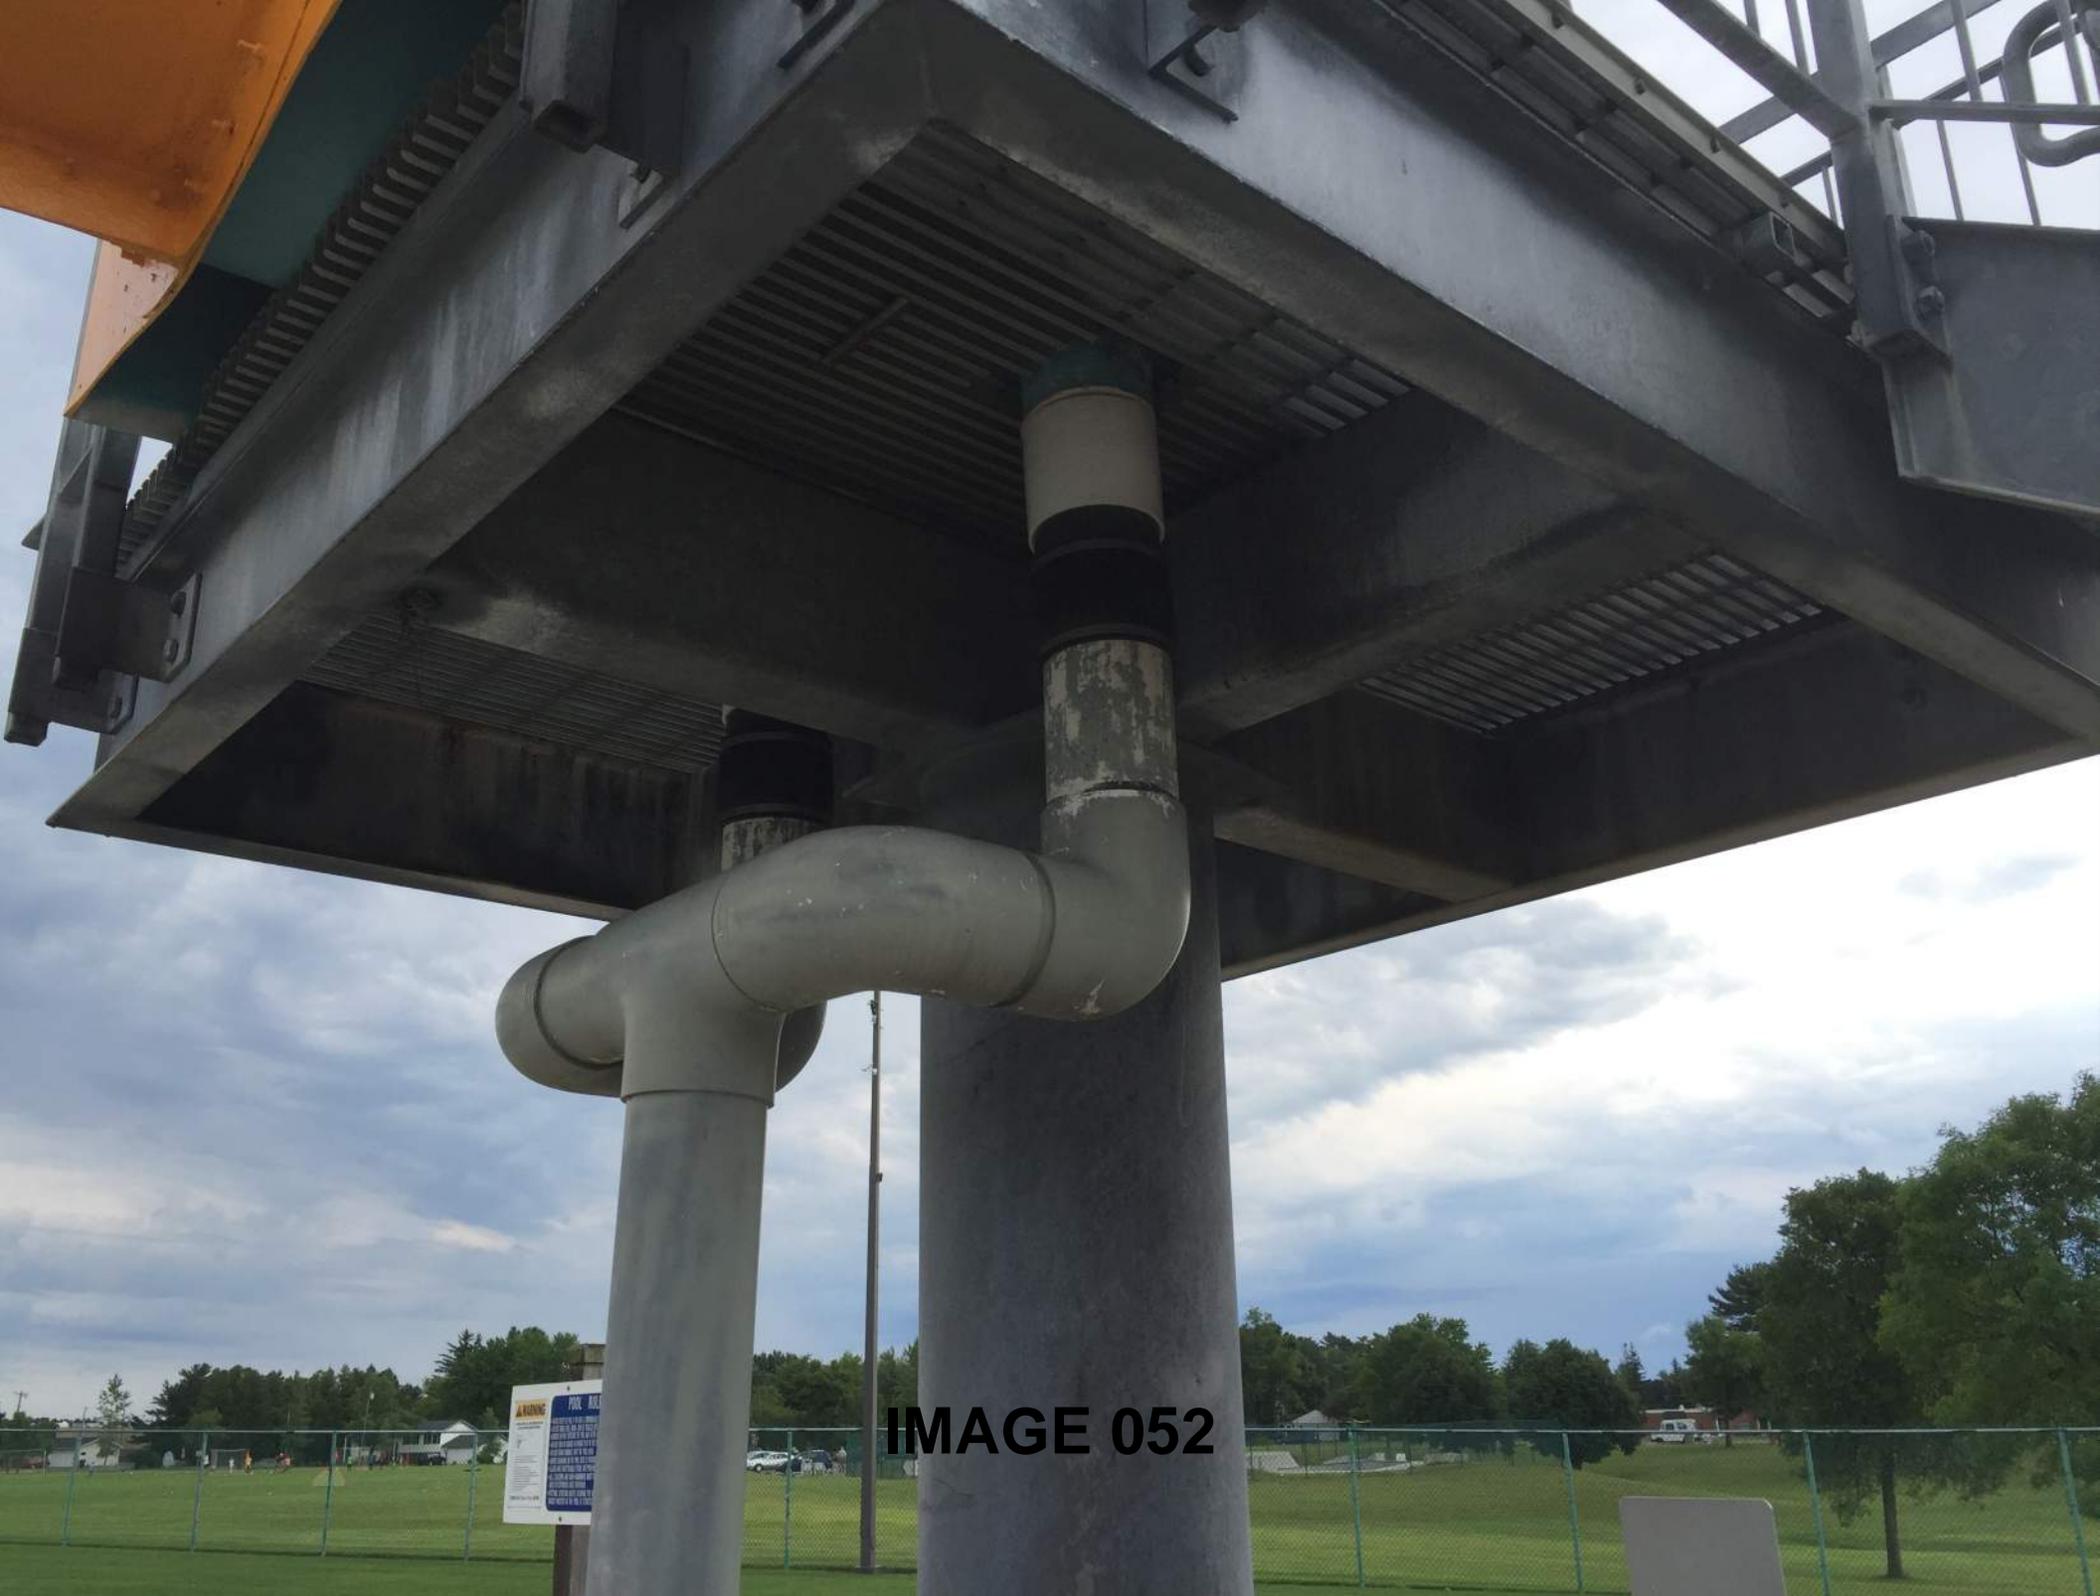
IMAGE 052

Image 052 – Drop slide tower from below

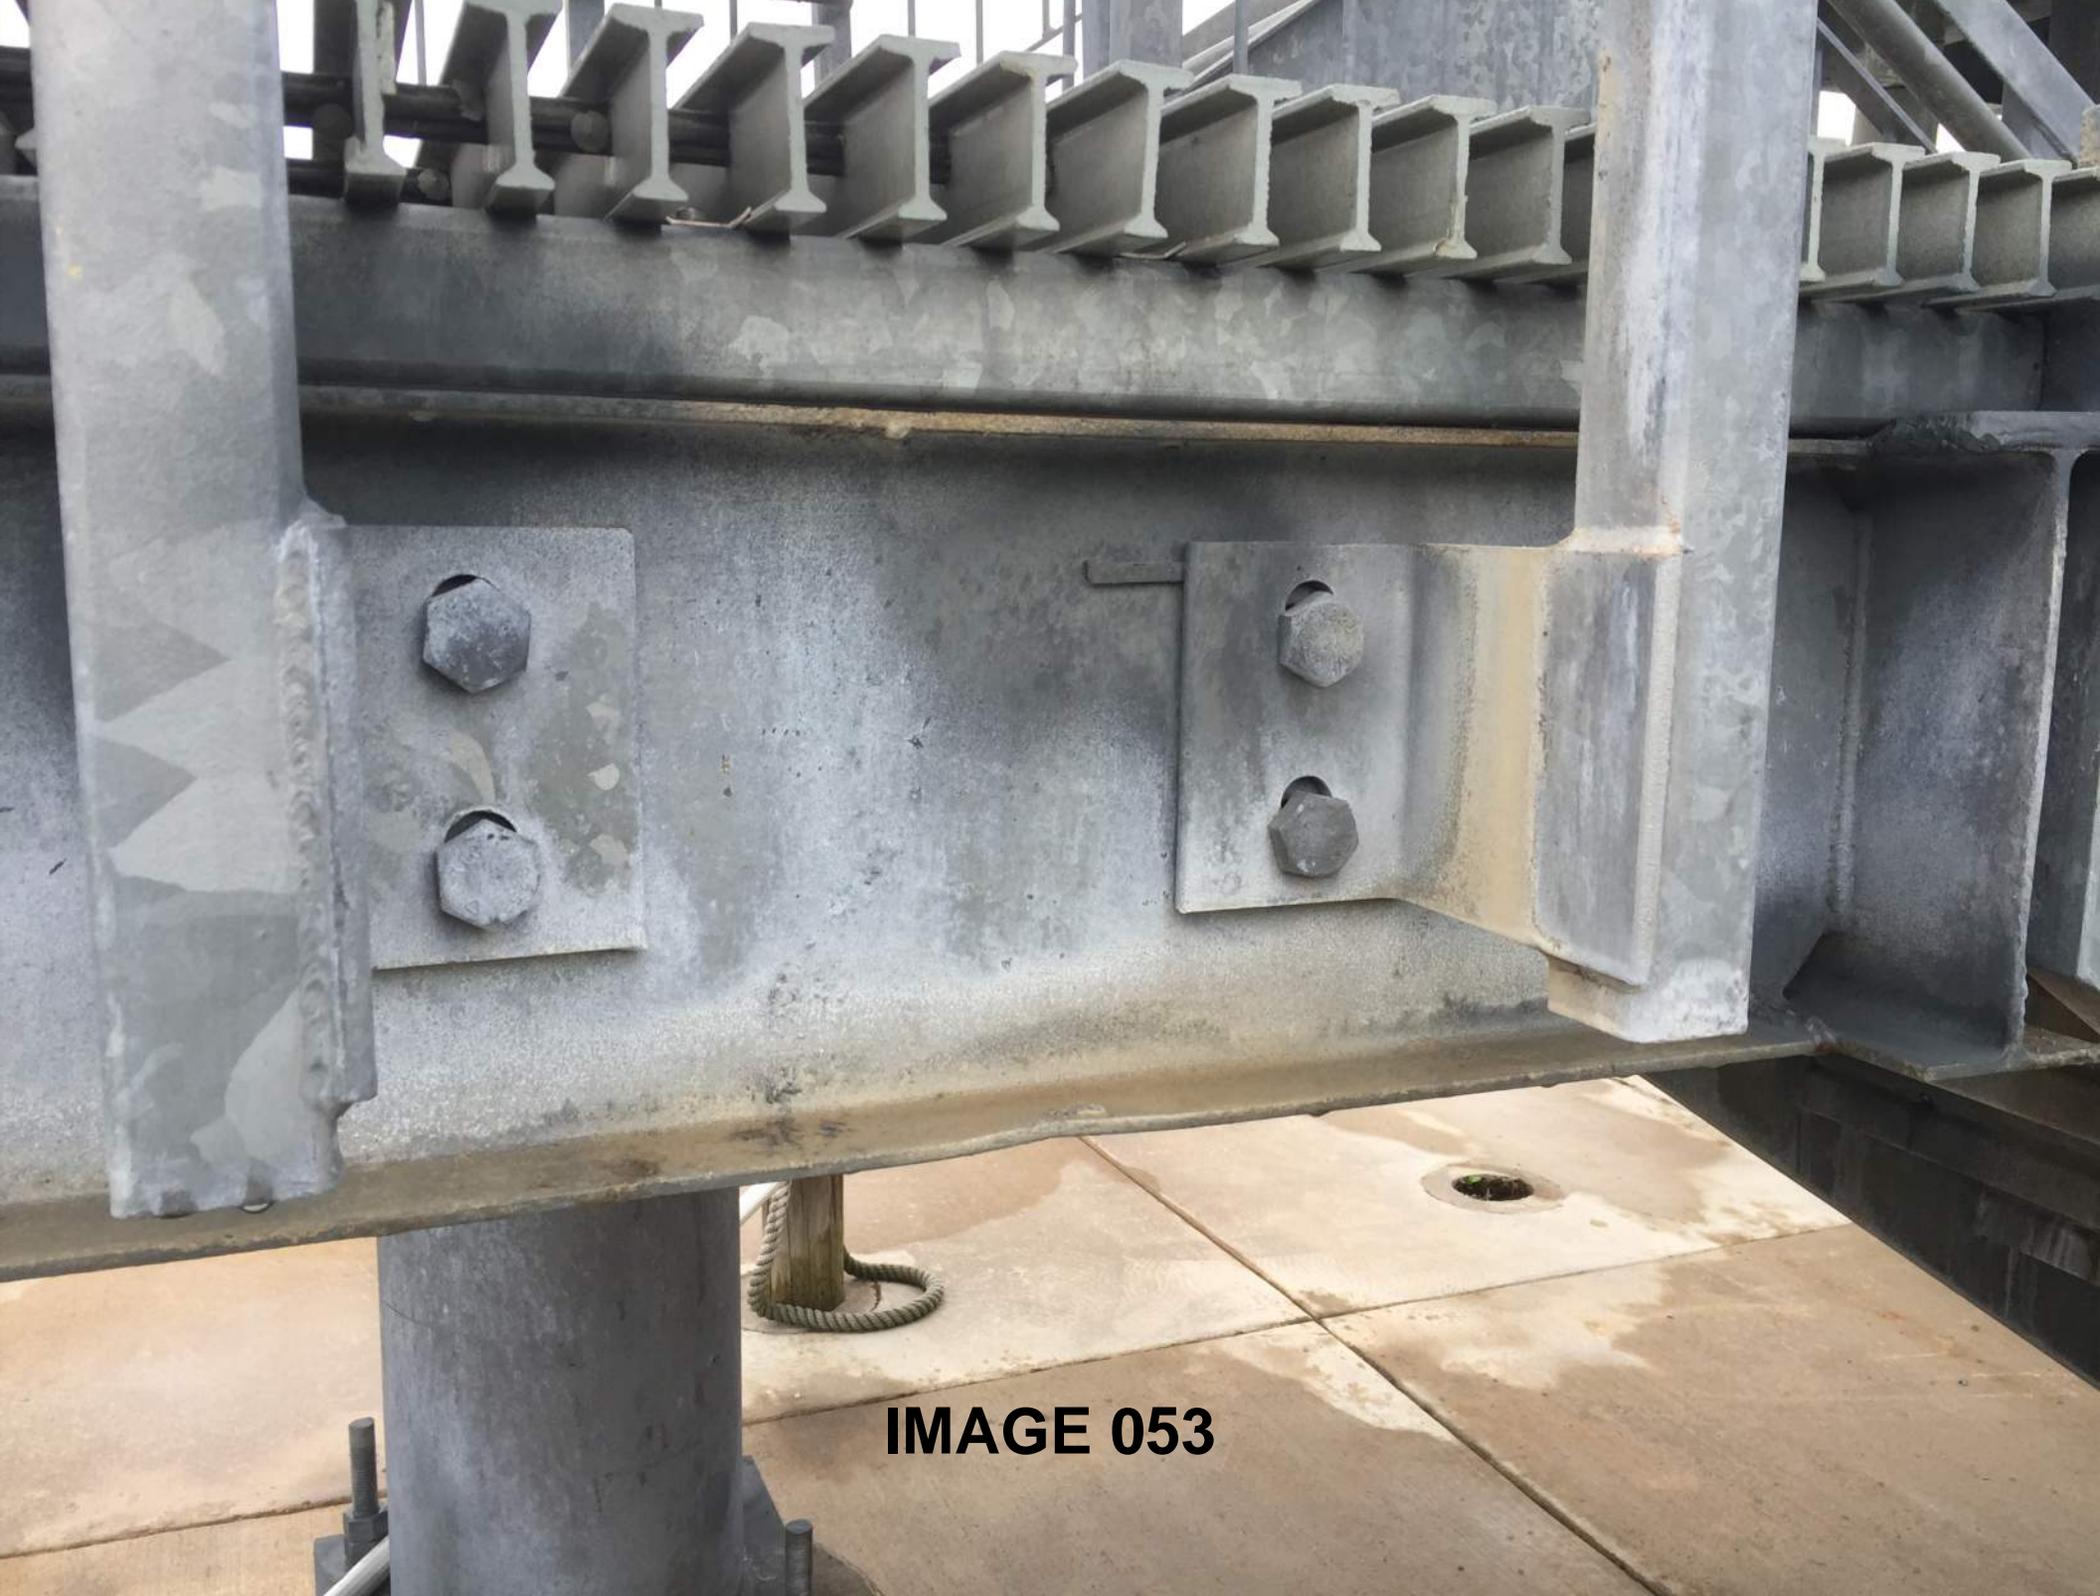
IMAGE 053

Image 053 – Corrosion on drop slide tower

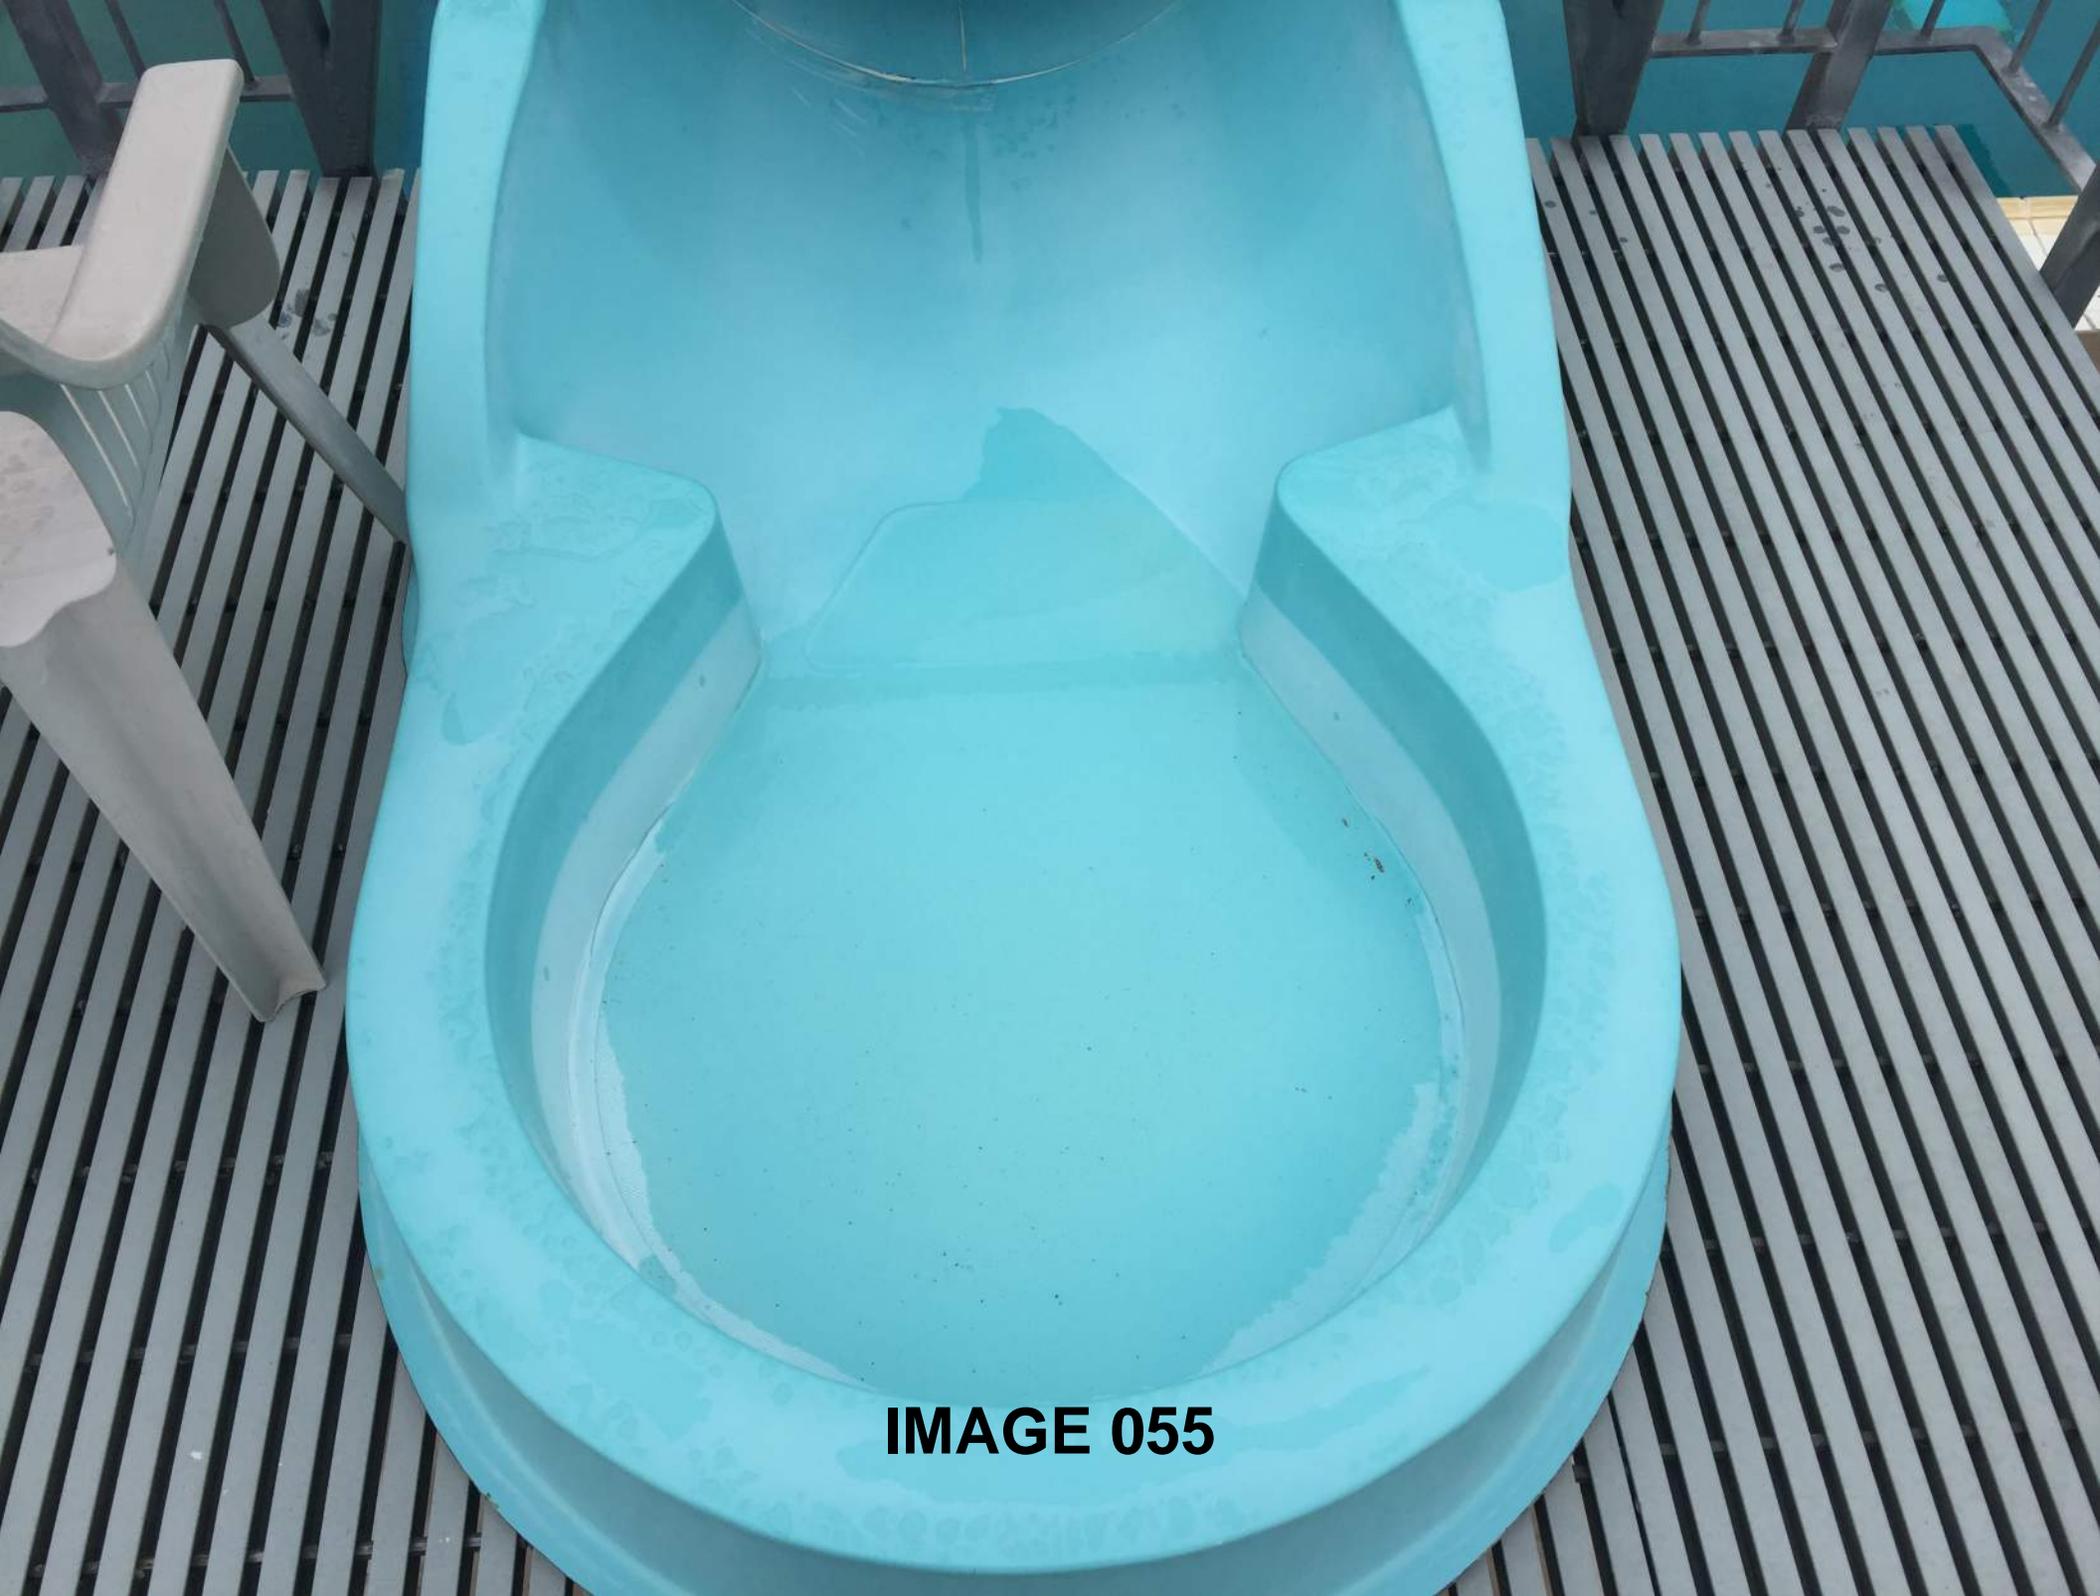
IMAGE 055

Image 055 – Drop slide start tub

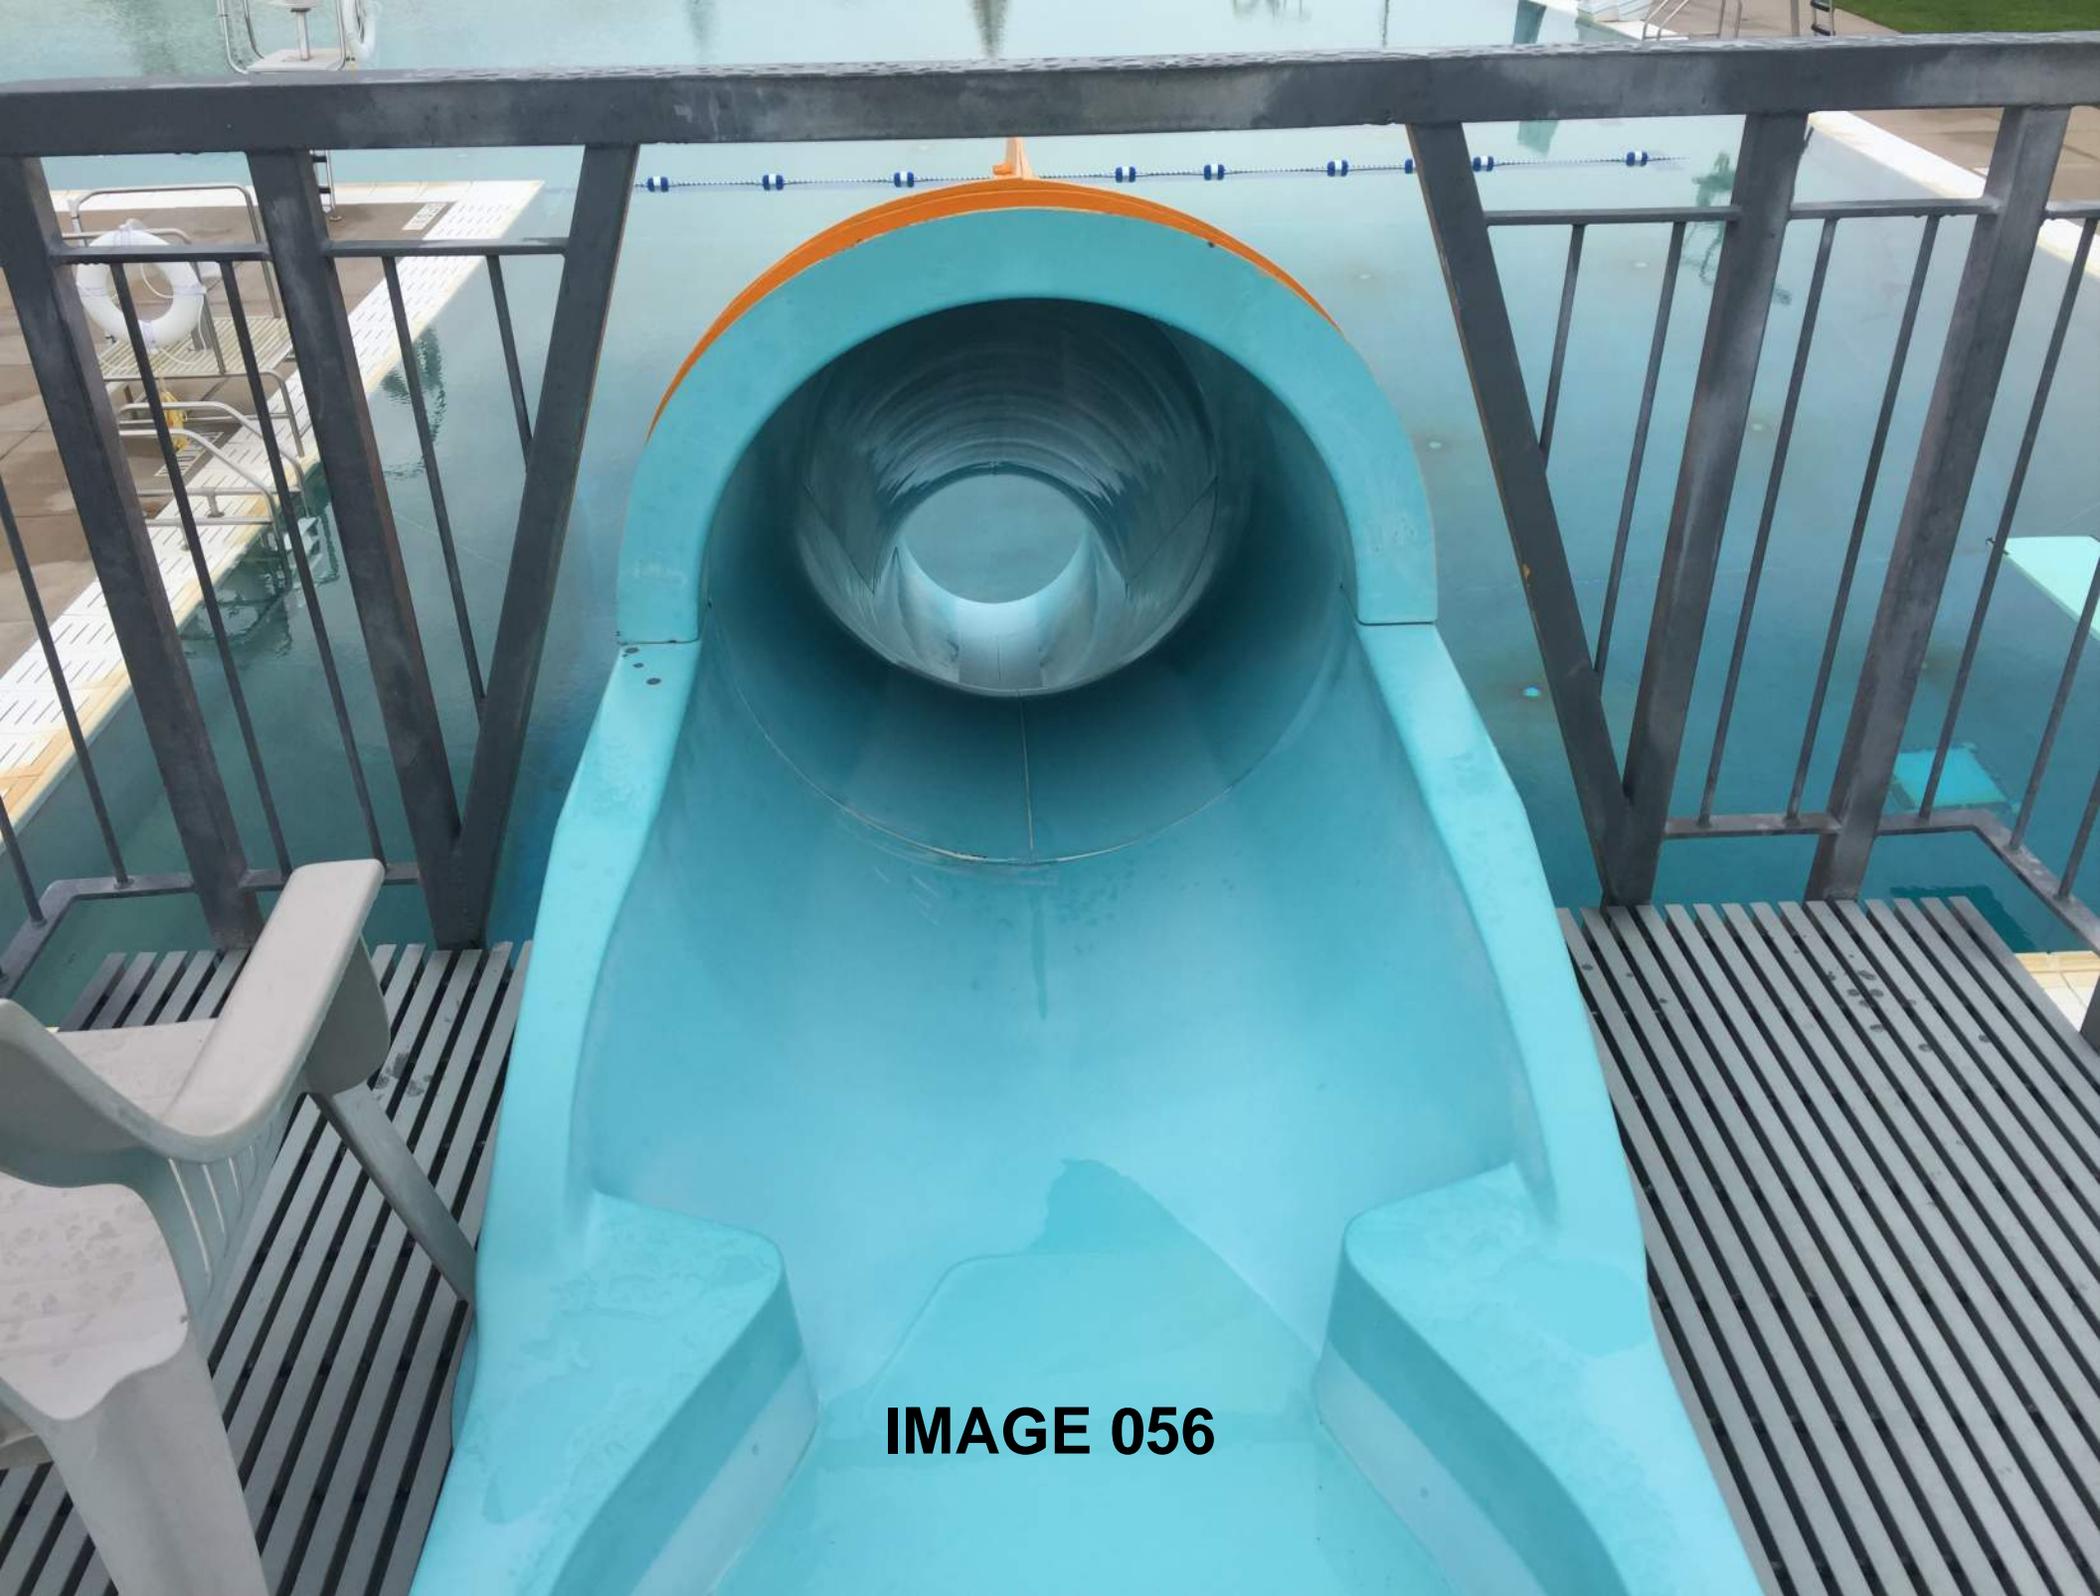
IMAGE 056

Image 056 – Drop slide flume interior

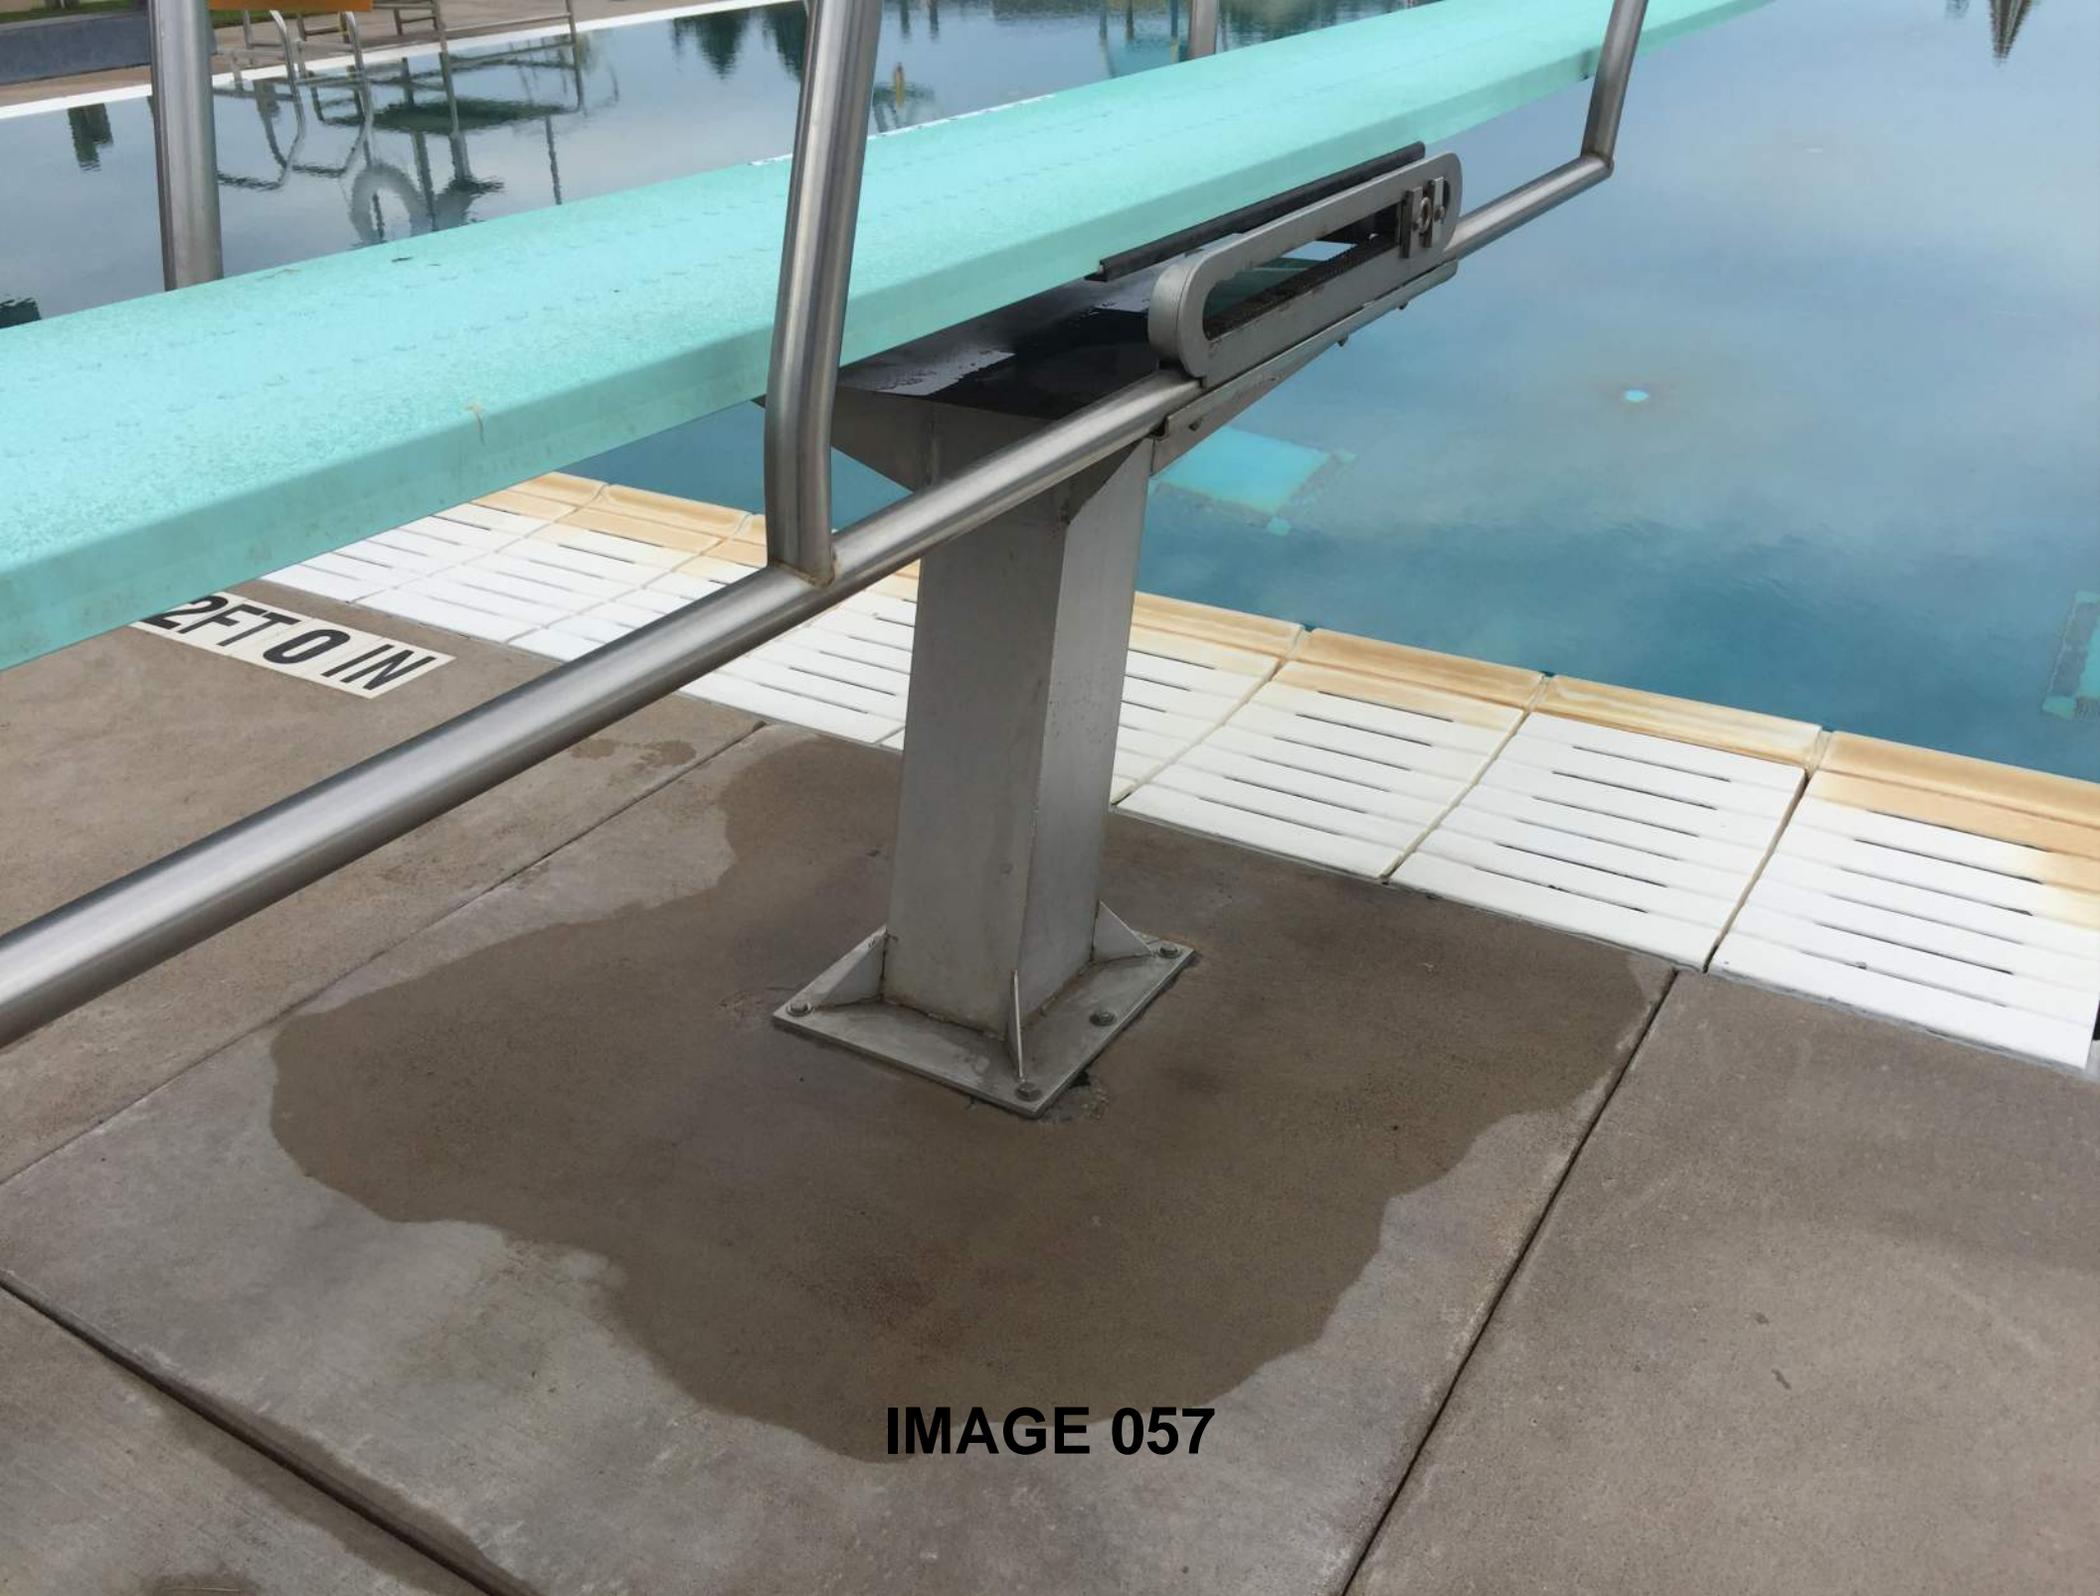
IMAGE 057

Image 057 – Diving board and stand

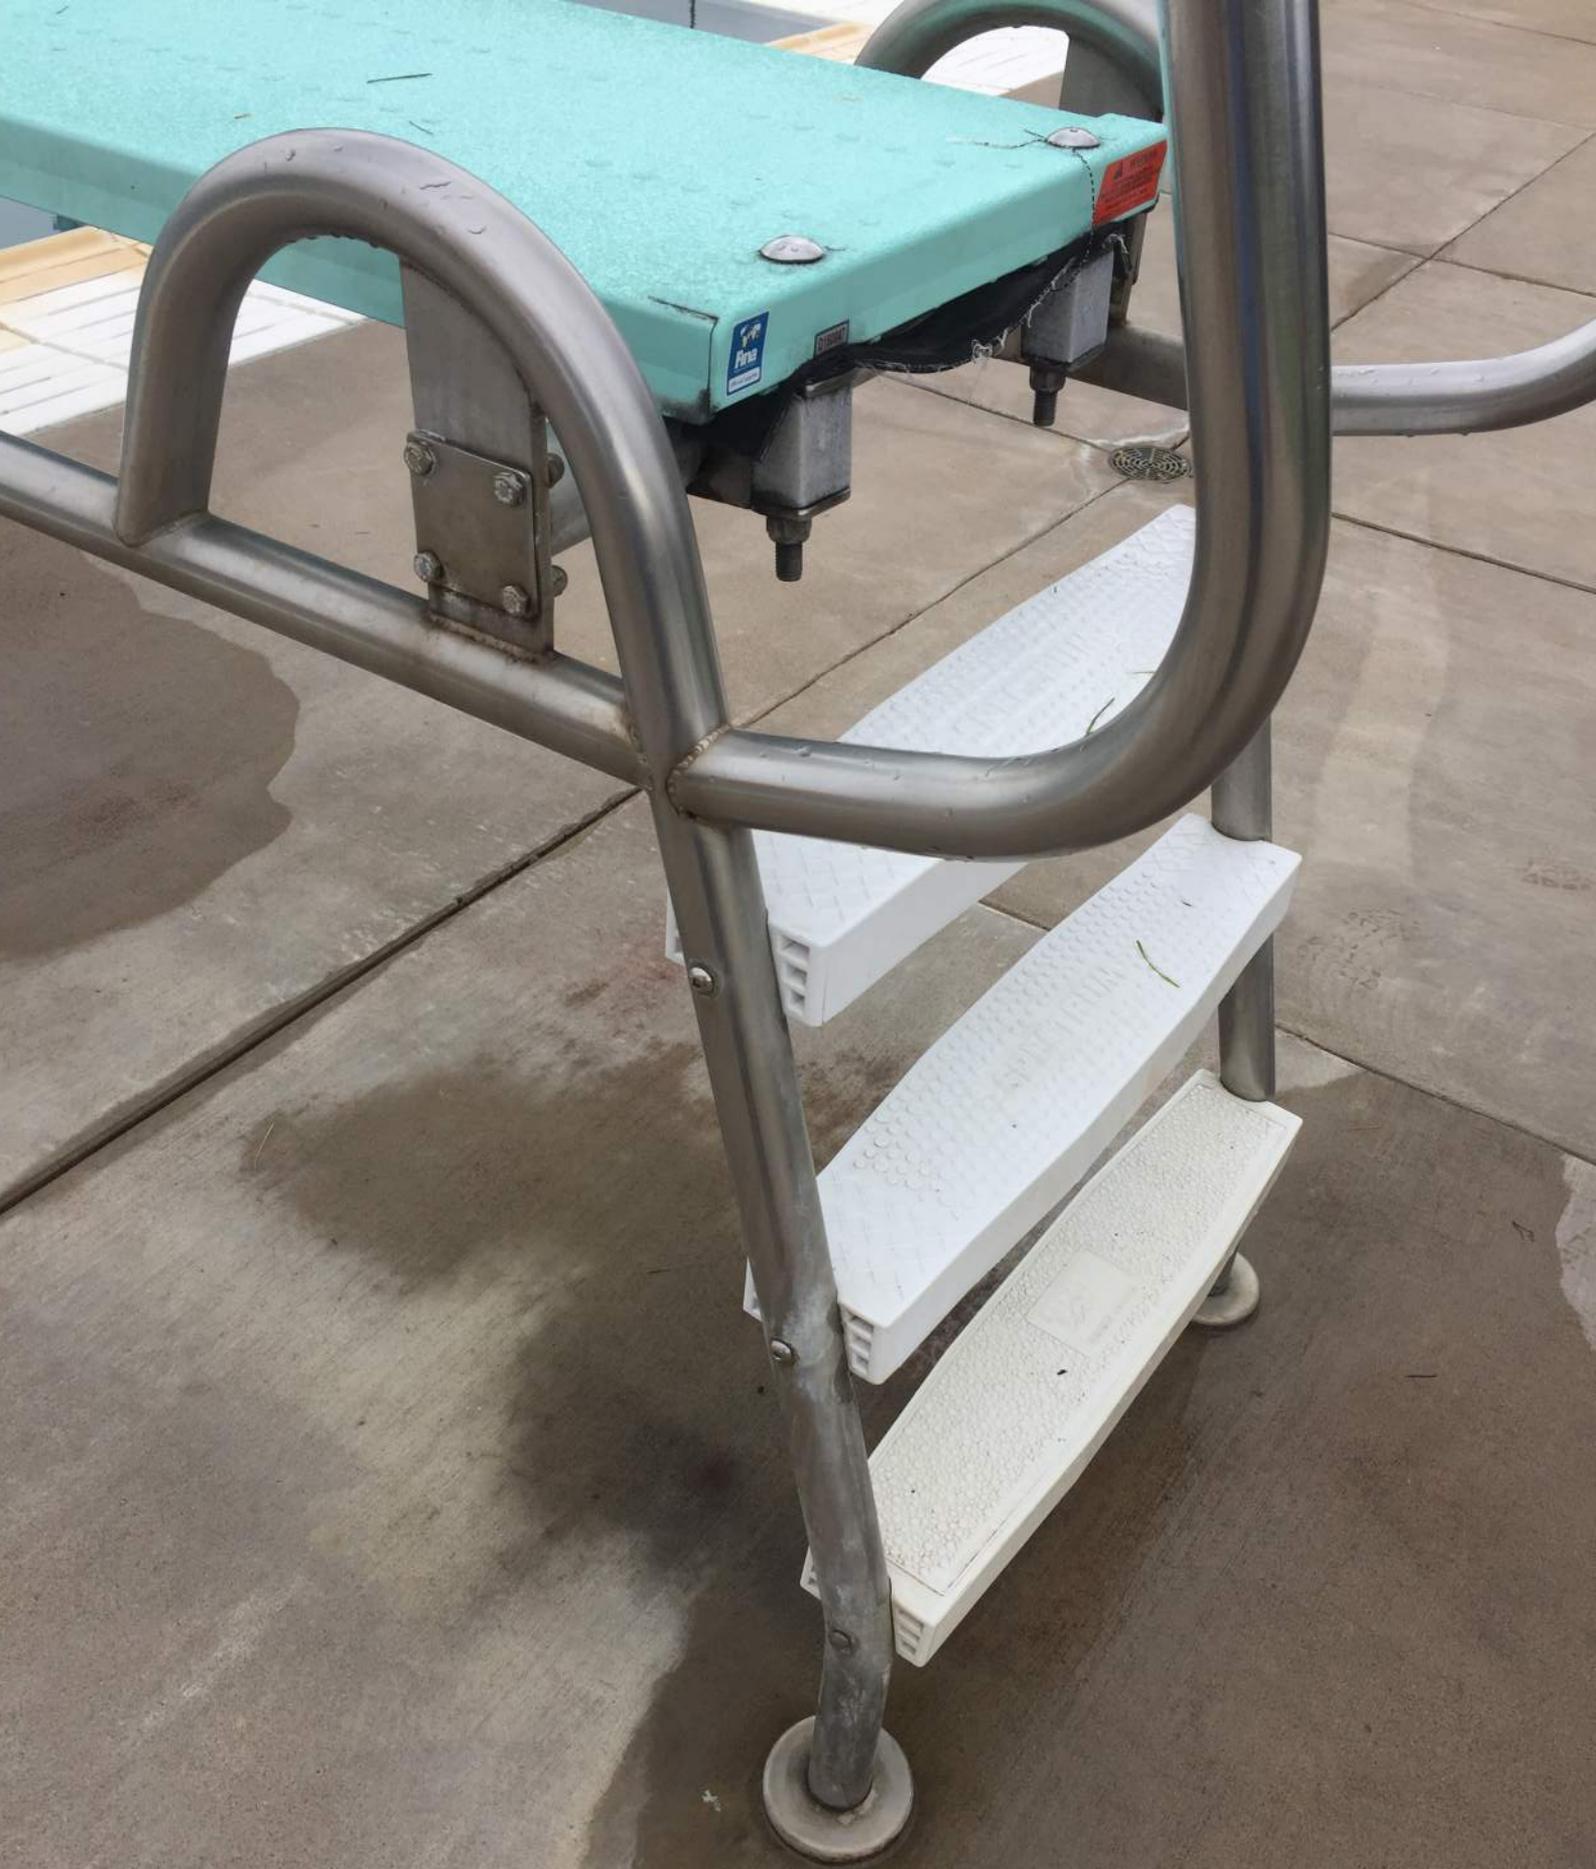
IMAGE 058

Image 058 – Diving board steps

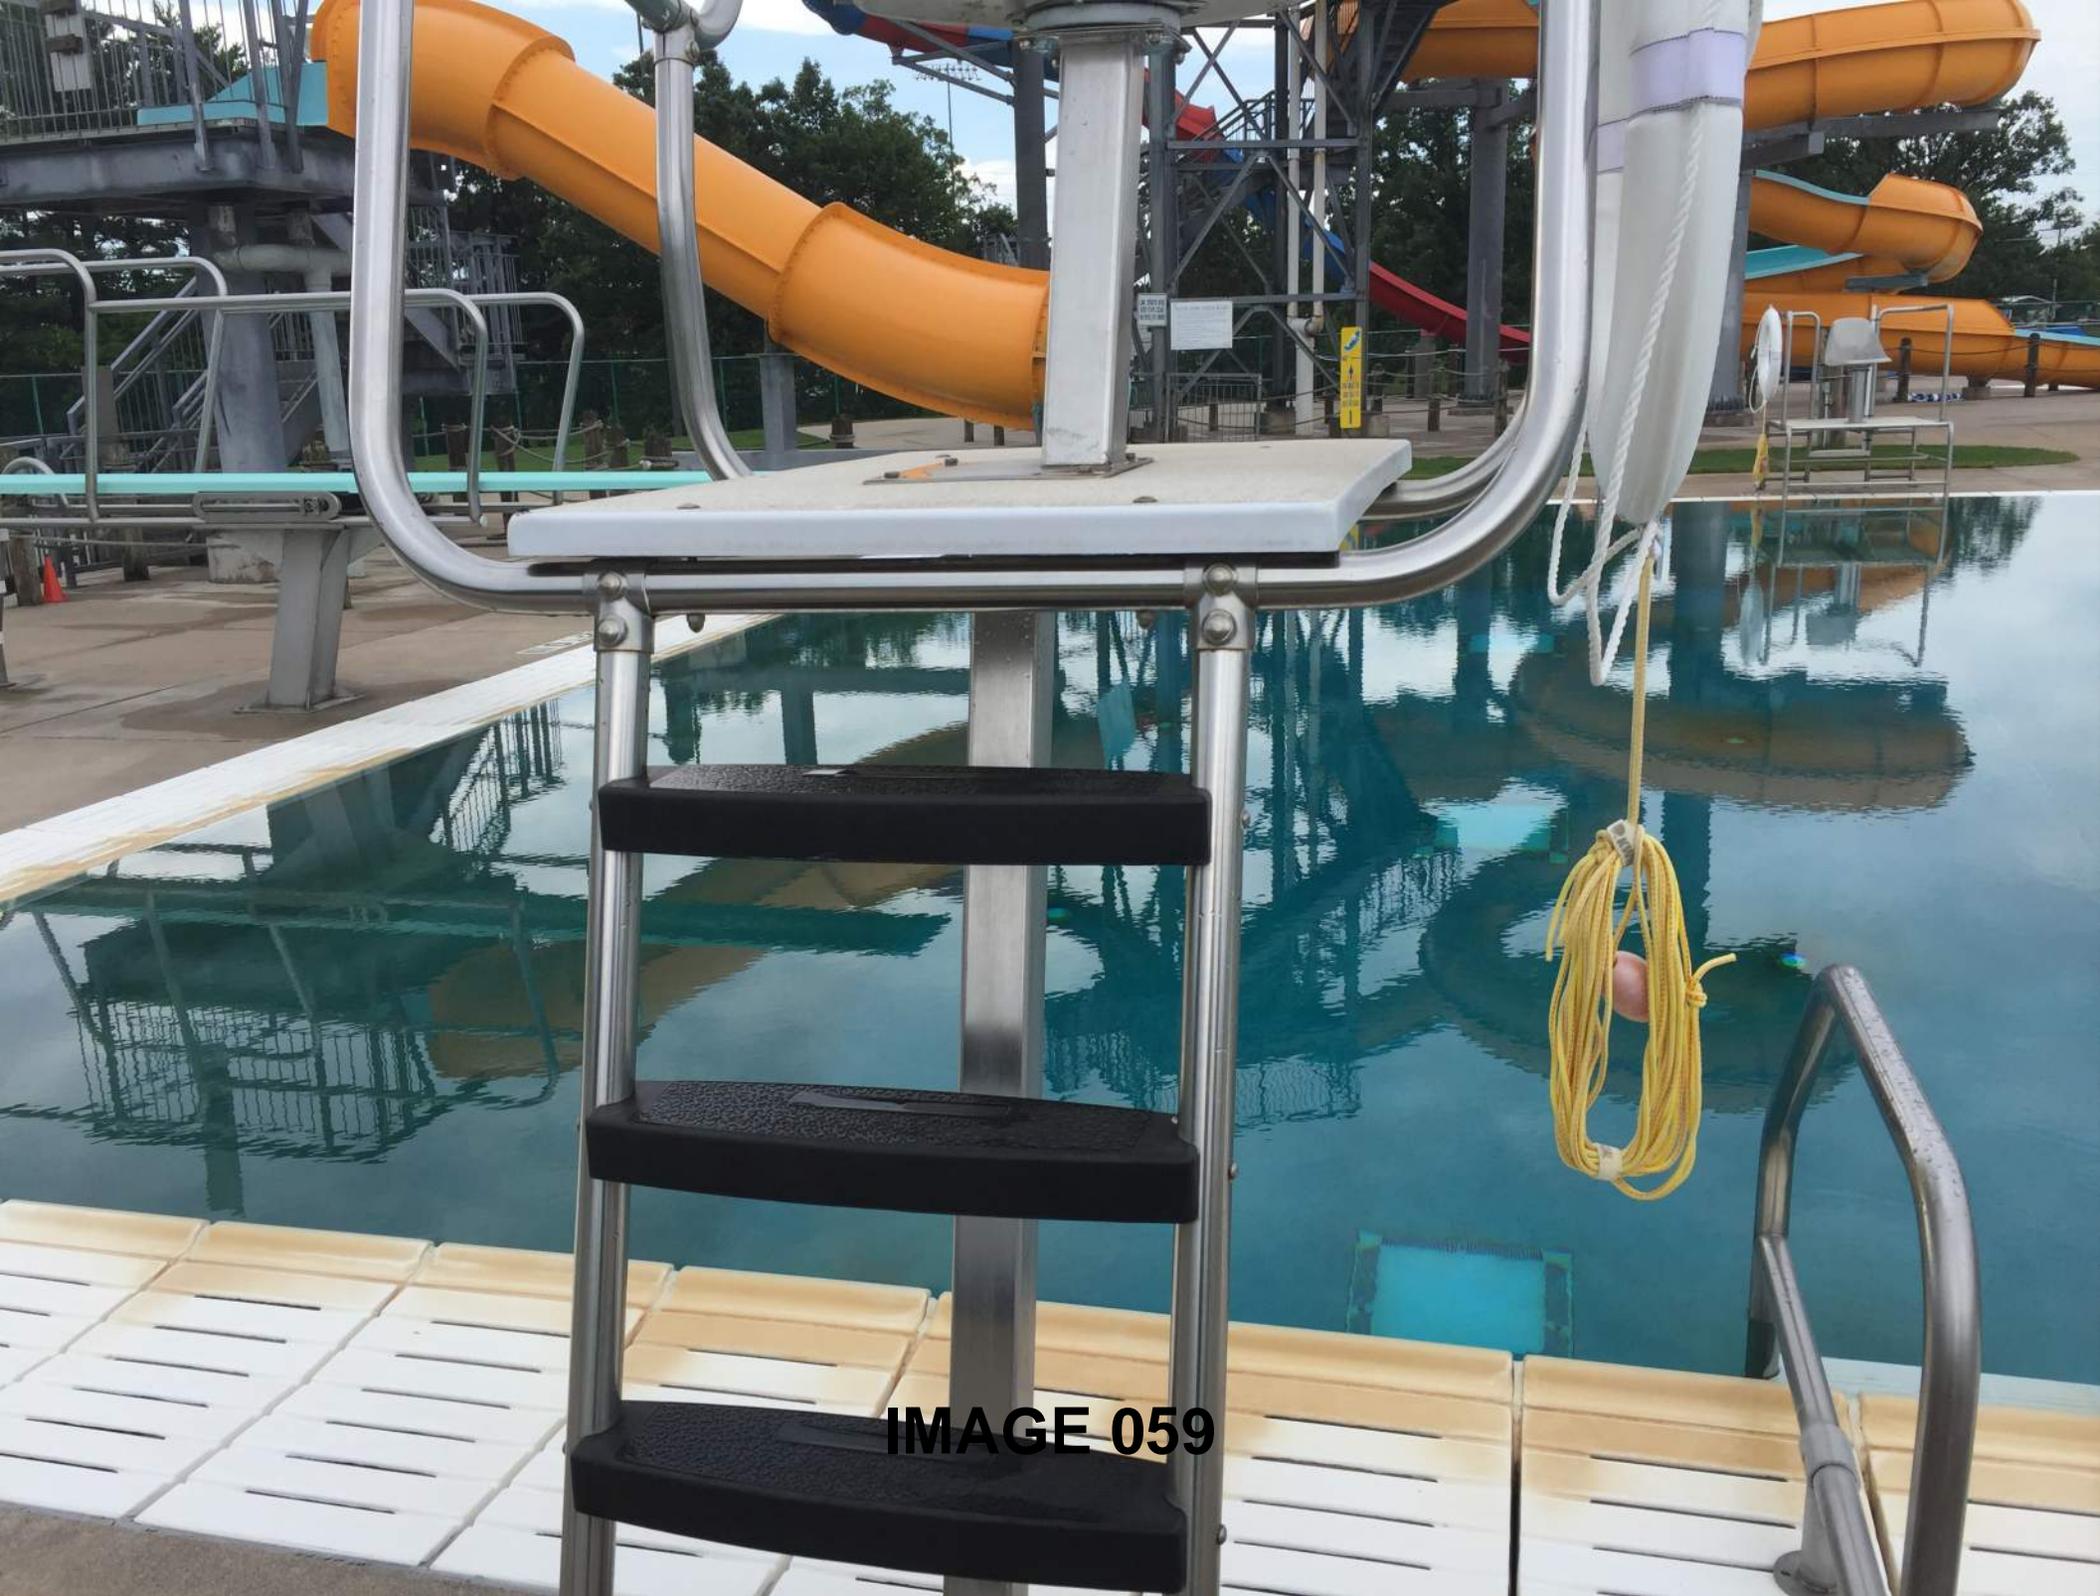
IMAGE 059

Image 059 – High-level lifeguard station
