Aquatic Facility Evaluation

Weston Aquatic Center
Weston, Wisconsin

September 14, 2016

Water Technology, Inc. (WTI)
100 Park Avenue, PO Box 614
Beaver Dam, WI 53916
www.wtiworld.com

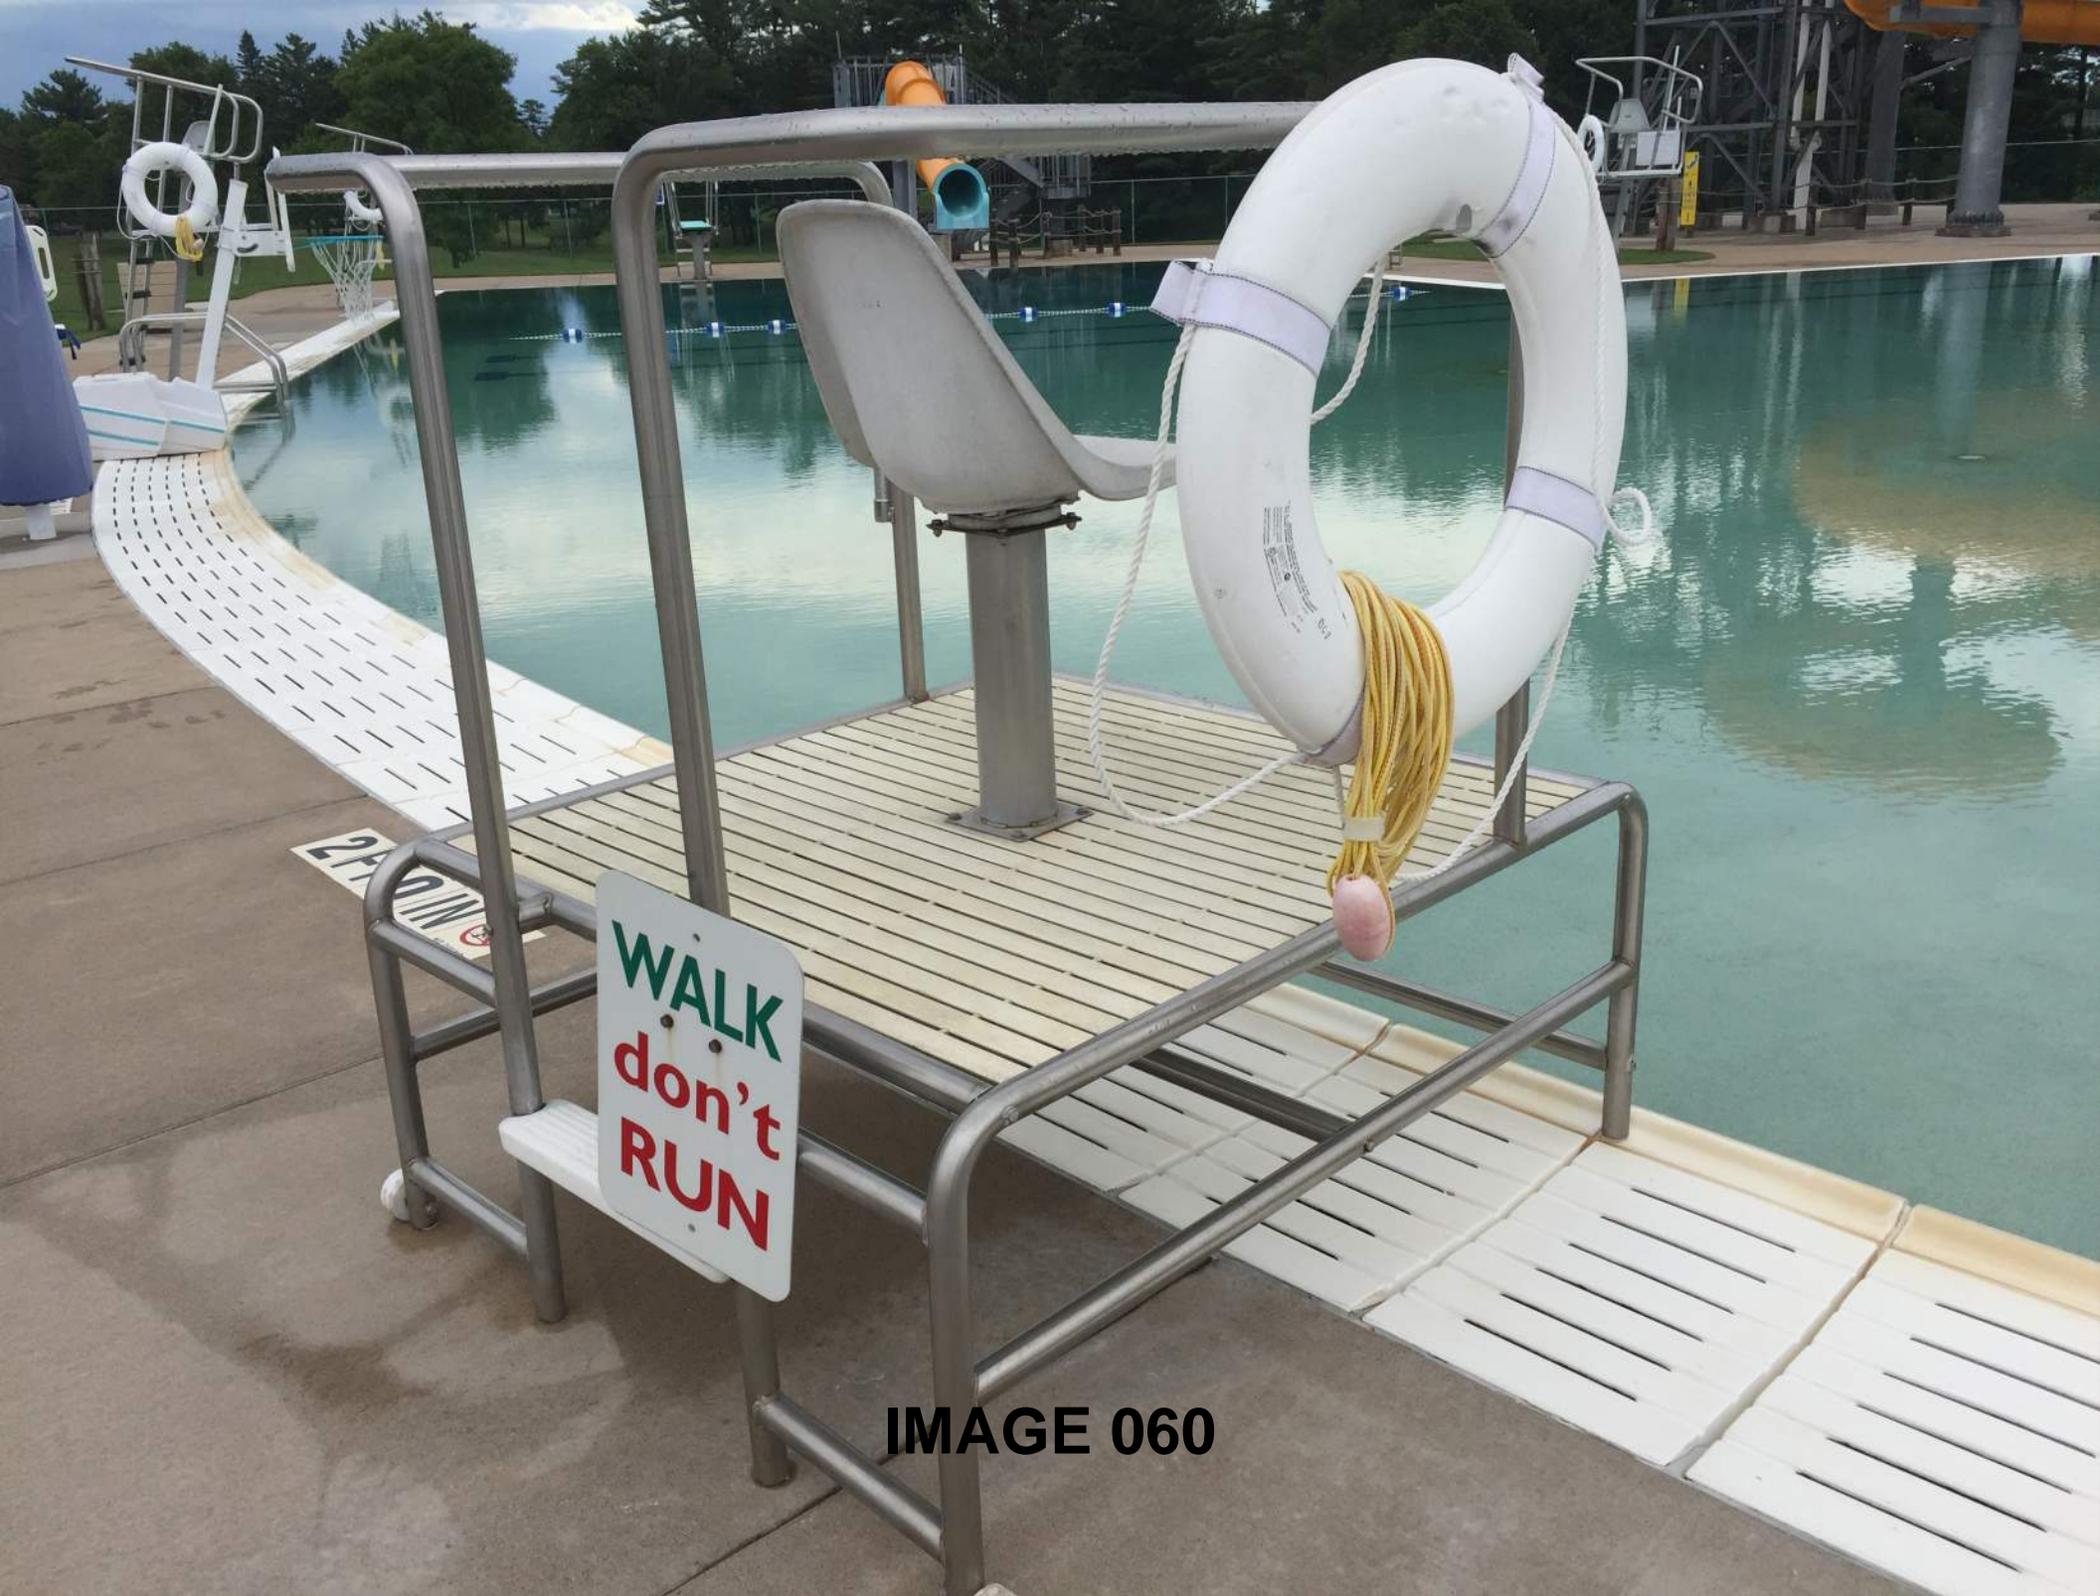
IMAGE 060

Image 060 – Low-level, mobile lifeguard station

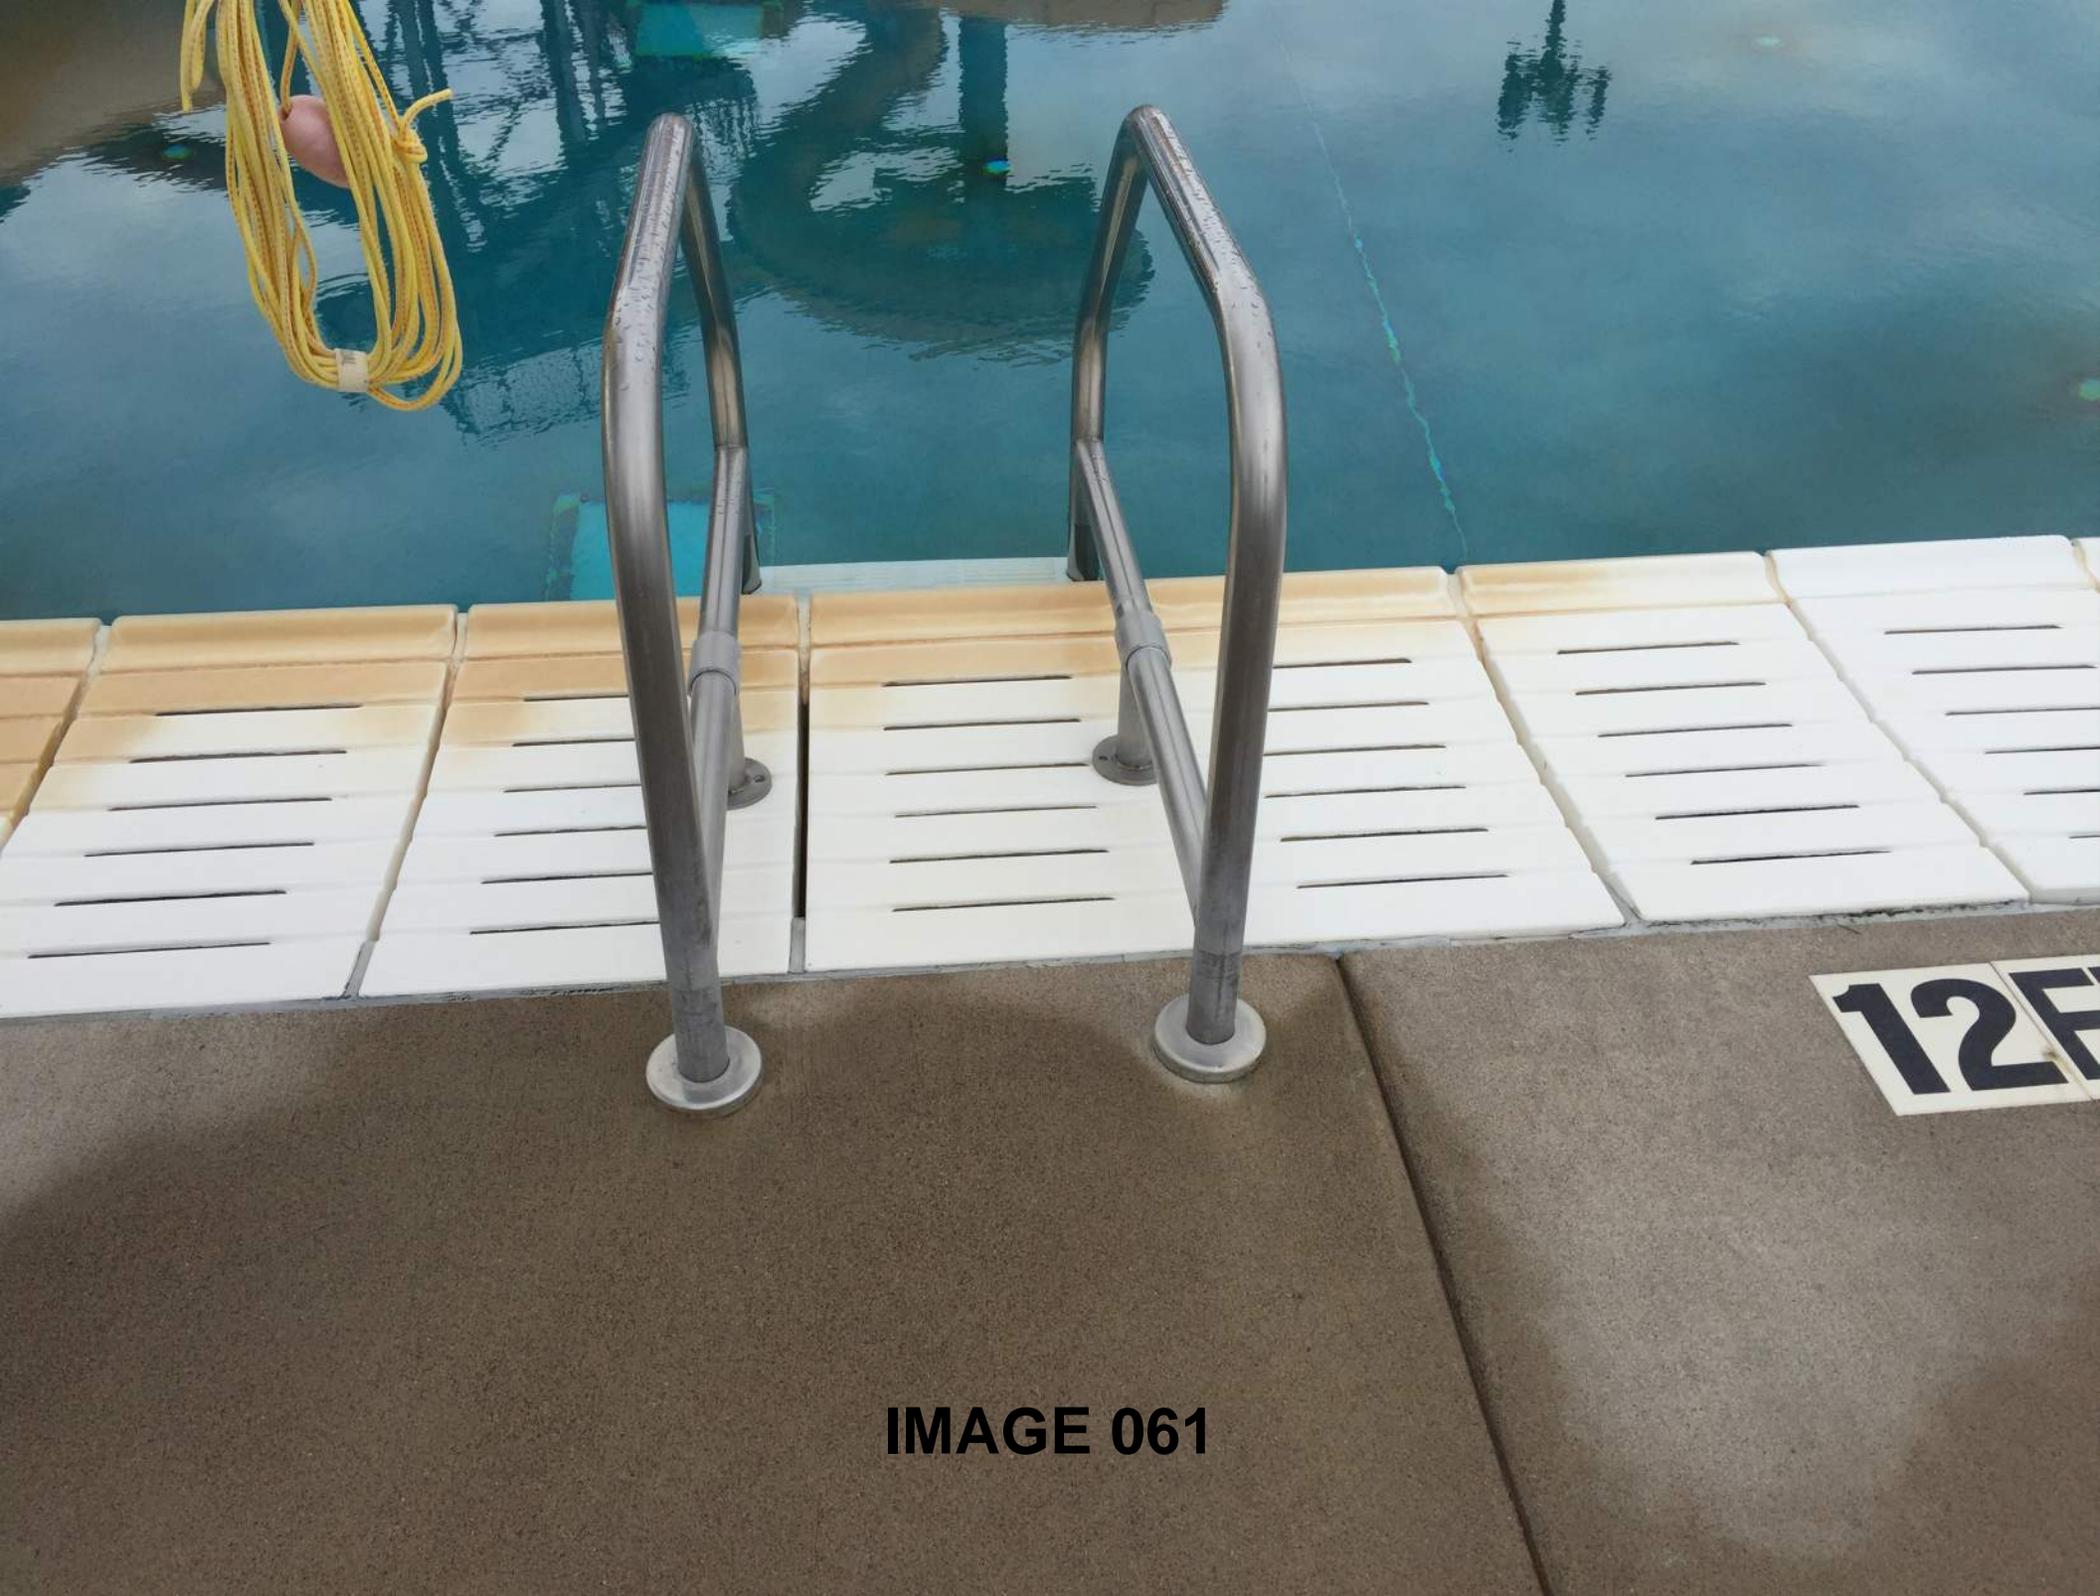
IMAGE 061

Image 061 – Handrails of pool ladder with scale formation on bottom of handrails and escutcheons

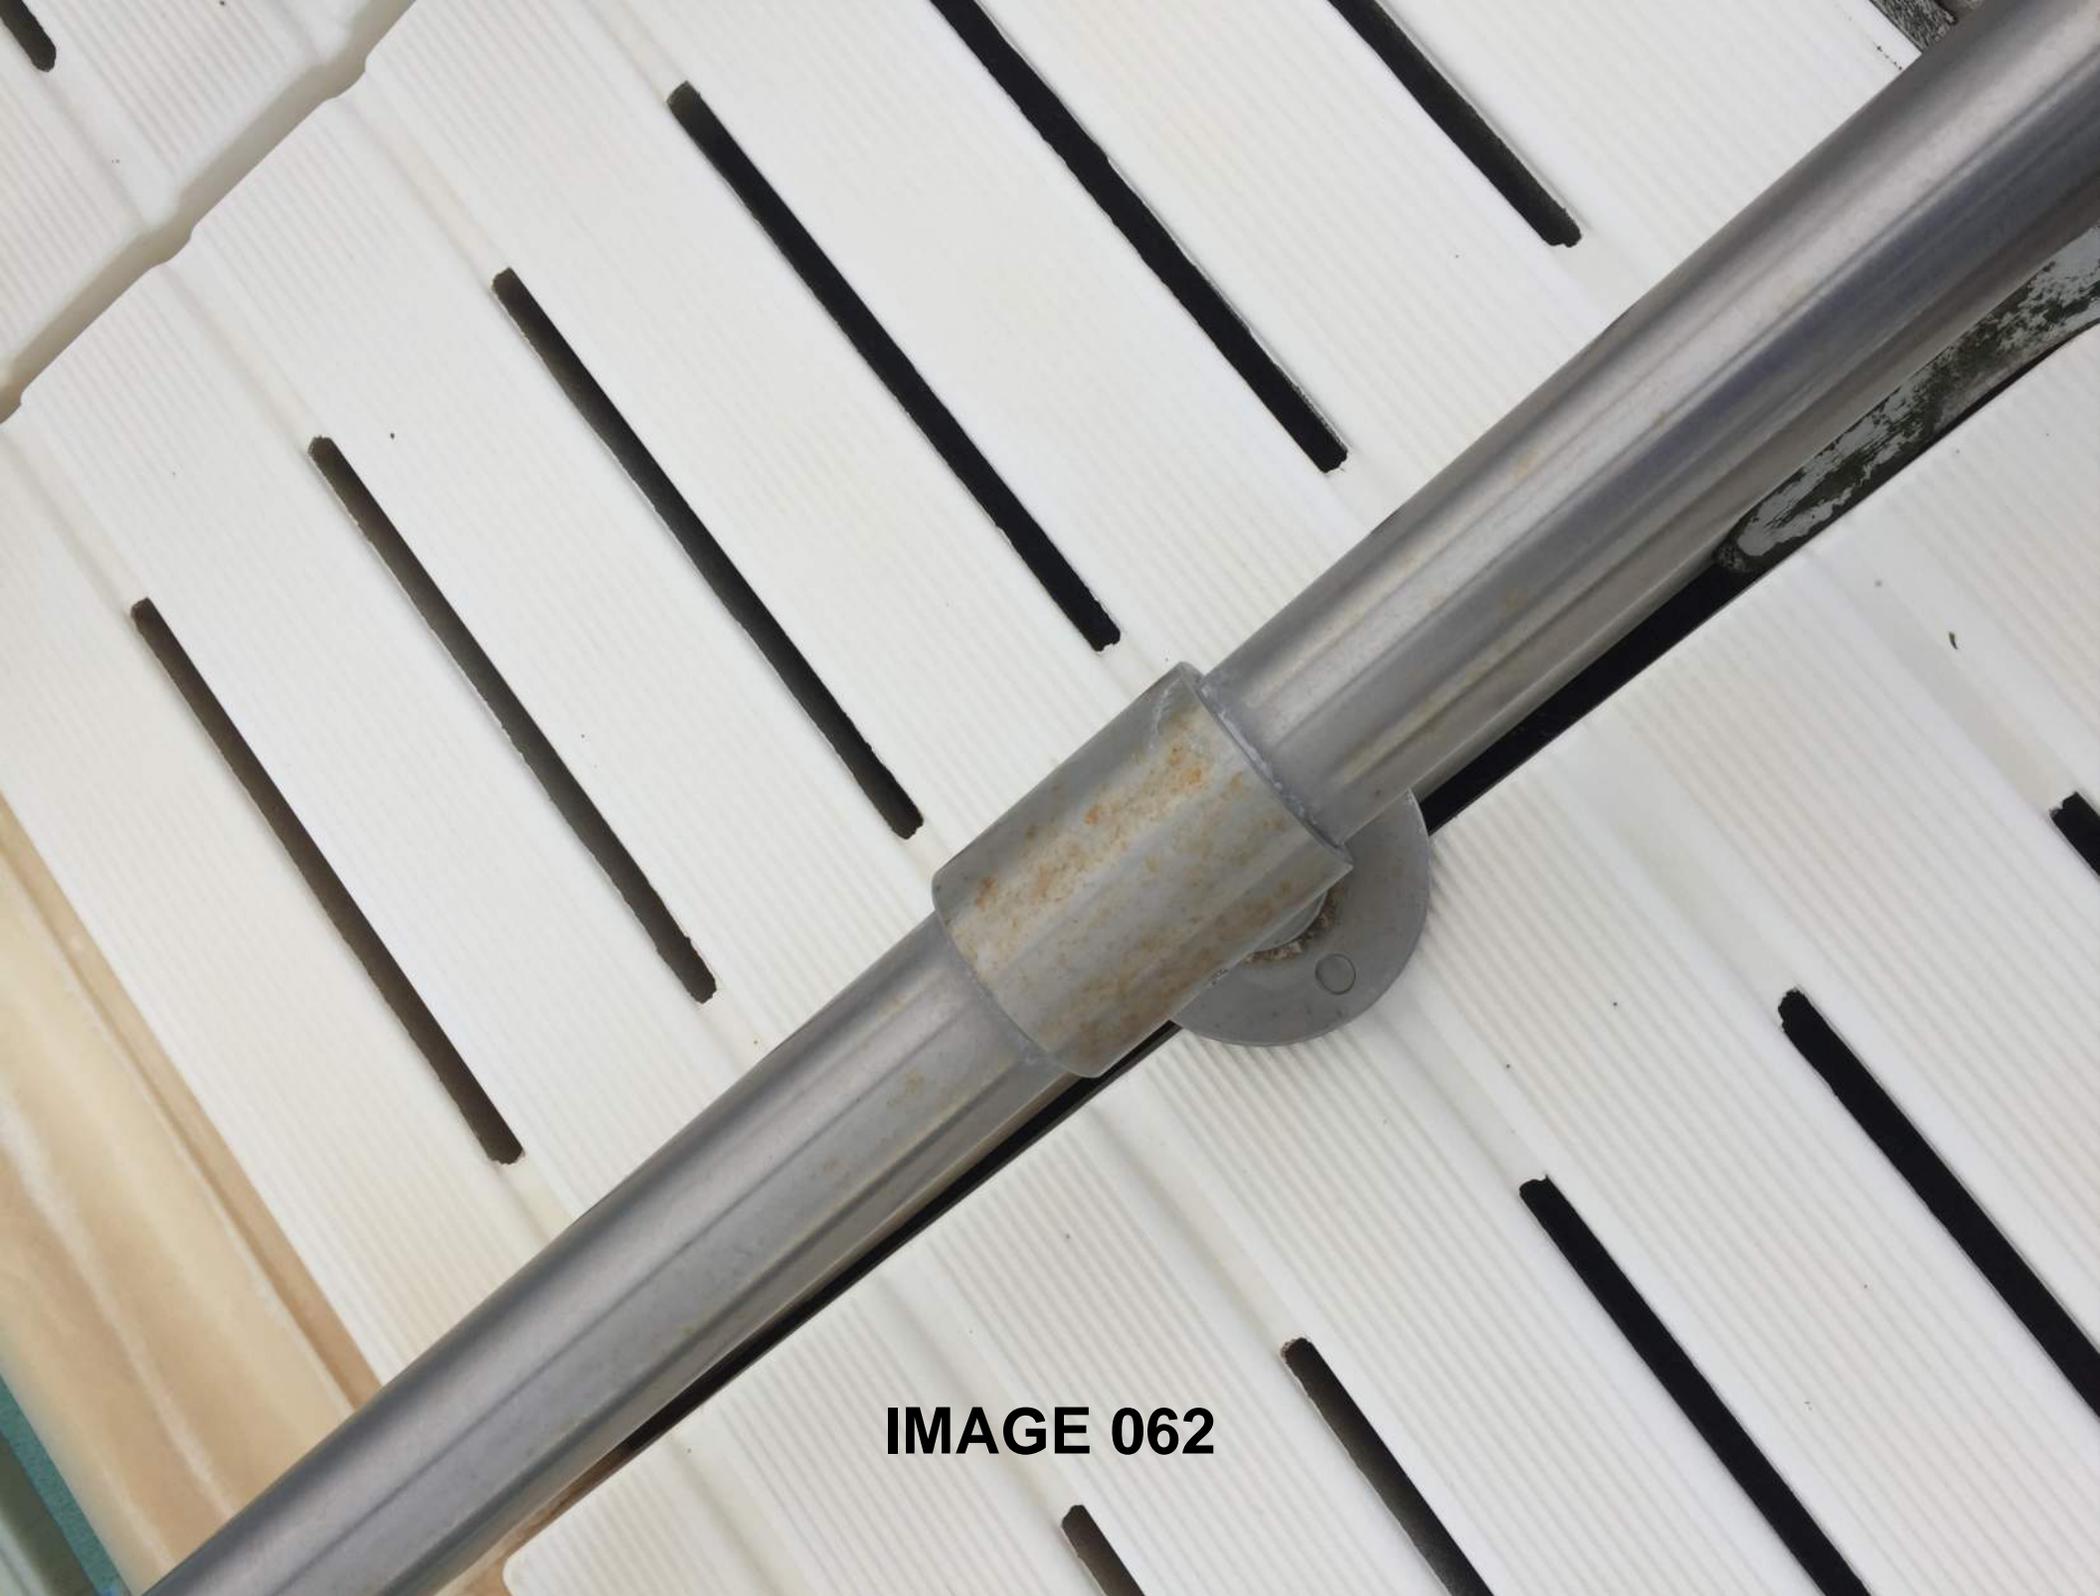
IMAGE 062

Image 062 – Rust forming on pool ladder handrail

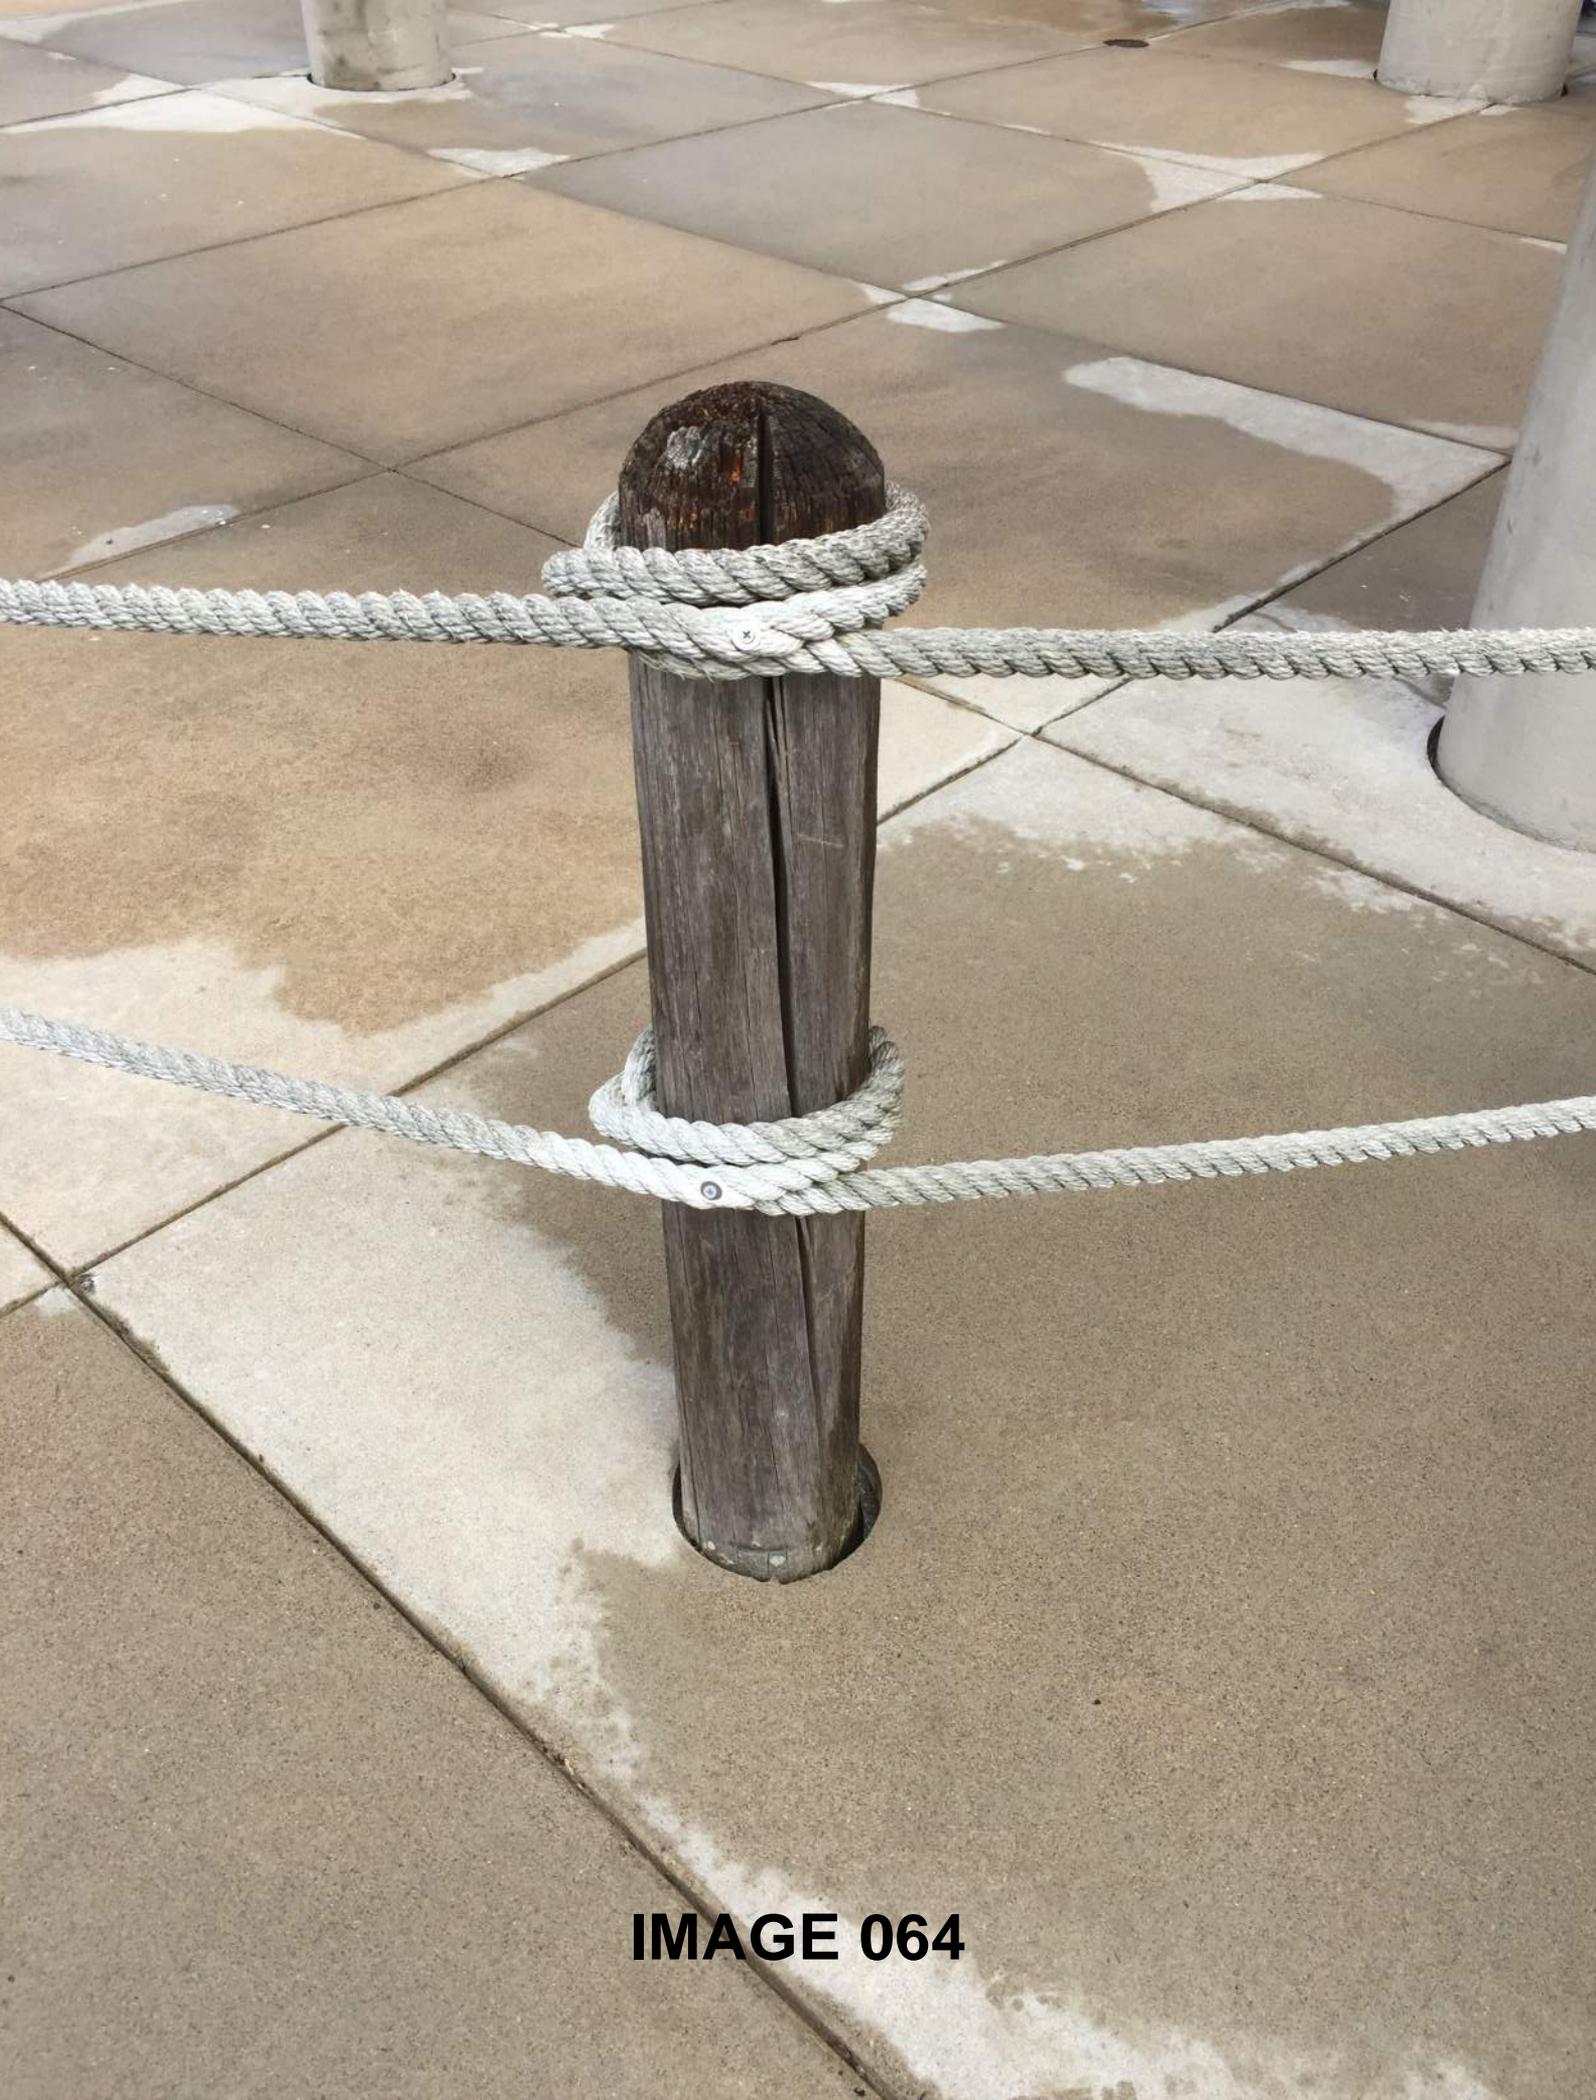
IMAGE 064

Image 064 – Post in pool deck without concrete setting

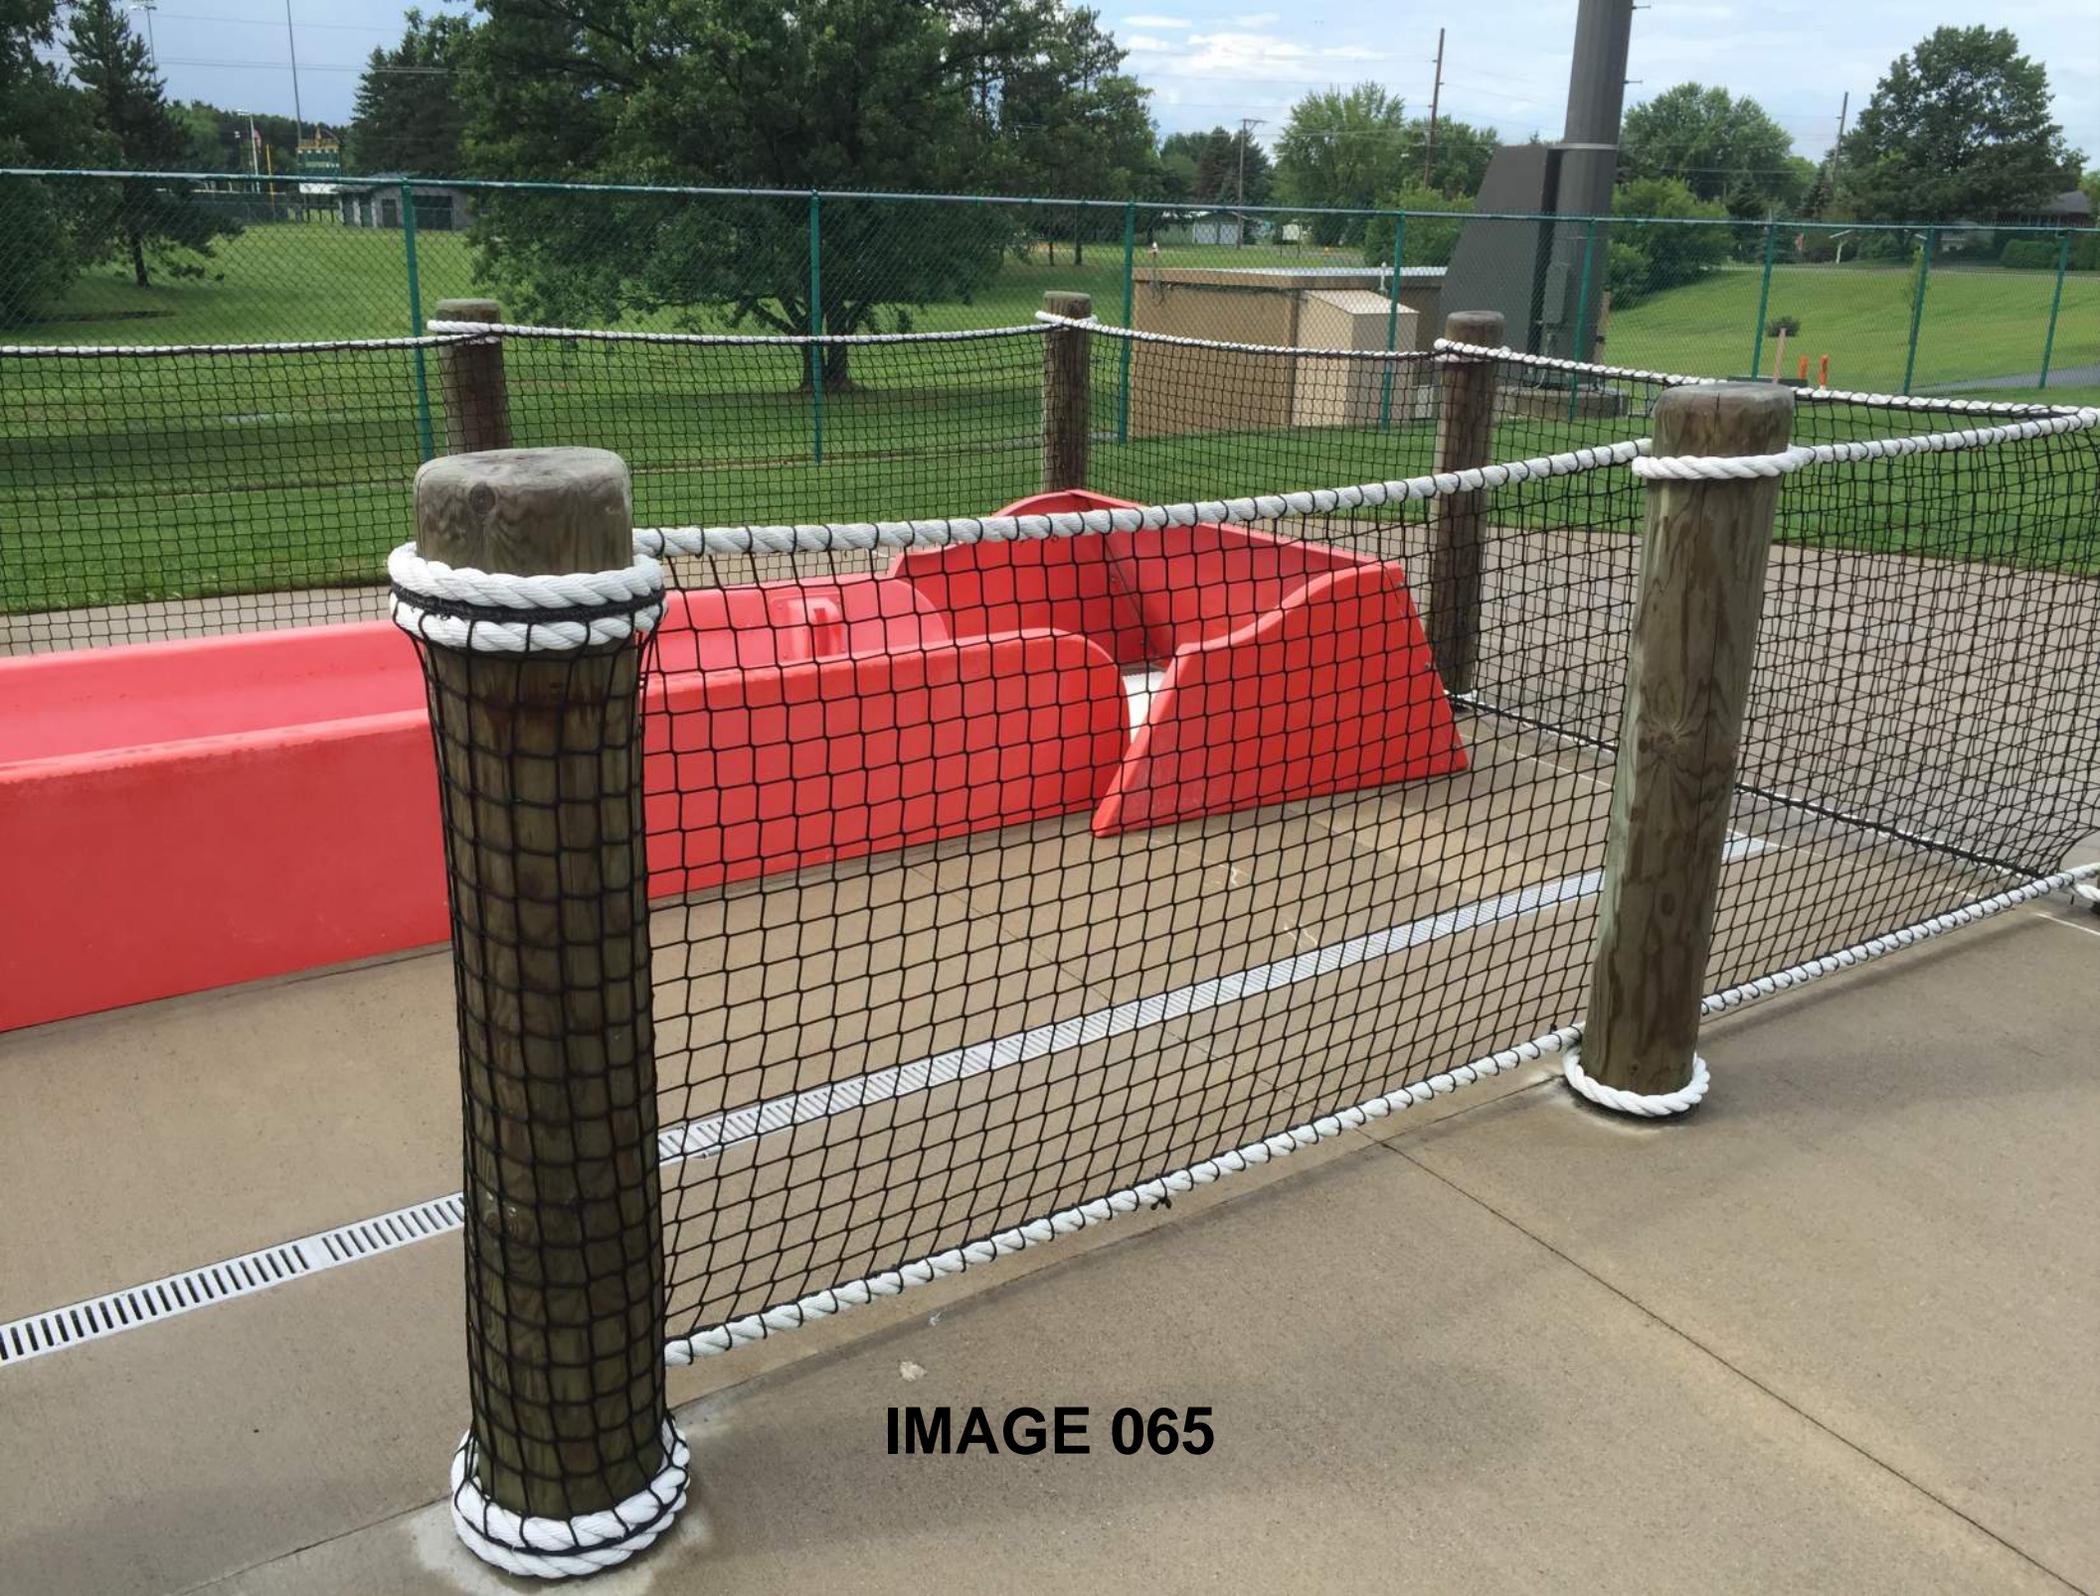
IMAGE 065

Image 065 – Post and rope barrier with additional netting

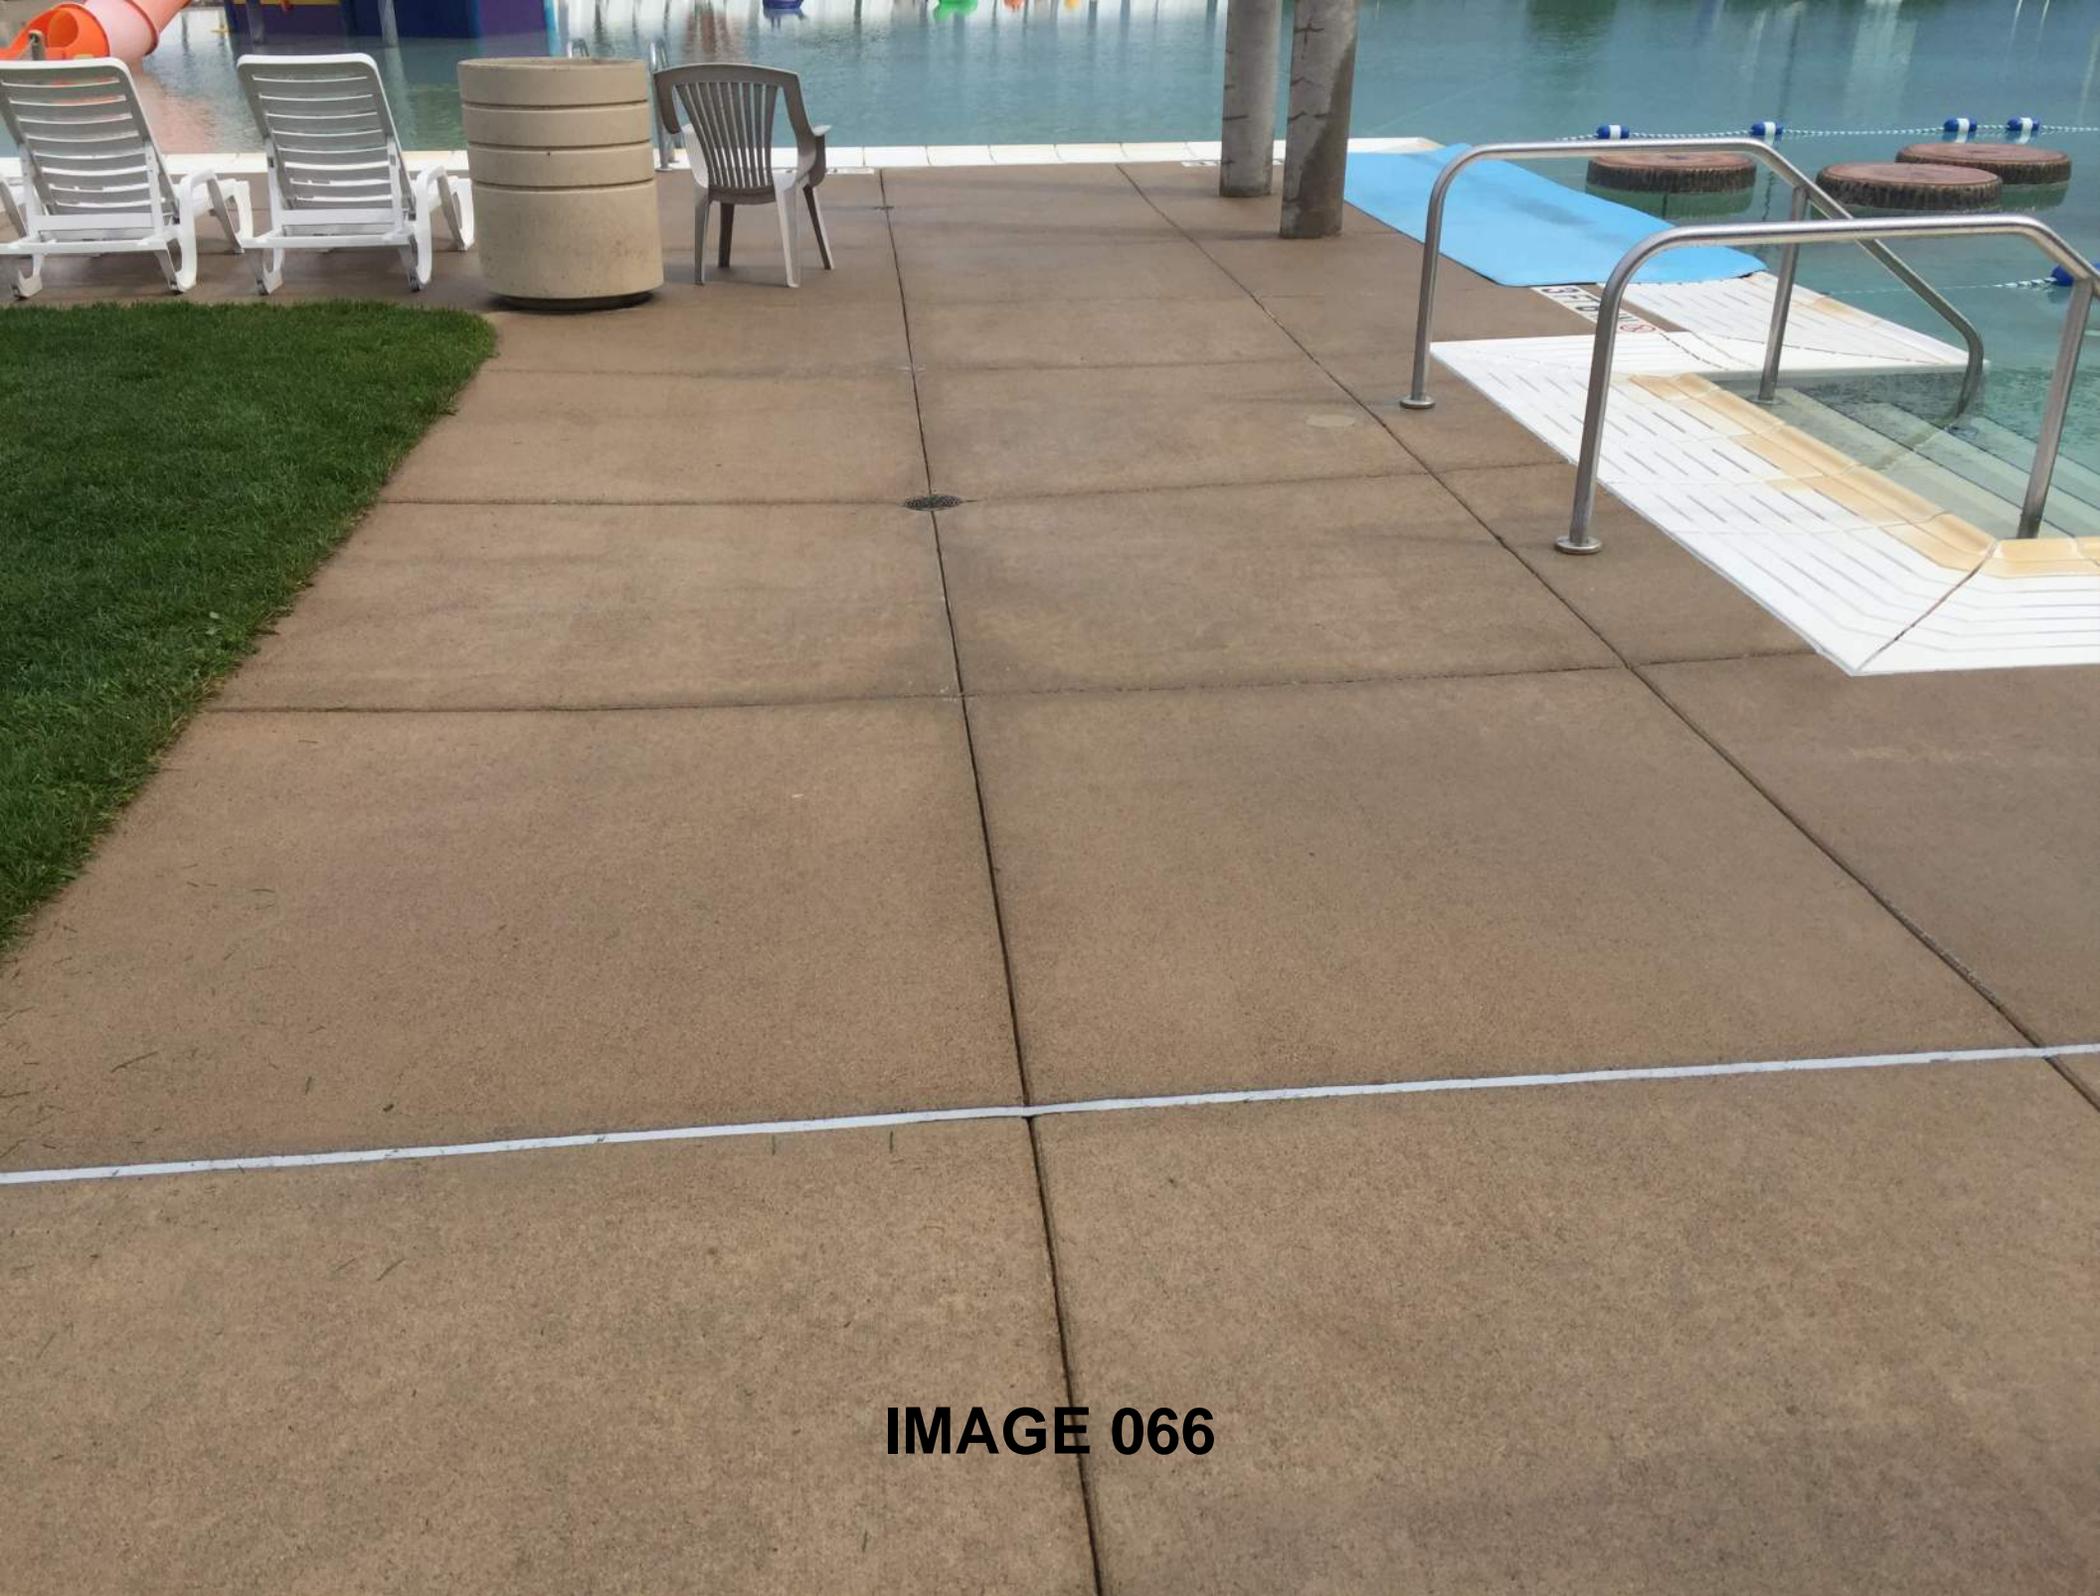
IMAGE 066

Image 066 – Pool deck with spot drain and rectangular scoring pattern
