Aquatic Facility Evaluation

Weston Aquatic Center
Weston, Wisconsin

September 14, 2016

Water Technology, Inc. (WTI)
100 Park Avenue, PO Box 614
Beaver Dam, WI 53916
www.wtiworld.com

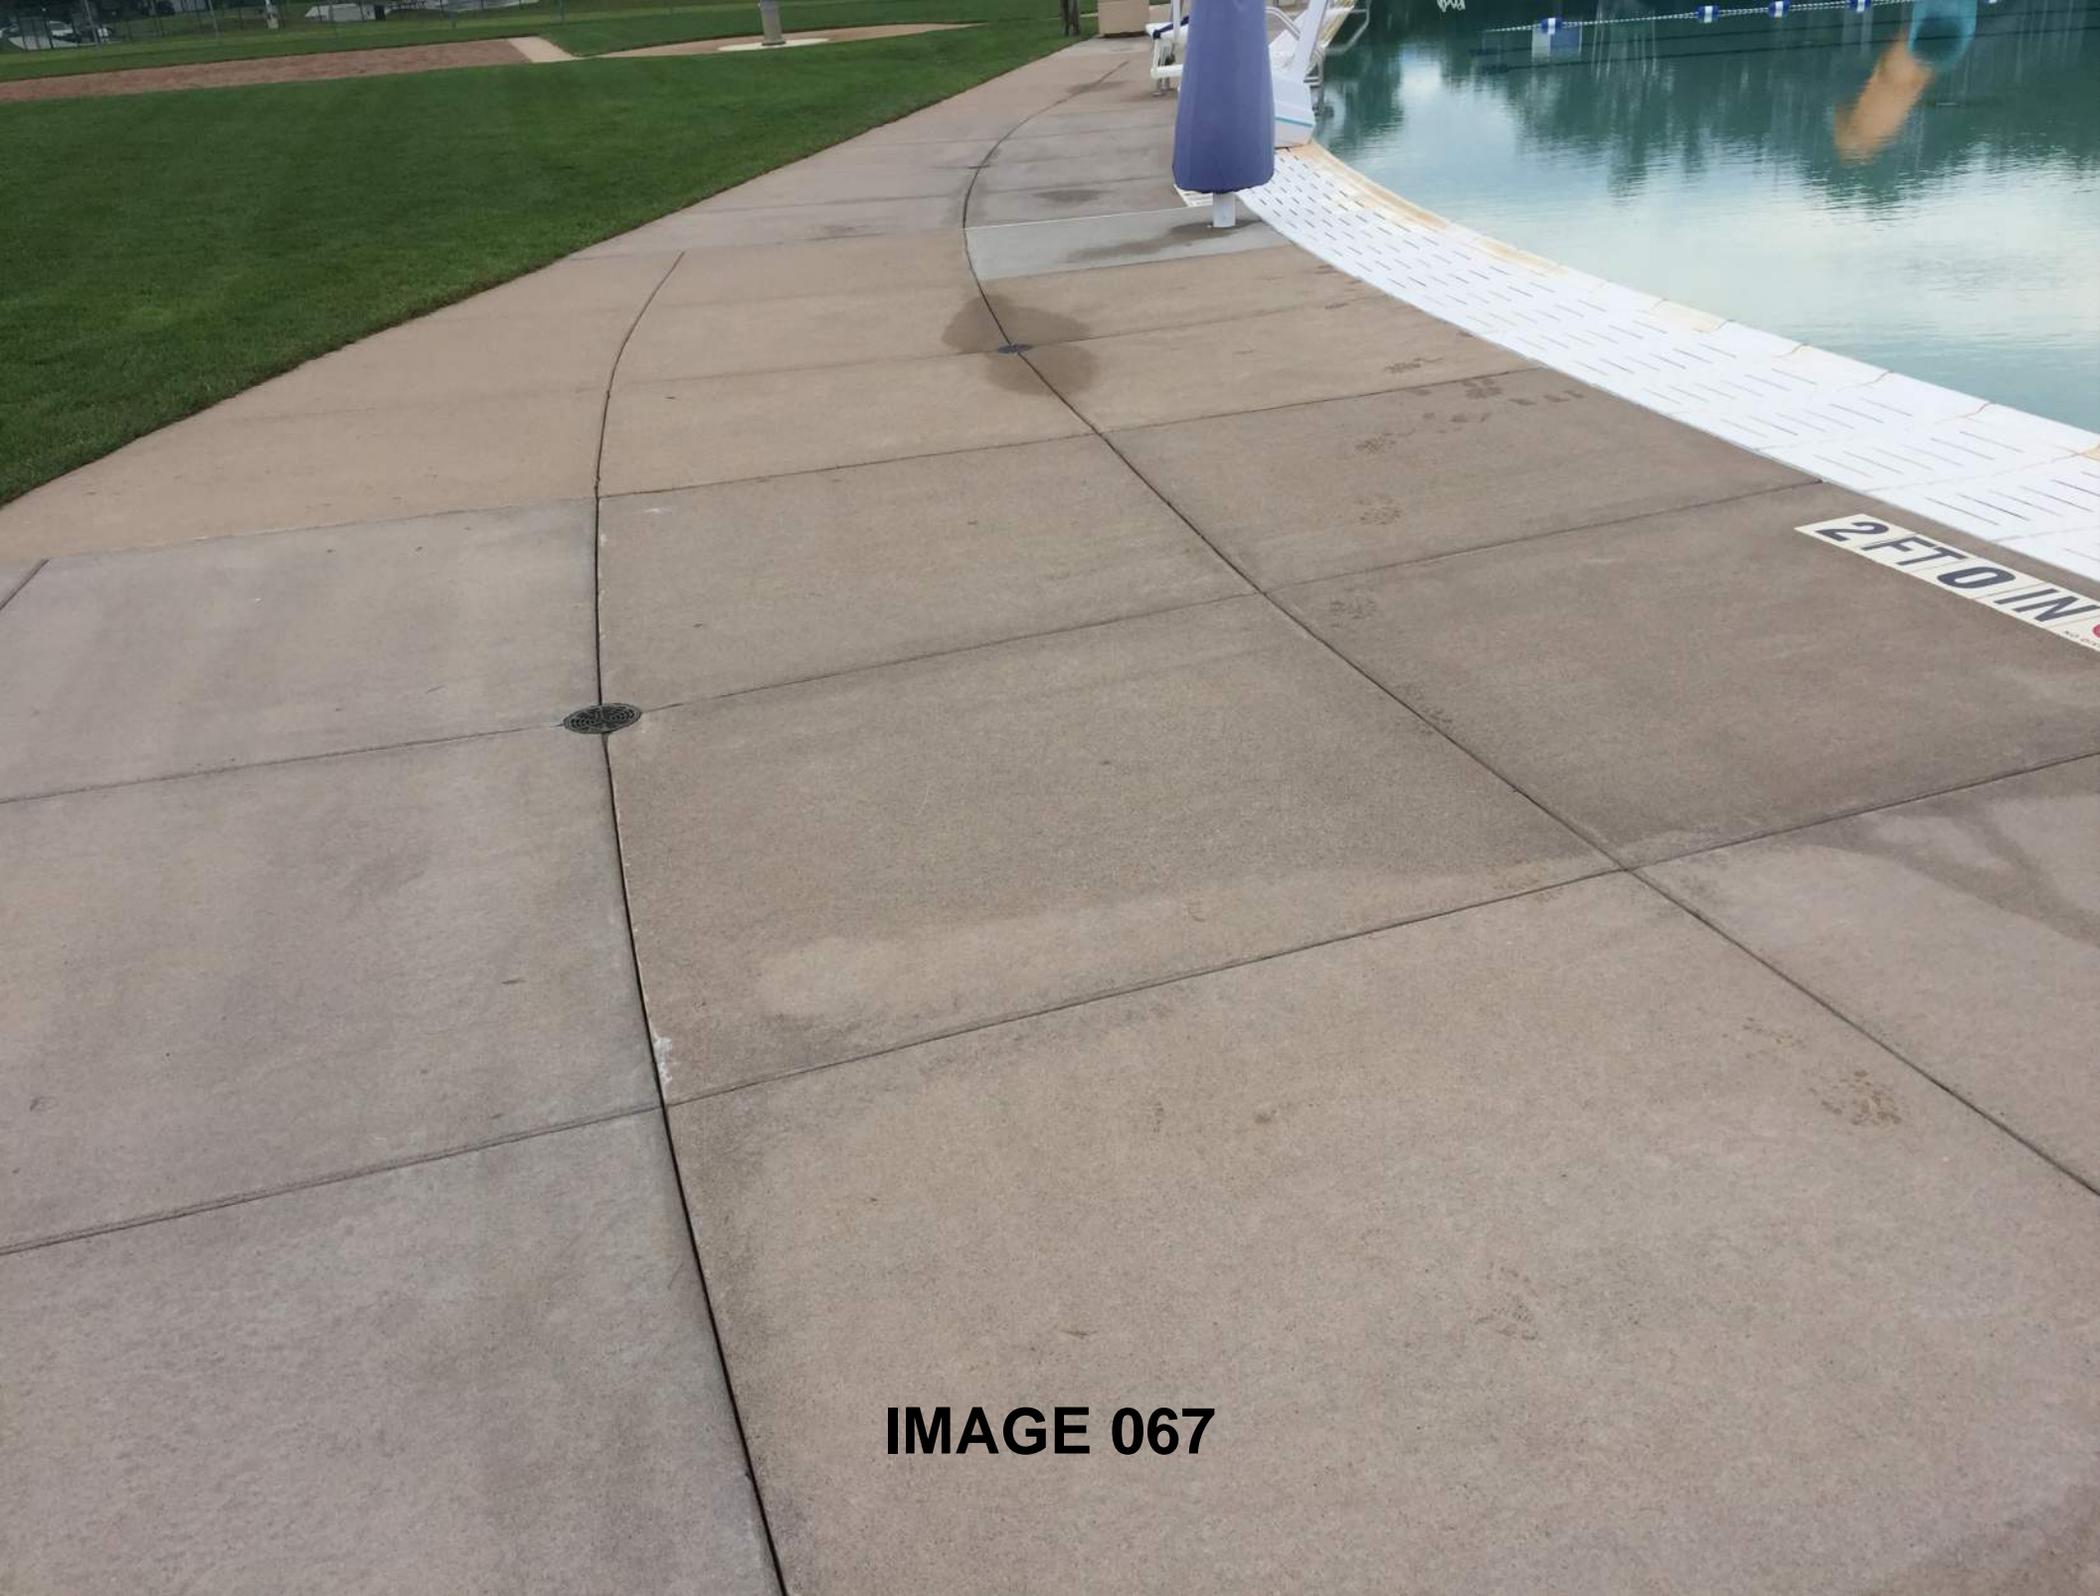
IMAGE 067

Image 067 – Pool deck with spot drain and rectangular/radial scoring pattern

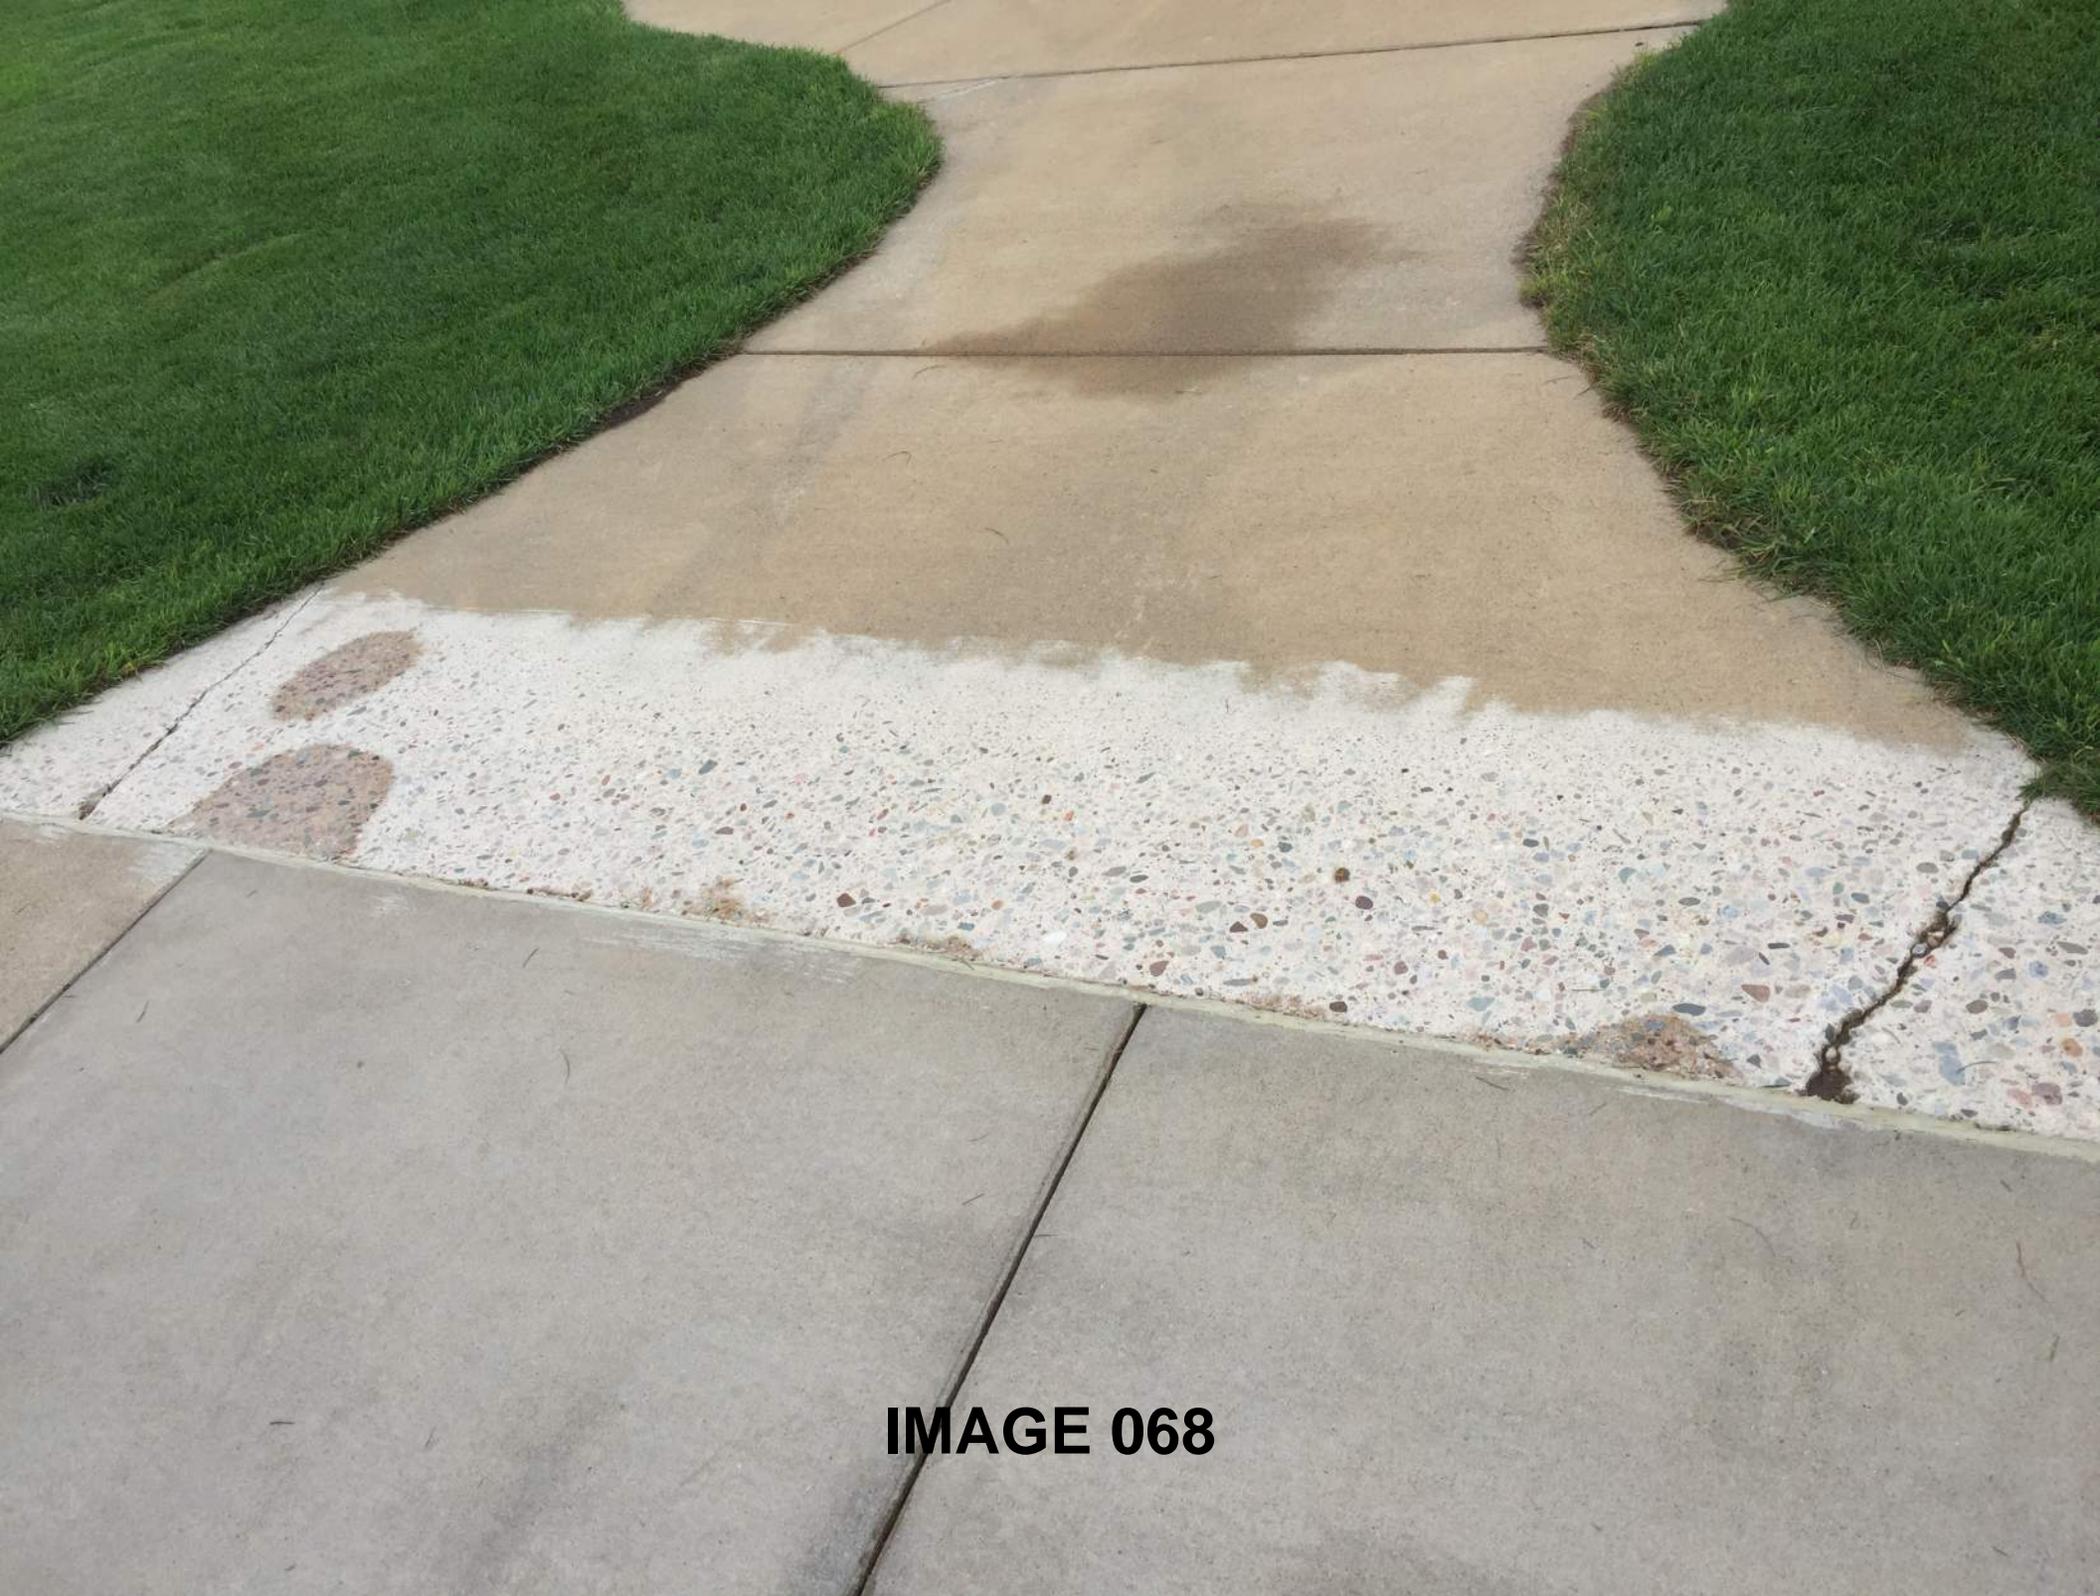
IMAGE 068

Image 068 – Grinded area of walkway to eliminate tripping hazard

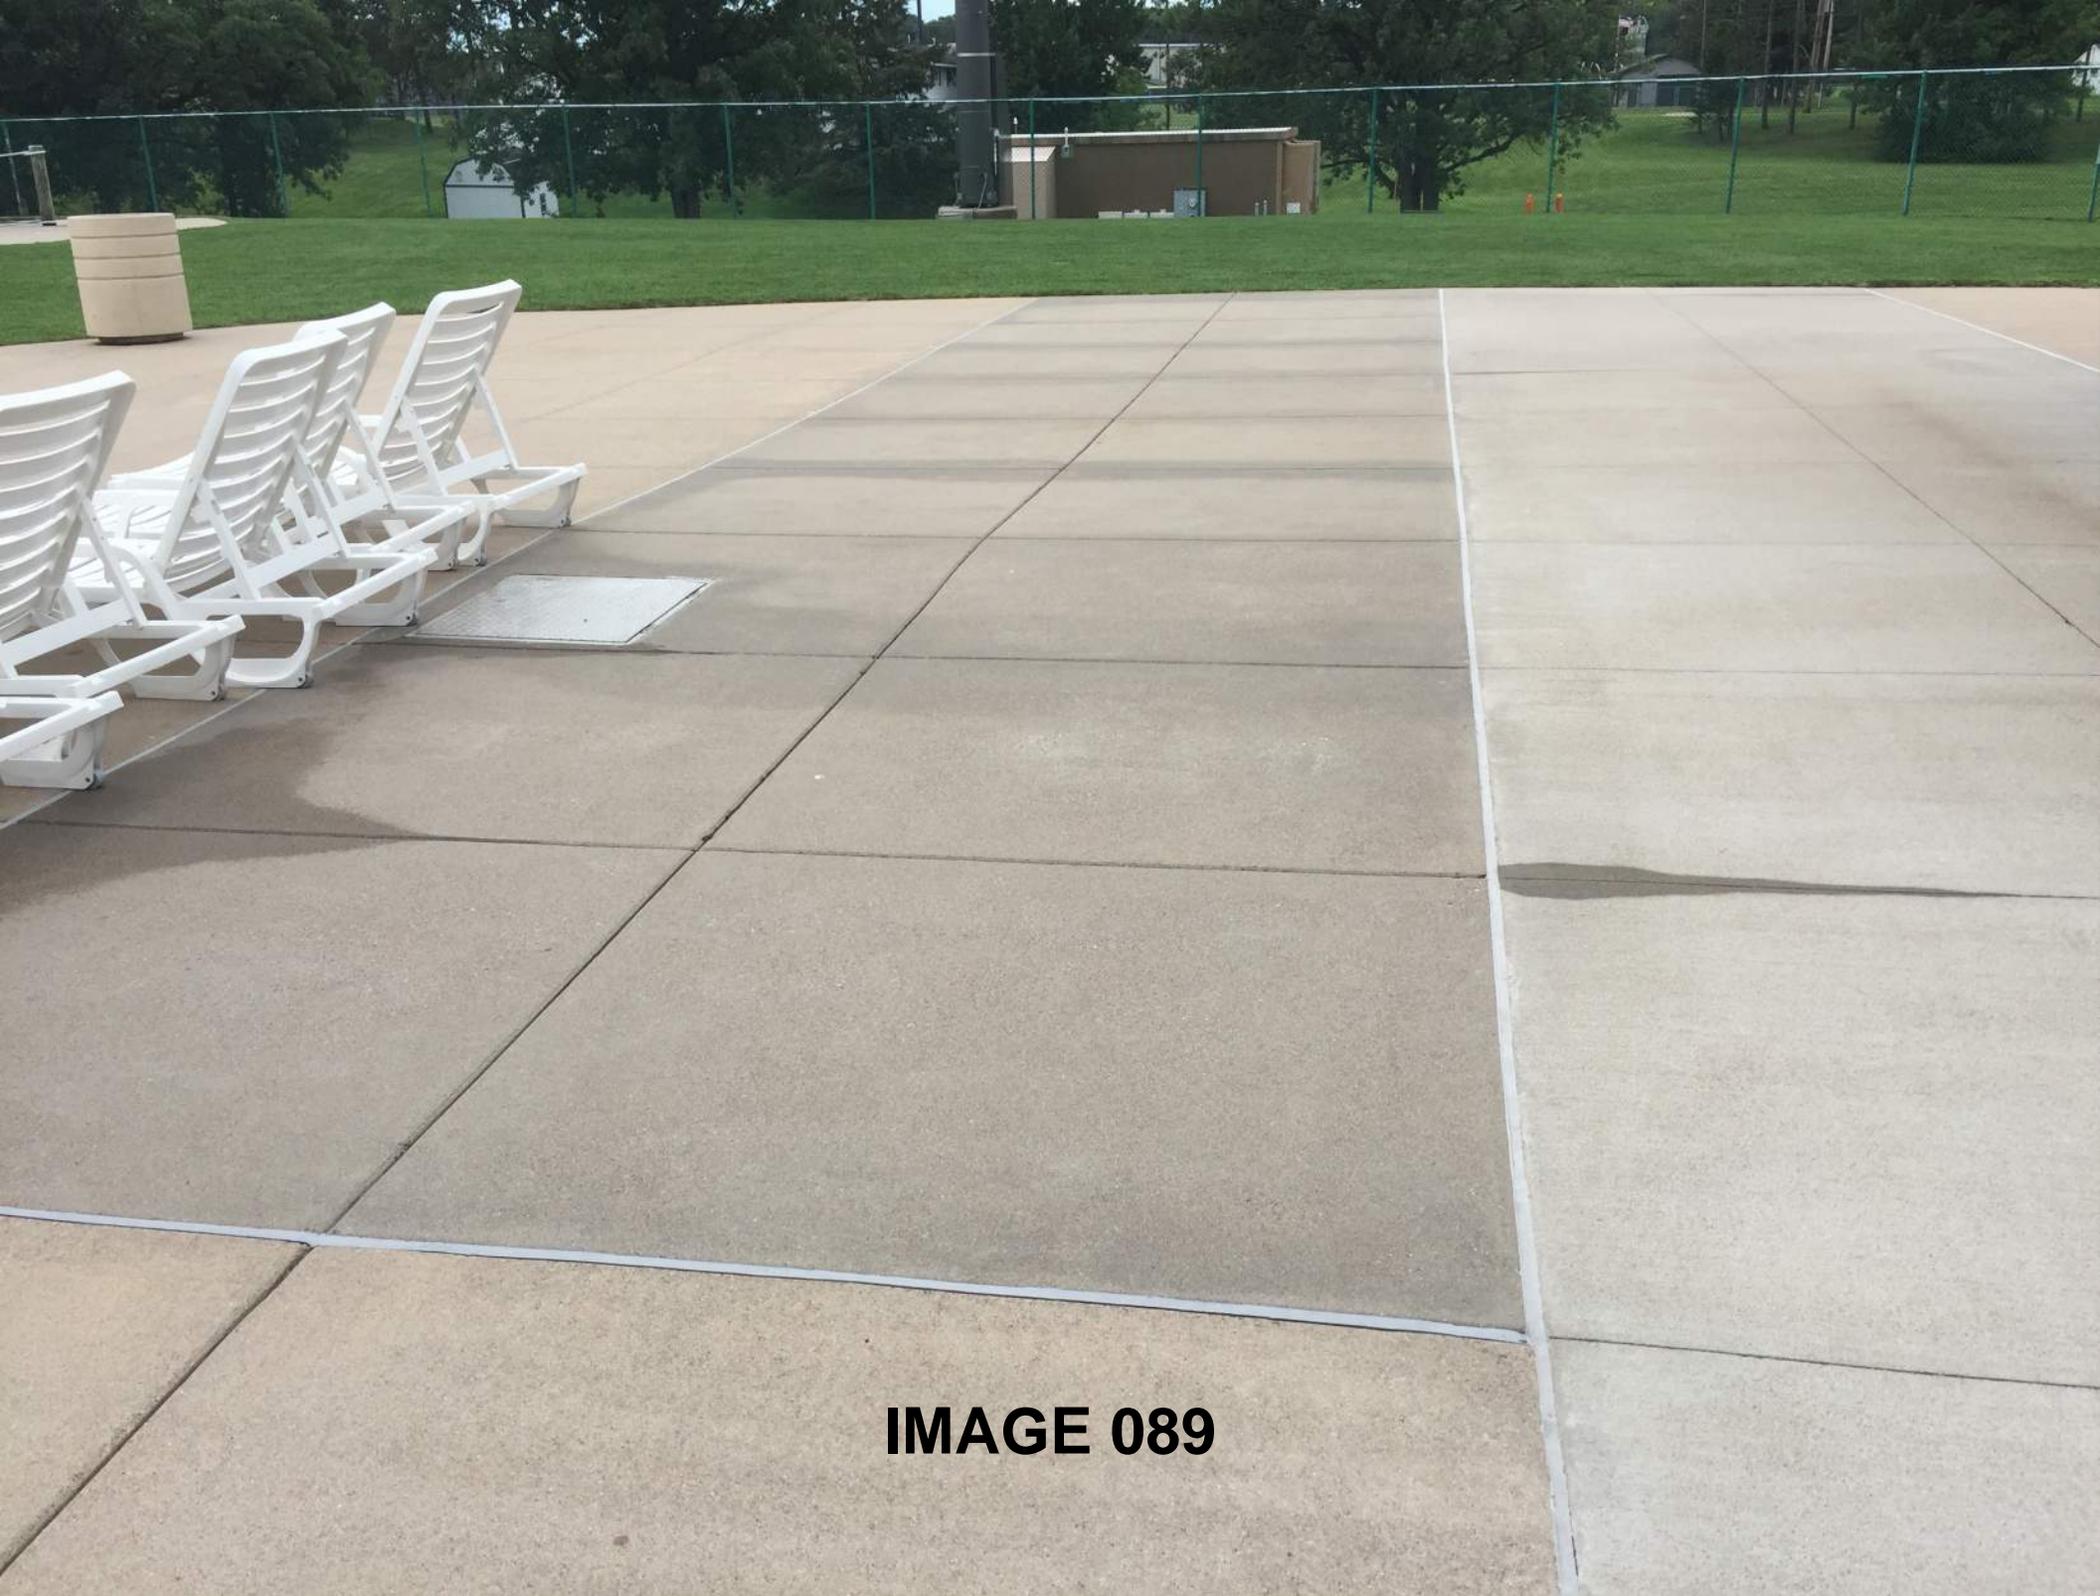
IMAGE 088

Image 088 – VFD and VFD control panel

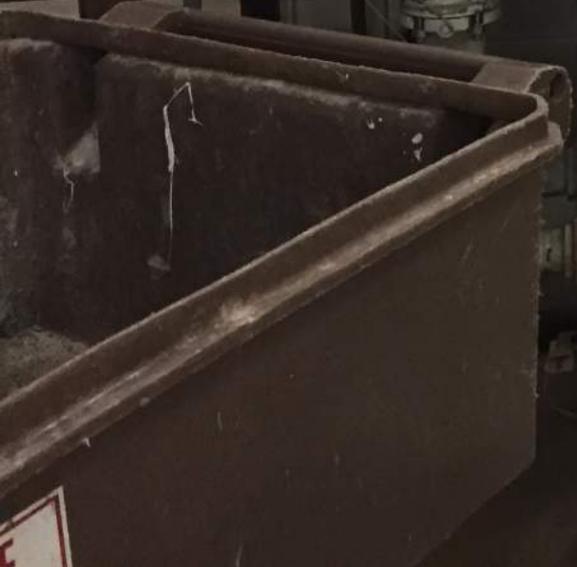
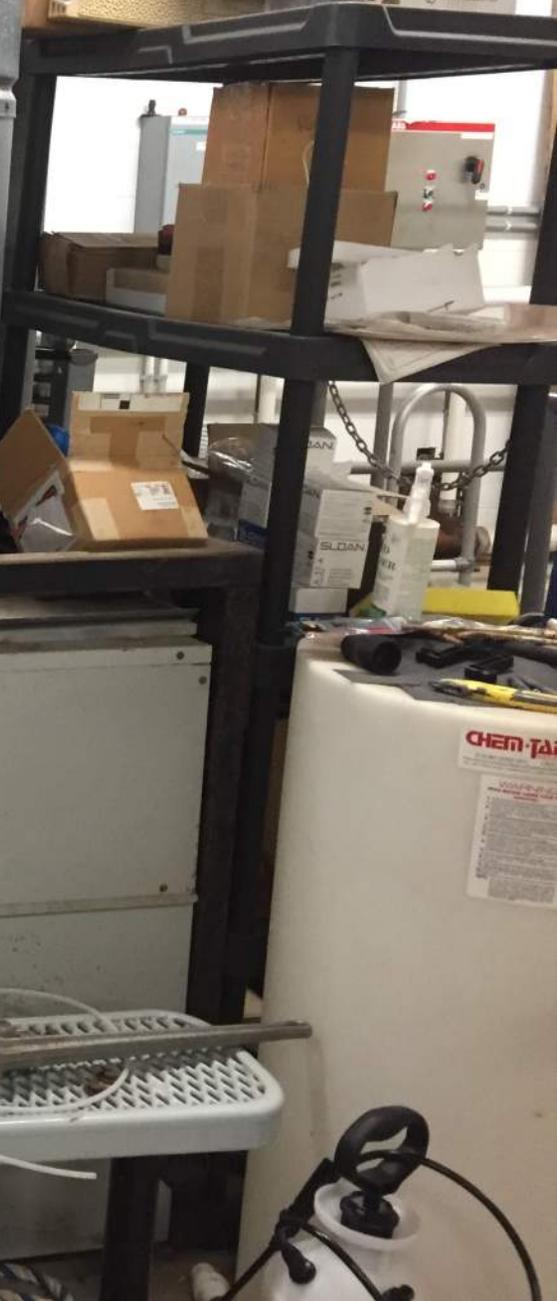
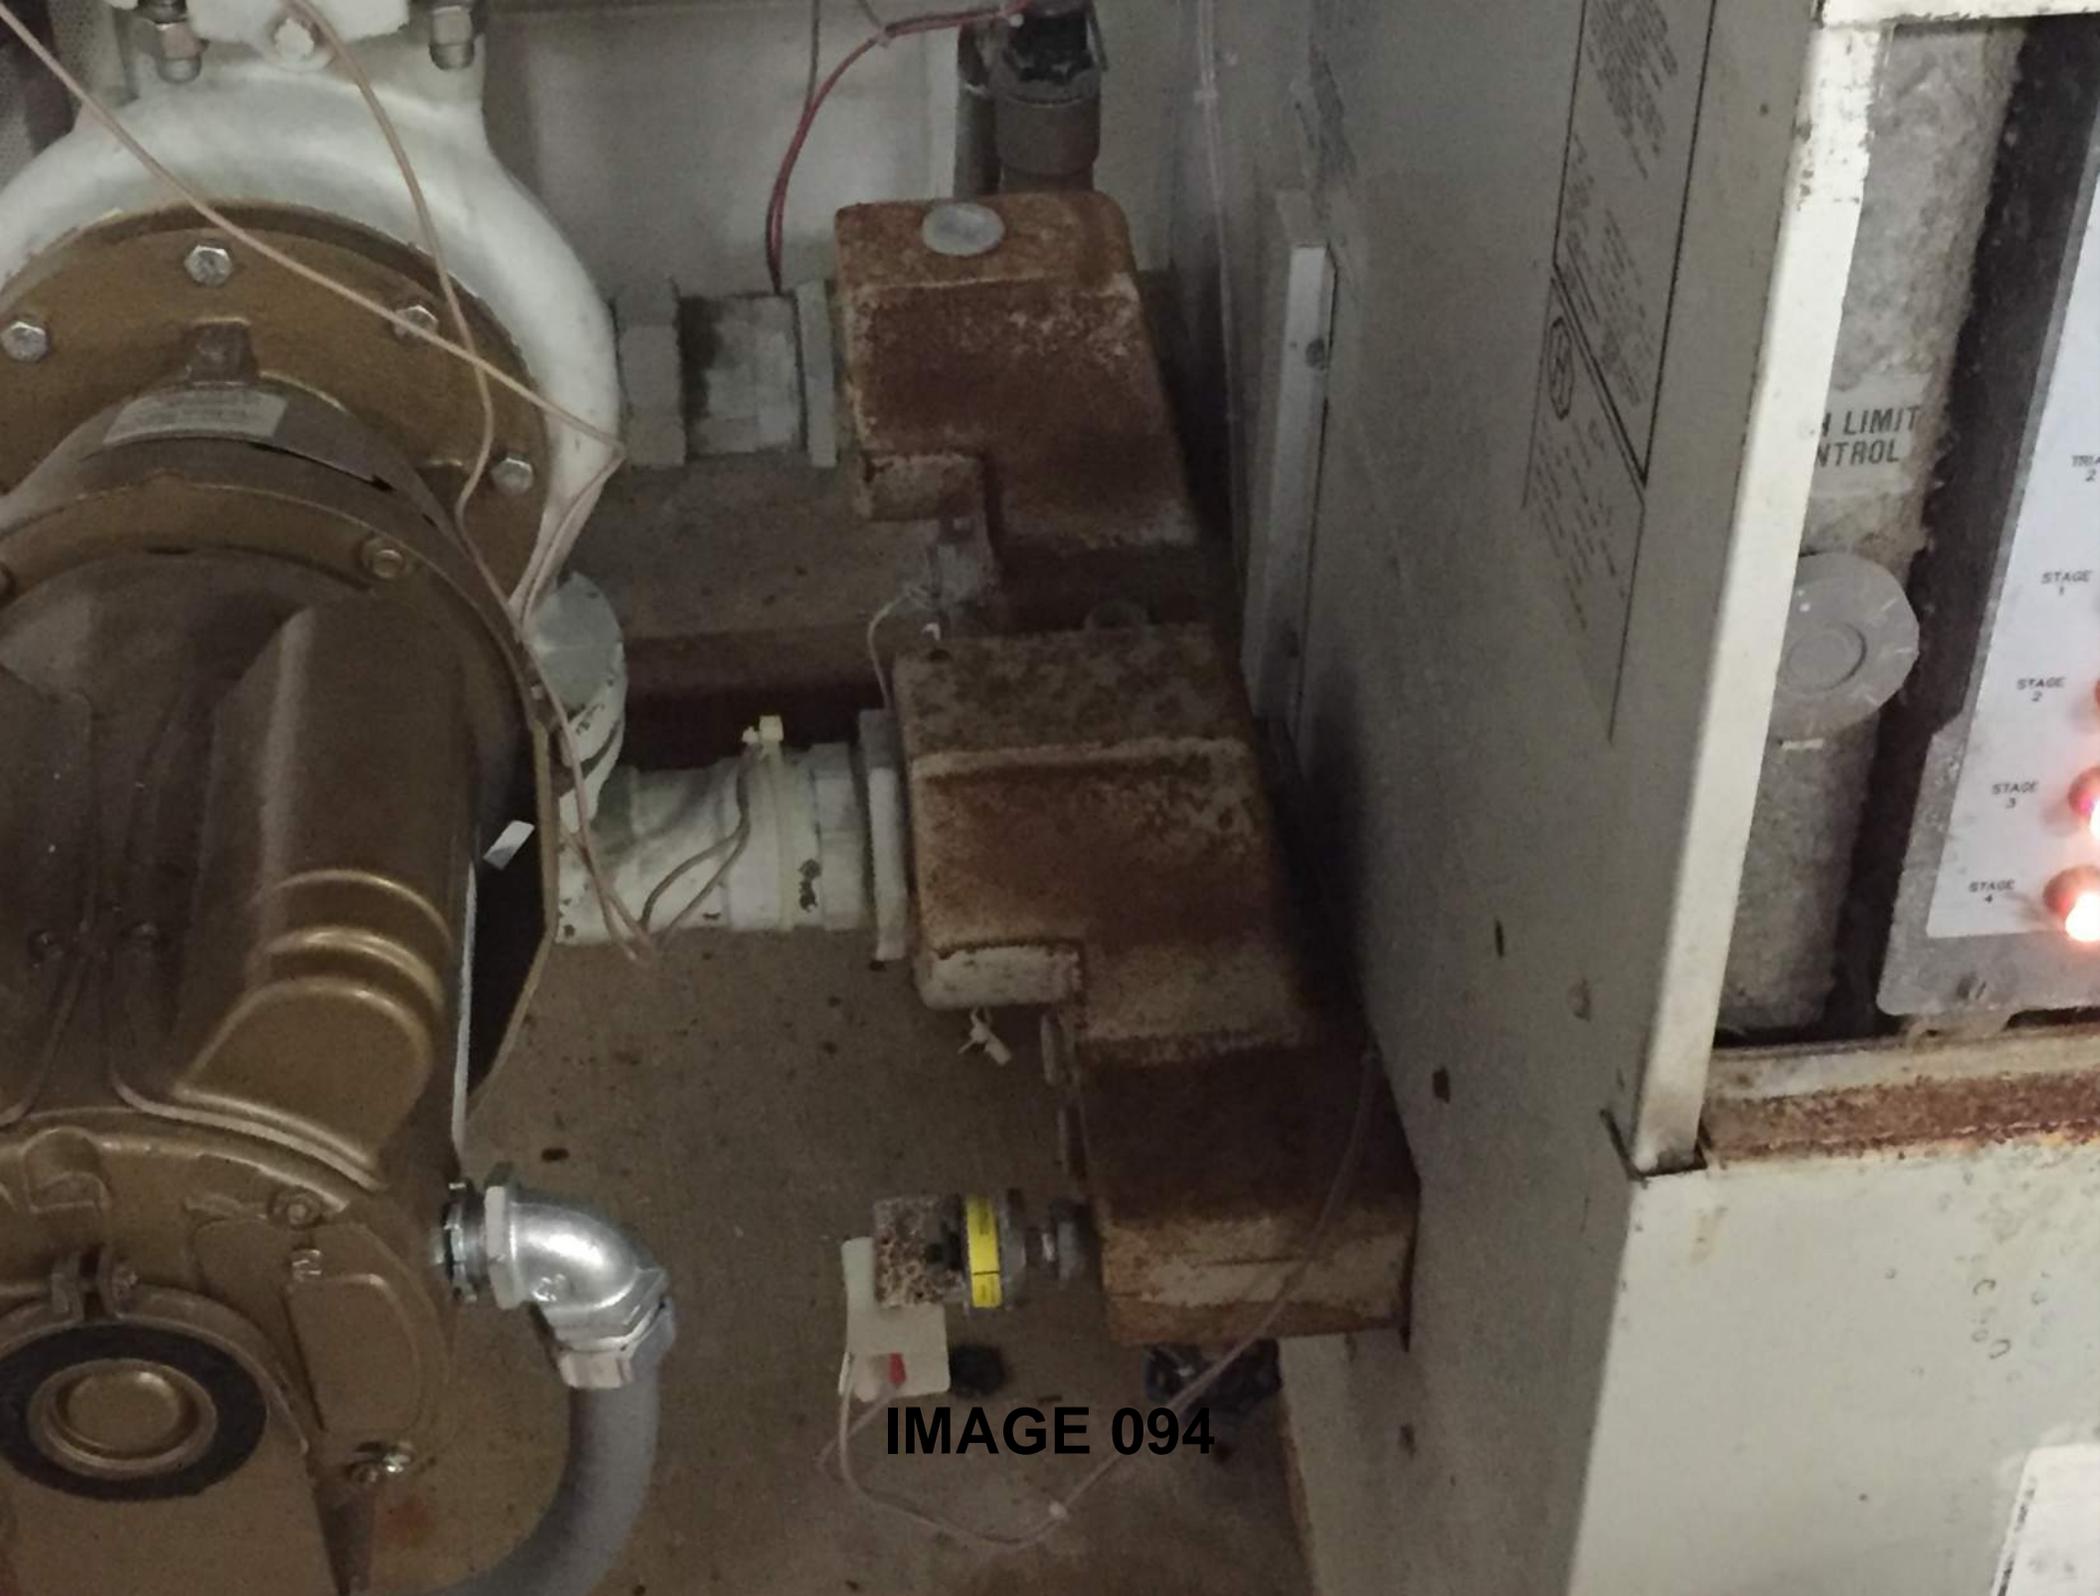
IMAGE 093

Image 093 – Pool heaters stacked for space savings

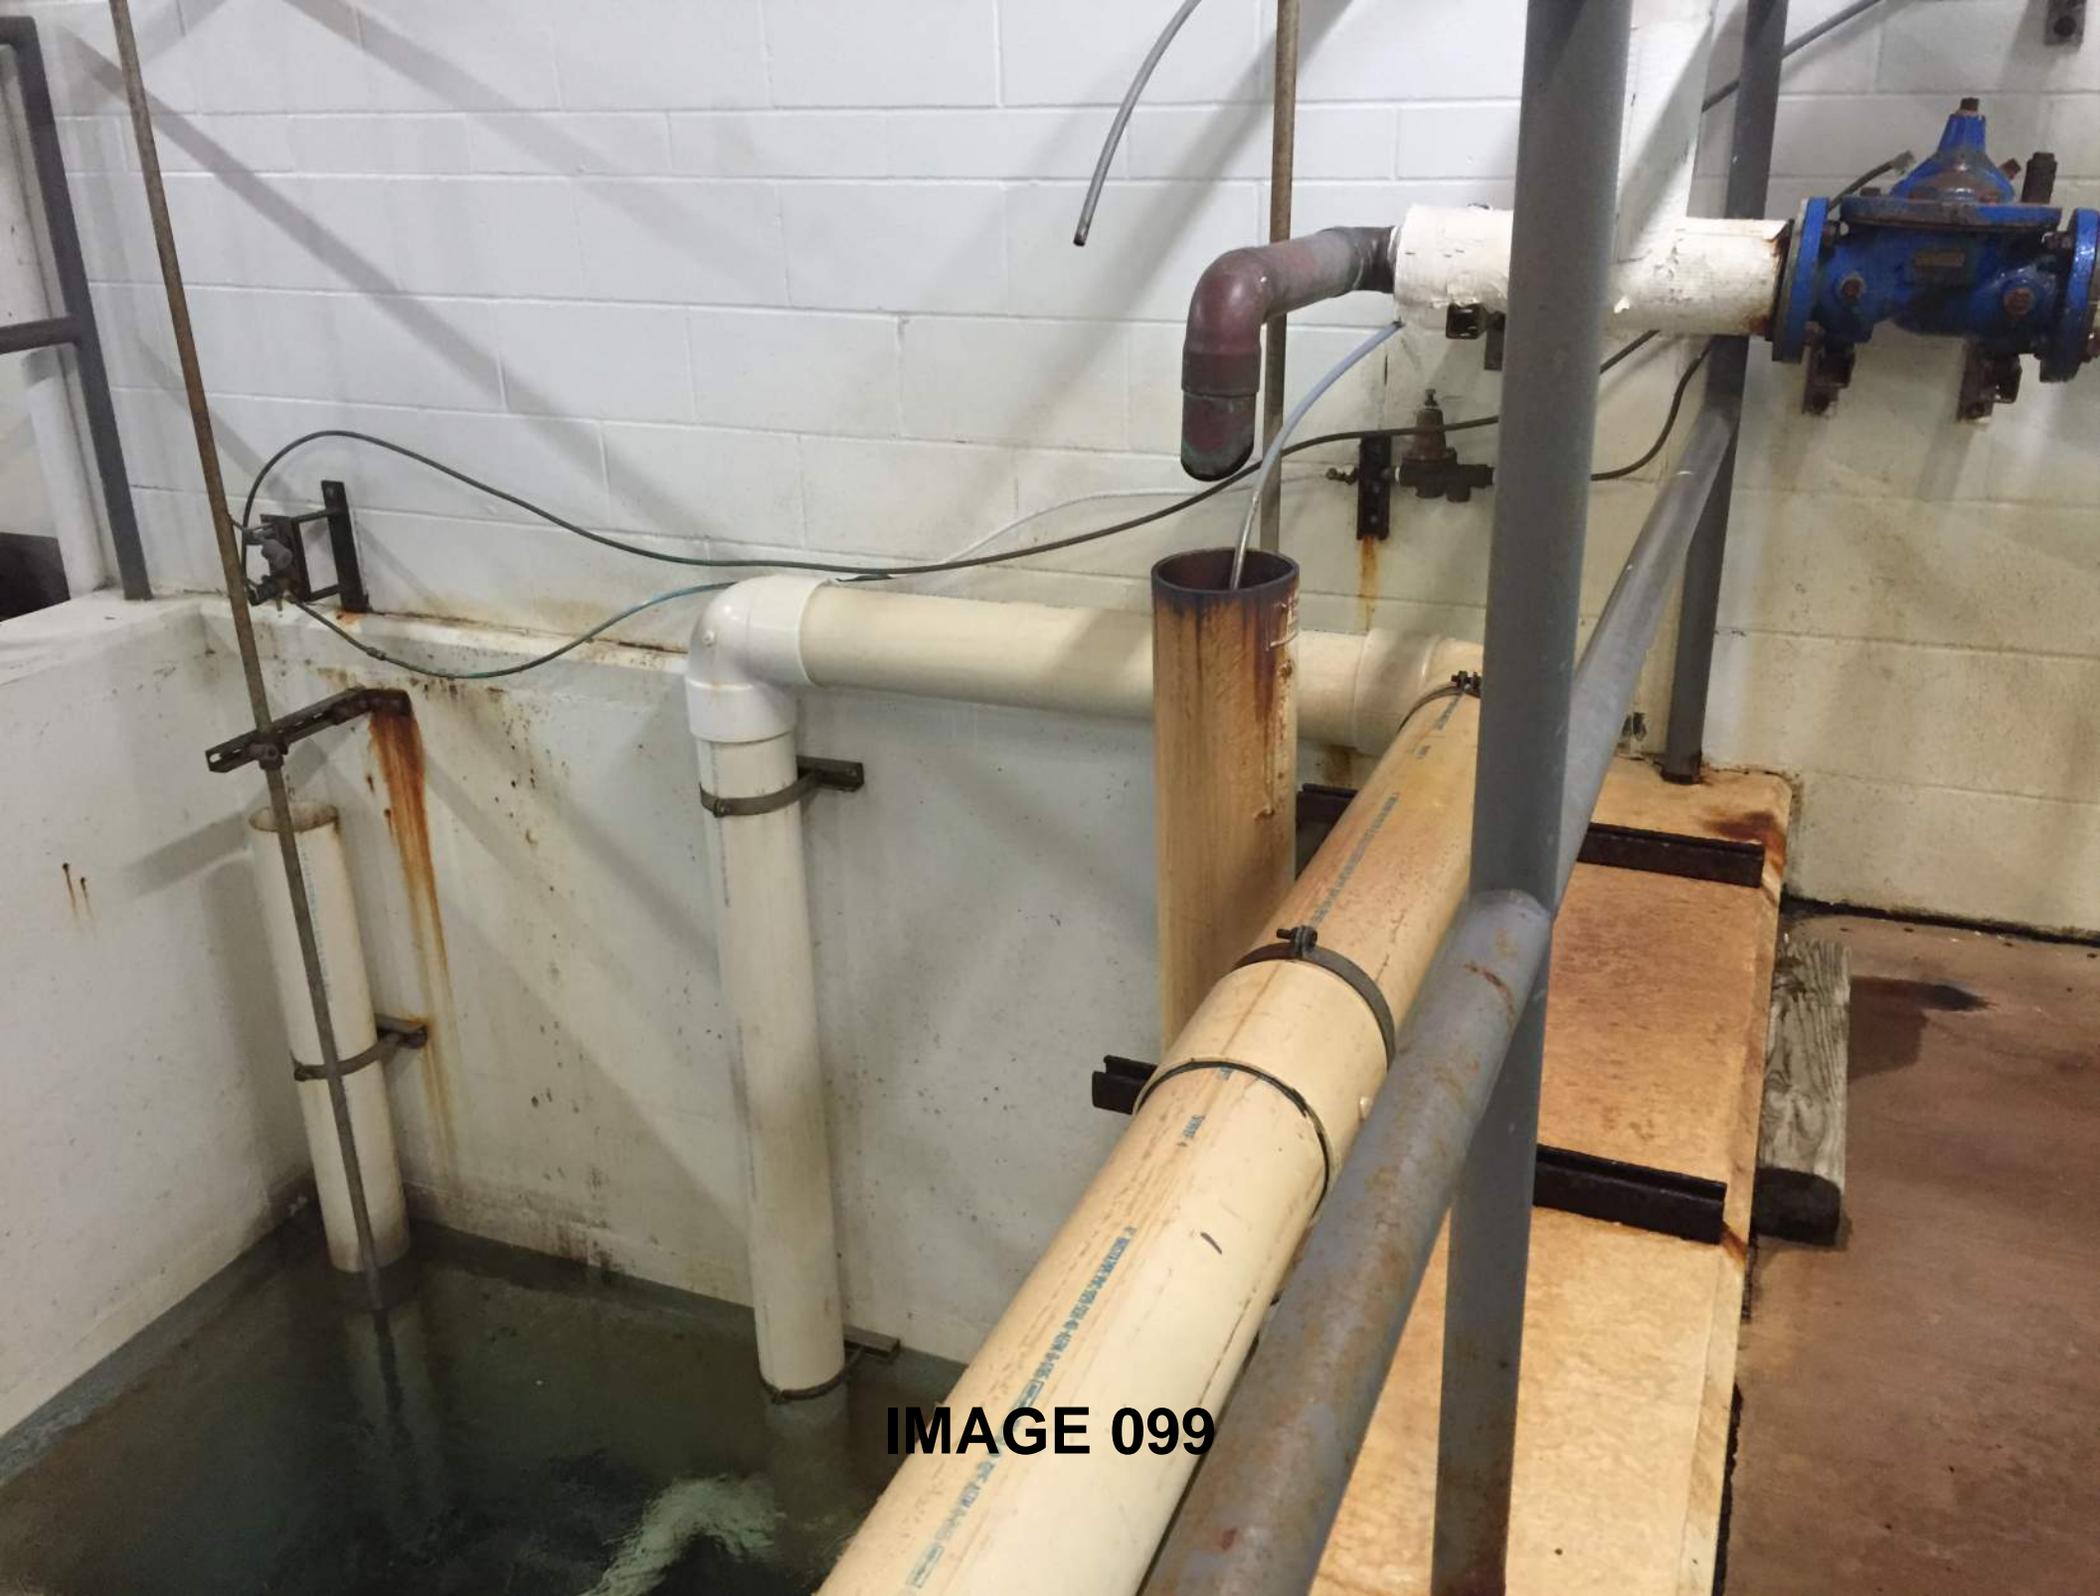
IMAGE 098

Image 098 – Containers of muriatic acid
